THE CONSTRUCTION OF THE GRIFFON COVE WRECK

A Thesis

Submitted to the Graduate College of  
Texas A&M University  
in partial fulfillment of the requirements for the degree of  
MASTER OF ARTS

December 1980

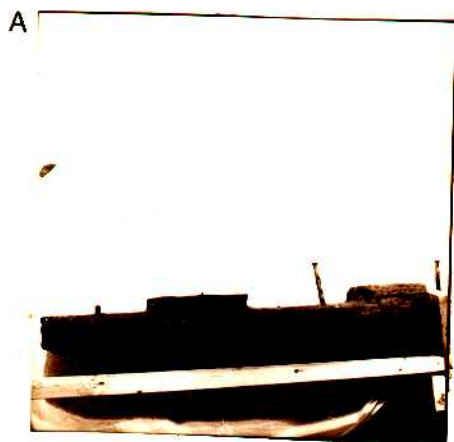
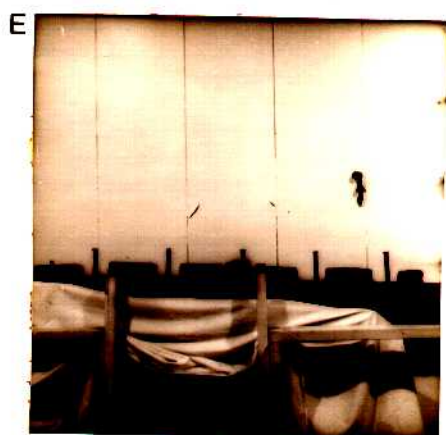
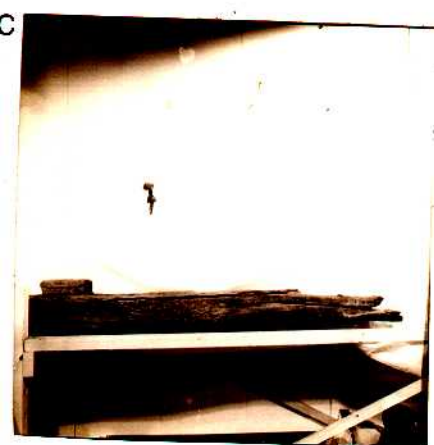
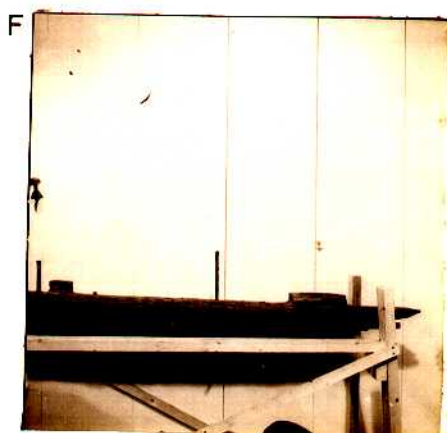
Figure 7. Construction Features of the Griffon Cove Keel

There are rectangular indentations at various points along the side of the keel (figs. 7a and f). Two occur on either side of the forward keel section. Both are 2.5 in. (0.0632 m.) wide and 0.5 in. (0.0126 m.) deep. The fastening holes within them are approximately 0.5 in. (0.0126 m.) and 0.25 in. (0.0063 m.) square. On the after keel section three depressions are visible on the port side and five on the starboard side. All except the aftermost depression on either side are approximately the same size as those on the forward keel section. The two aftermost depressions, one occurring aft of the stern knee scarf, on either side of the keel are the largest and have been partially lost due to abrasion (fig. 7f). Both of these depressions are 10.5 in (0.2655 m.) long, 4.0 in. (0.1012 m.) high, and 0.5 in. (0.0126 m.) deep. Three nail holes are visible in the starboard depression, while five nail holes can be seen in the port side depression.

In the bottom of the keel are six holes. Three contain remnants of iron bolts which are 0.75 in. (0.0189 m.) square. One of these bolts was removed for analysis and conservation. These fastenings were spaced approximately 4 to 5 ft. (1.20 to 1.50 m.) apart.

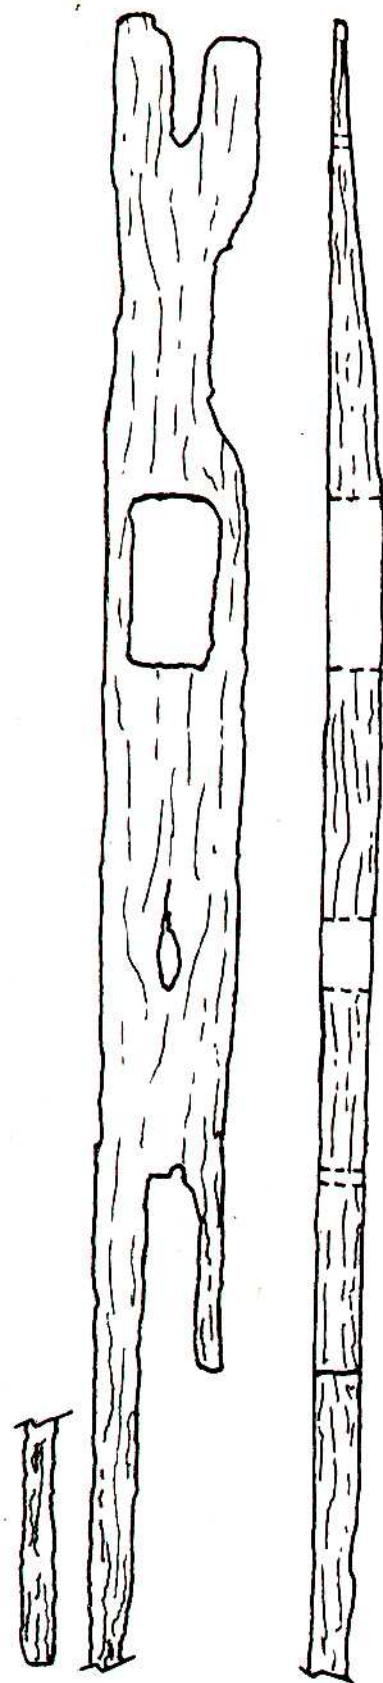
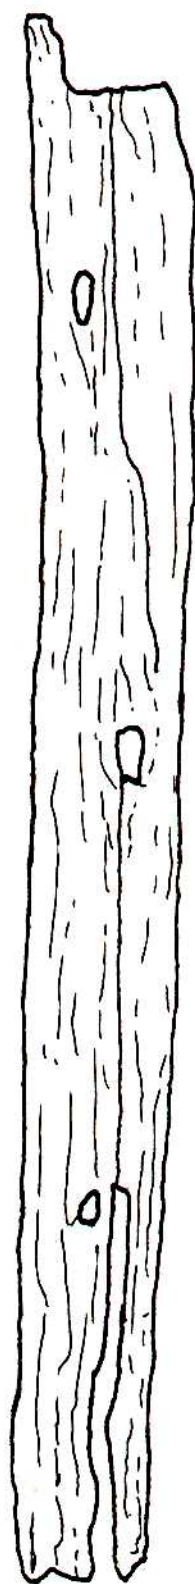
Figure 8. Keelson Fragments from the Griffon Cove Vessel

Two segments of the keelson were found and analyzed. One piece, OCV-77-01-102, is 8 ft. 5 in. (2.4265 m.) long, is moulded 7.5 in. (0.1897 m.) and is sided 3.0 in. (0.0759 m.) (fig. 8). This piece has a 4.5 in (0.1138 m.) by 9.0 in. (0.2277 m.) rectangular hole cut in it. There is evidence of three bolt holes along its length. The other piece, OCV-77-01-103, is 6 ft. 10 in. (2.0530 m.) long, has a maximum width of 8.5 in. (0.2150 m.) and a thickness of 3.0 in. (0.0759 m.). It also shows evidence of three bolts along its length.

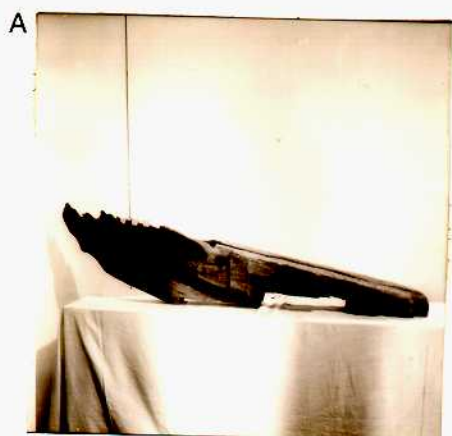
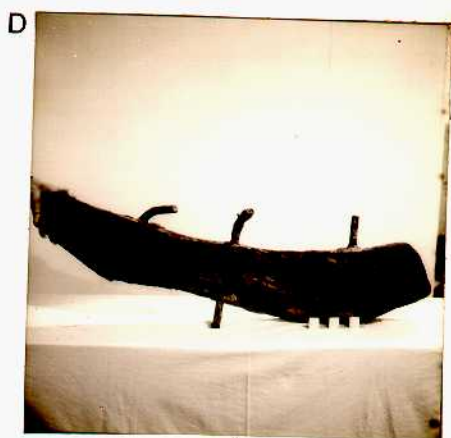
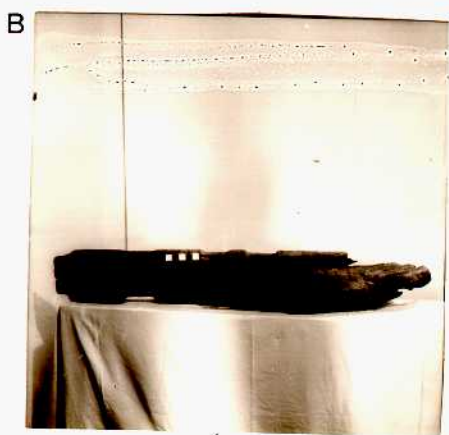
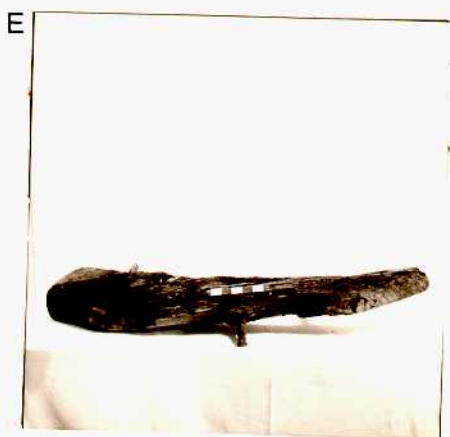
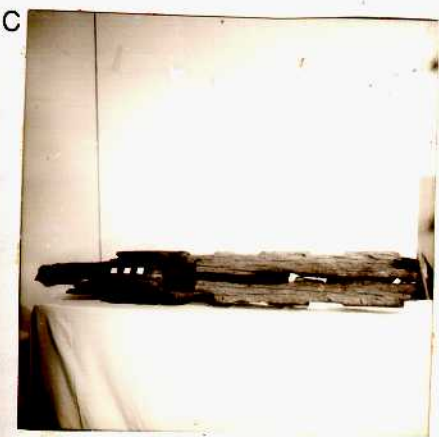
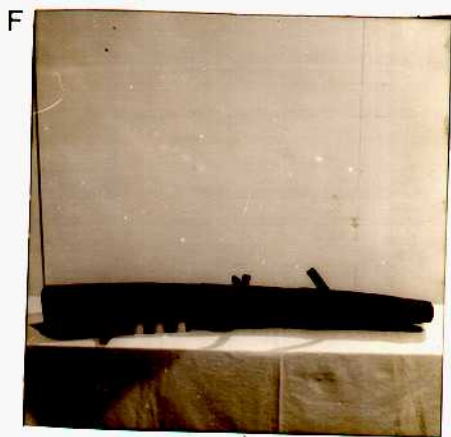
There are three bolt holes in the leading face of the stempost (fig. 9b). The upper bolt hole is in the eroded area of the timber but is evident due to compressed grain which did not deteriorate as rapidly as the wood around it and by a rust stain in the bolt hole.

4 in. (0.1012 m. ) wide, and 3.5 in. (0.0885 m.) deep (fig. 9c). In the base of the mortice is a round impression and a shallow v-notch.

There is a crack which runs the entire length of the stem piece and the deteriorated condition of the wood is causing this crack to threaten the structural integrity of the piece. Careful handling was necessary to prevent further damage or splitting of this piece into two parts.

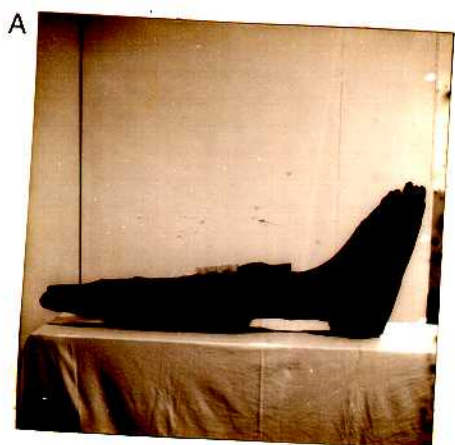
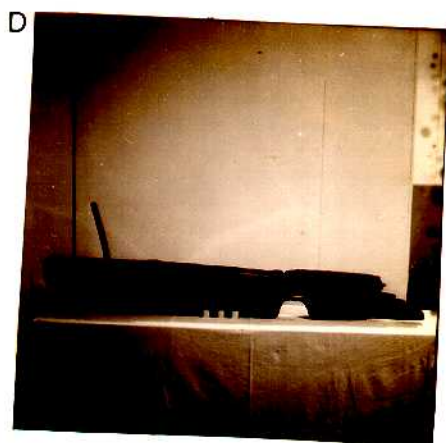
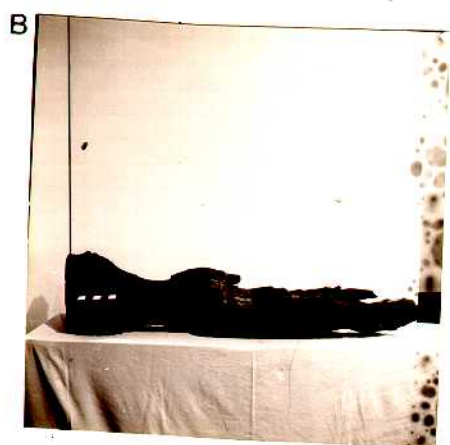
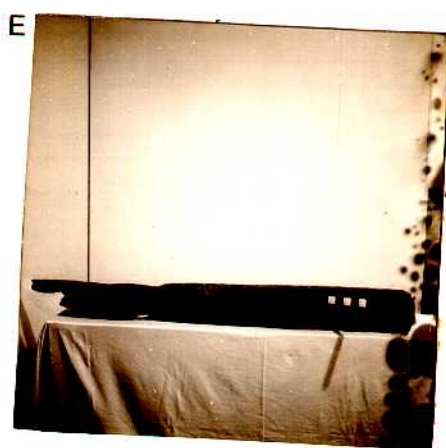
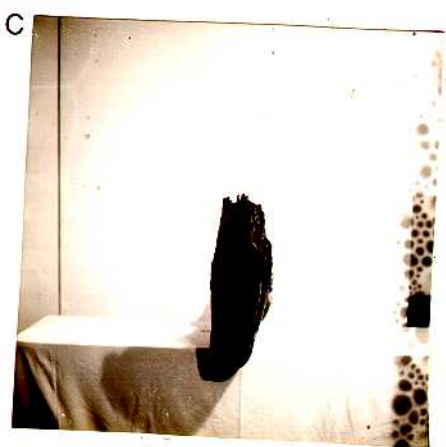
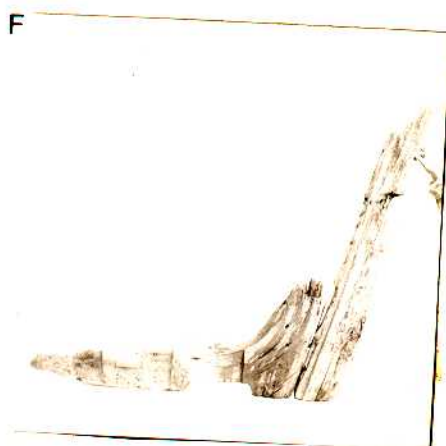
There is a rabbet in the sternpost. A line of nail holes is evident showing where the planking terminated. The rabbet is approximately 2 in. (0.0056 m.) deep, but varies due to the wood's deteriorated condition. The width of the sternpost between the rabbets ranges from 3.5 to 4.2 in. (0.0885 to 0.1062 m.).

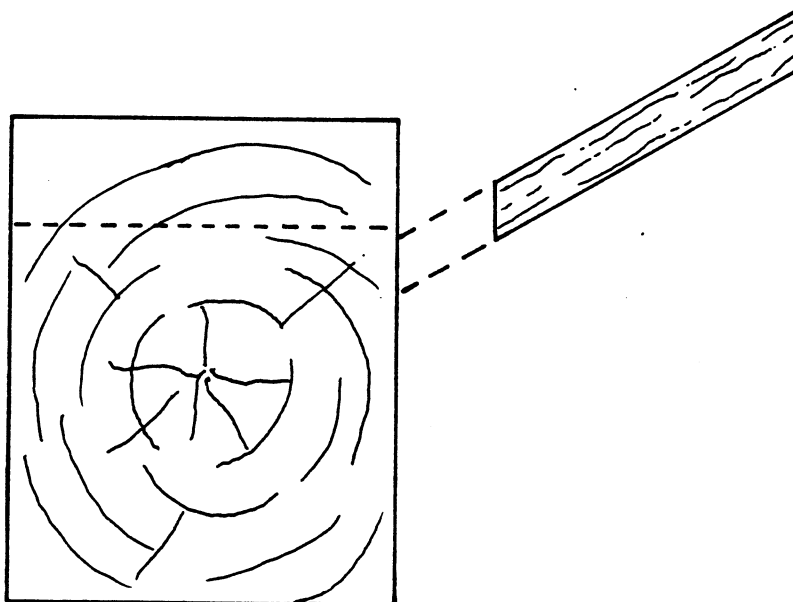
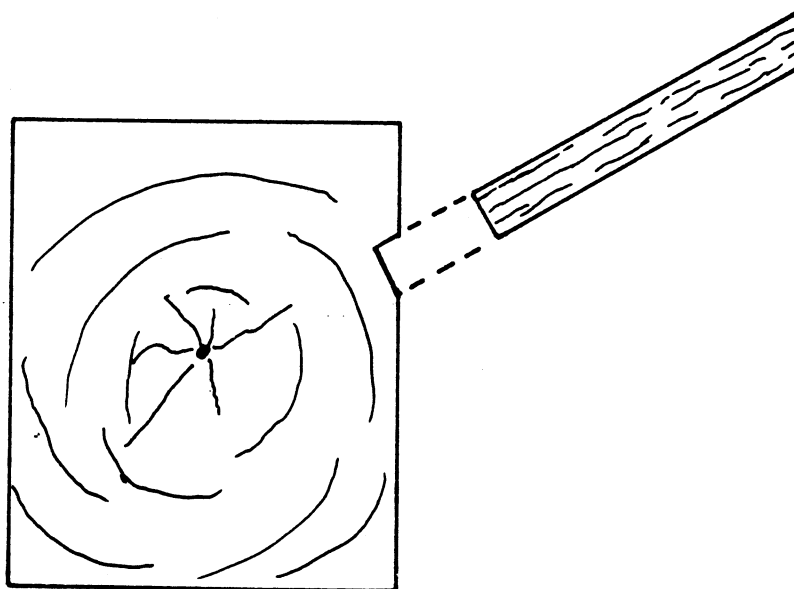
Figure 13. Keel-Garboard Construction of the Griffon Cove Vessel  
and Construction of A Rabbeted Keel

There does not appear to be a rabbet in the keel, but only slight indentations at various points along its length where one would expect to find a rabbet. There are two possible explanations for this. The first is that these features are the remnant of a rabbet which was eroded through years of abrasion on the rocks of the cove. The second is that the ship was planked without a rabbet and normal movements between the keel and the planking wore the impressions in the keel during the life of the vessel. The second explanation is the more probable, due to features of the garboard and other major timbers. The edge of the garboard is beveled at an angle such that when it is held against the bottom of the floors as if it were fastened to them, the edge fits against the side of the keel exactly (fig. 13). If the keel had been rabbeted, the edge of the garboard would have been left square in order to set in the rabbet at the proper angle (fig. 13).

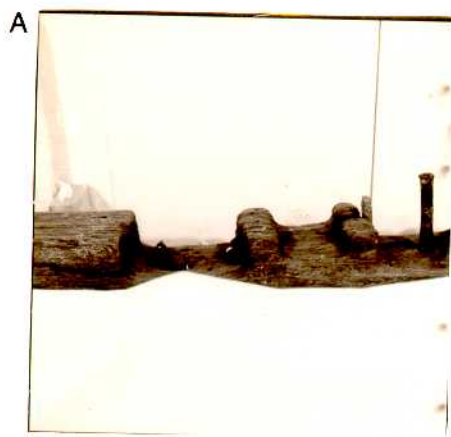
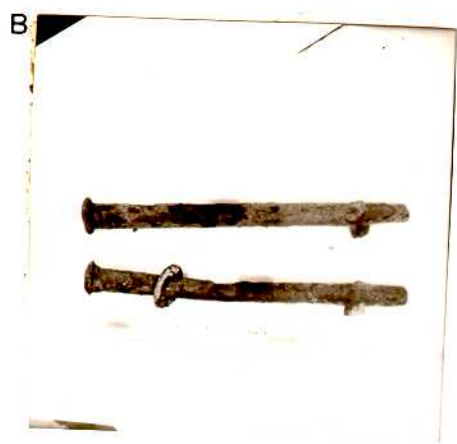
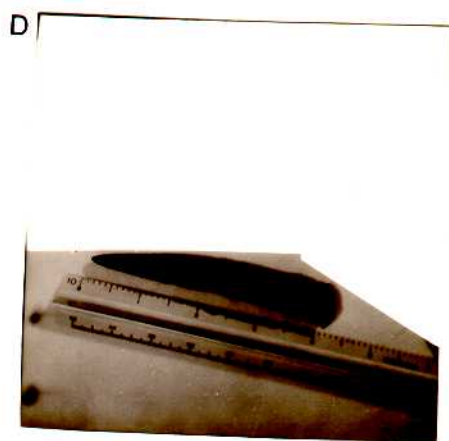
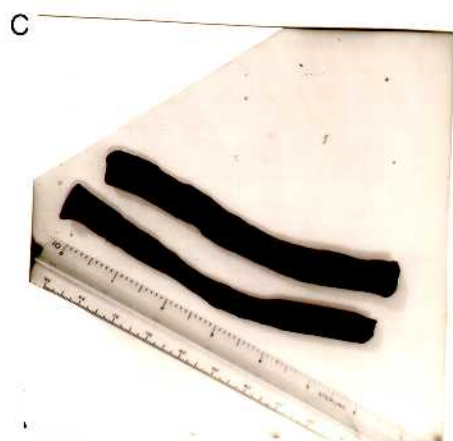
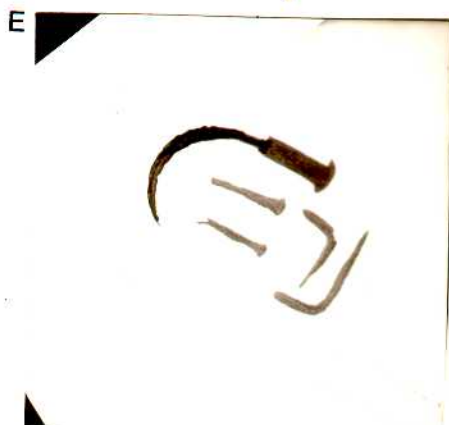
those used for the gripe and sternpost, 0.75 in. (0.0189 m.) in diameter.

Forelocked bolts were used to fasten the stem and stern knee to the keel (fig. 15, p.76 ). A wedge or key, driven into a slot in the end of these bolts, prevented their loosening. No bolts of this type have been found intact, but a number are in the collection associated with the timbers, and others have been found during the course of excavation by the Canadians. These bolts have diameters of .75 in. (0.0189 m.).
