The Drogheda boat and clinker boats of the Renaissance on Europe's western seaboard

Holger Schweitzer

Ph.D. thesis
submitted December 2013 to
the University of Southern Denmark

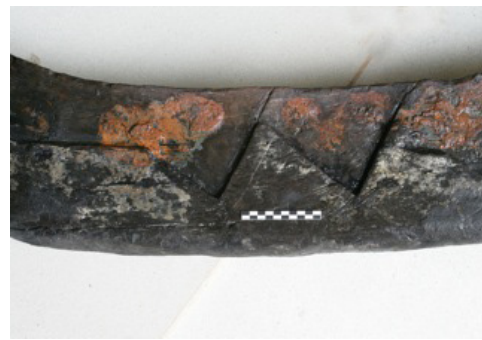
Figure 3-12: Detail of hood end rebates with setting out marks (Brogan 2009)

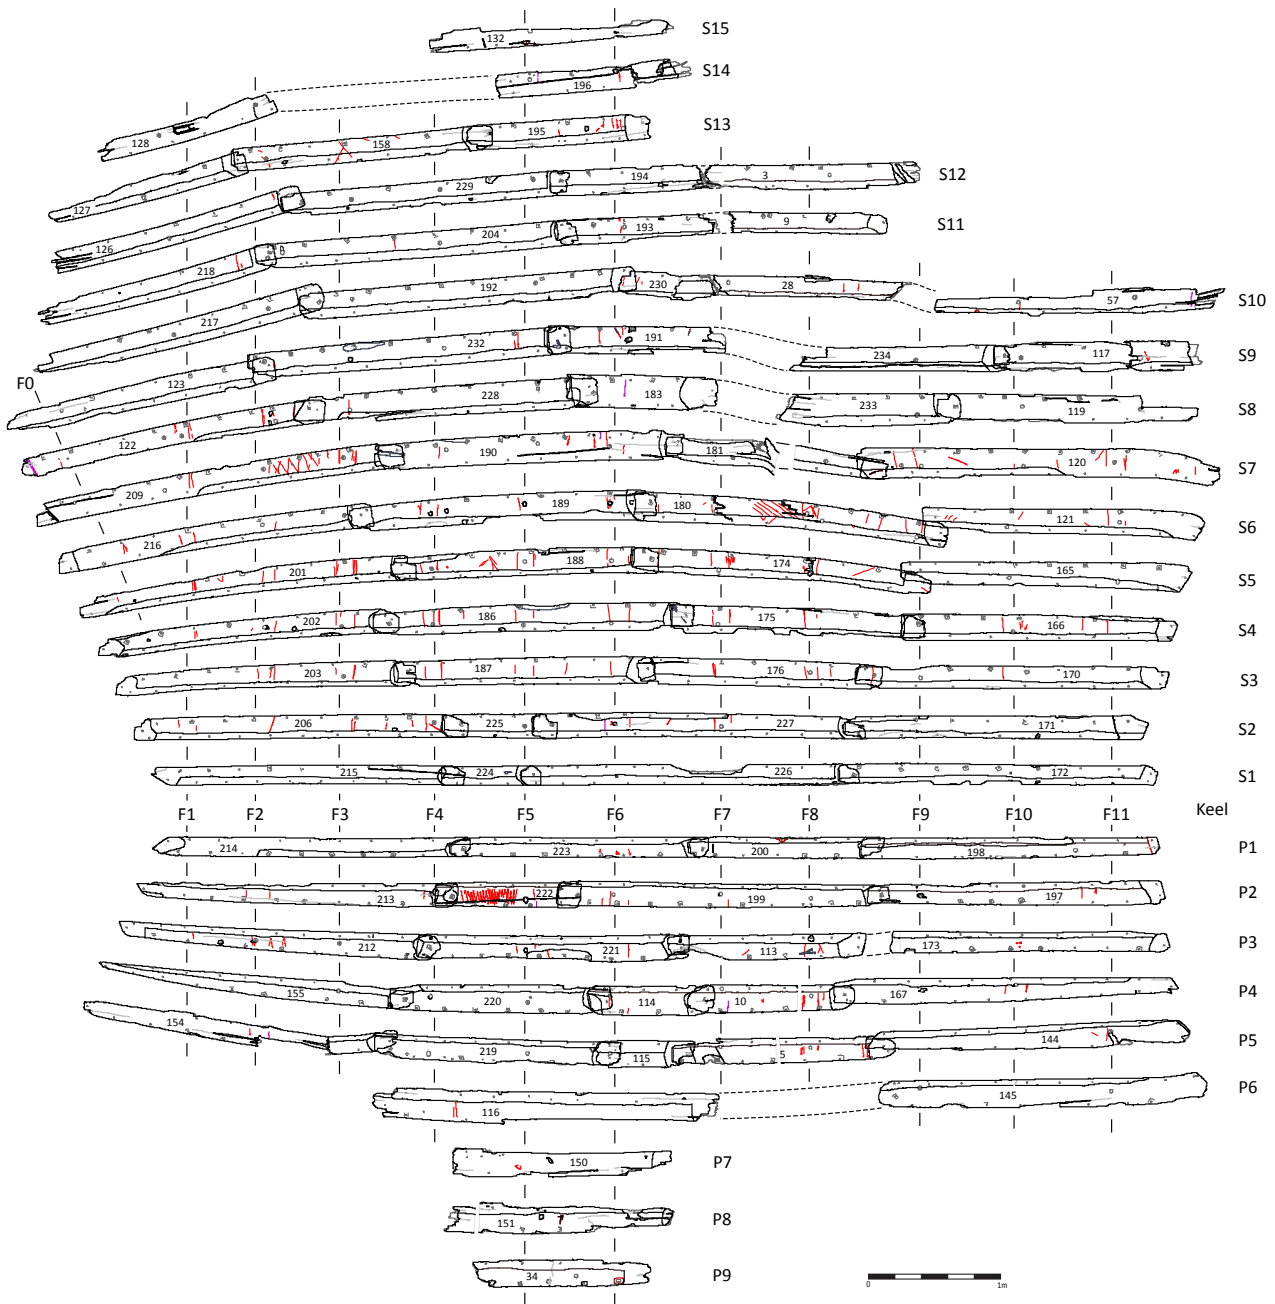
Figure 3-15: Strake diagram showing the wreck as found based on the Rhino drawing of the hull planks (Schweitzer 2013)

The framing comprises twelve preserved frame stations, which have been numbered consecutively from bow to stern (Figs. 3-15 and 3-26). Each of the preserved frame stations (F1 to F11) consists of a floor timber and abutting side timber placed aft of the floor timber with an overlap of two strakes. Of the eleven frame stations all floor timbers were at least partially preserved. Of the side timbers ten were preserved on the starboard side either in-situ or found dislodged from their

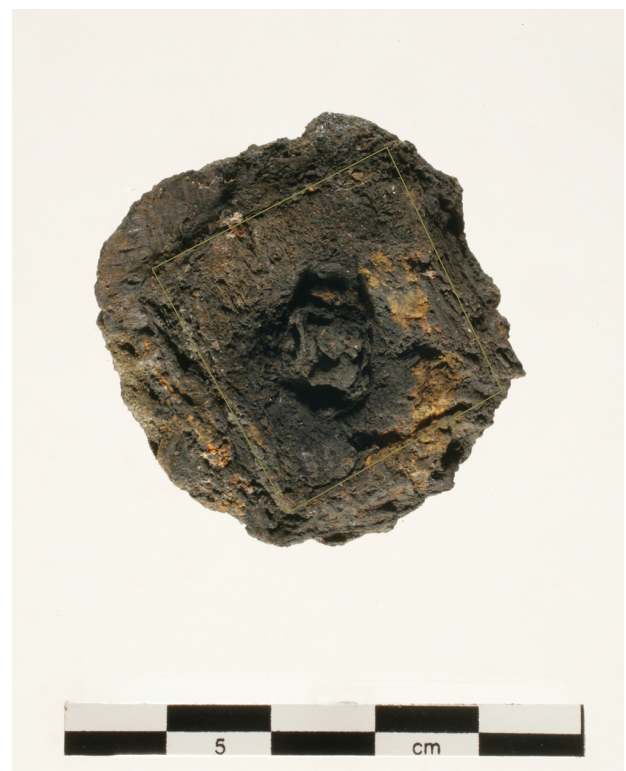
Figure 3-20: Concreted rove with outline highlighted in red (after Brogan 2009)

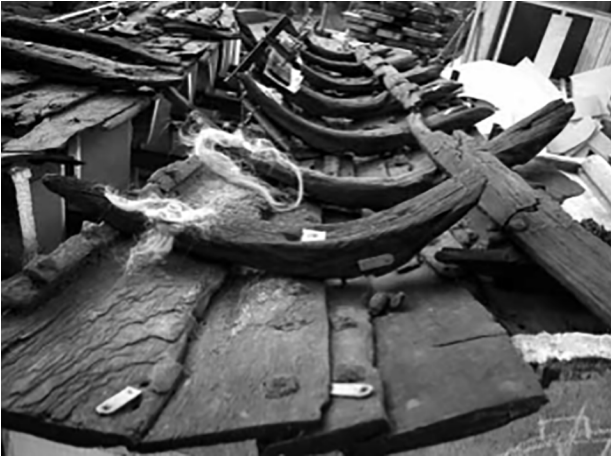
Figure 4-22: Hull planking after conservation with “reinforced” strakes visible in the foreground (Rieth, 2006 p. 608)

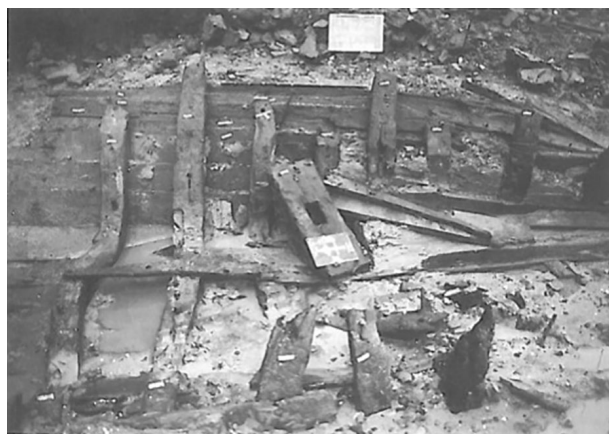
Figure 4-30: Disarticulate mast step in stern section of the Bremen Teerhof wreck (Brandt, 1979 p. 325)

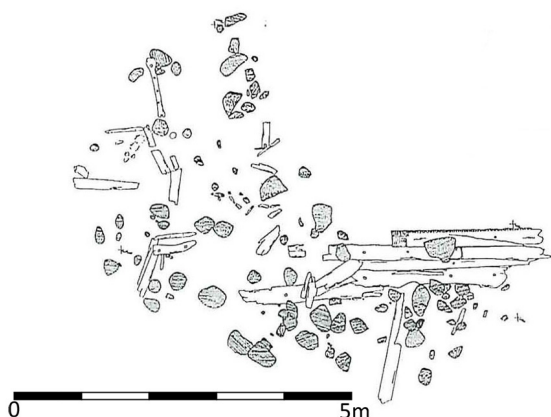
Figure 4-45: Site plan of Dokøen 4 (after Gøthche & Høst-Madsen, 2001 p. 30)

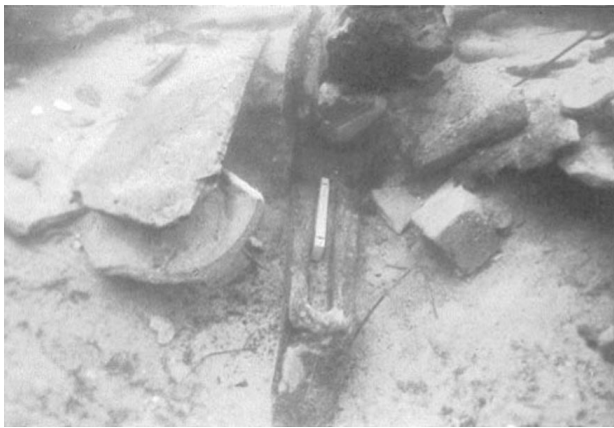
Figure 4-51: Stern end of keel with mortise for sternpost of Lundeborg 2 wreck (Skaarup, 1979 p. 70)
