**THE CONSTRUCTION OF THE BROWNS BAY VESSEL**

A Thesis

**CHRISTOPHER FRANCIS AMER**

The Construction of the Browns Bay Vessel.

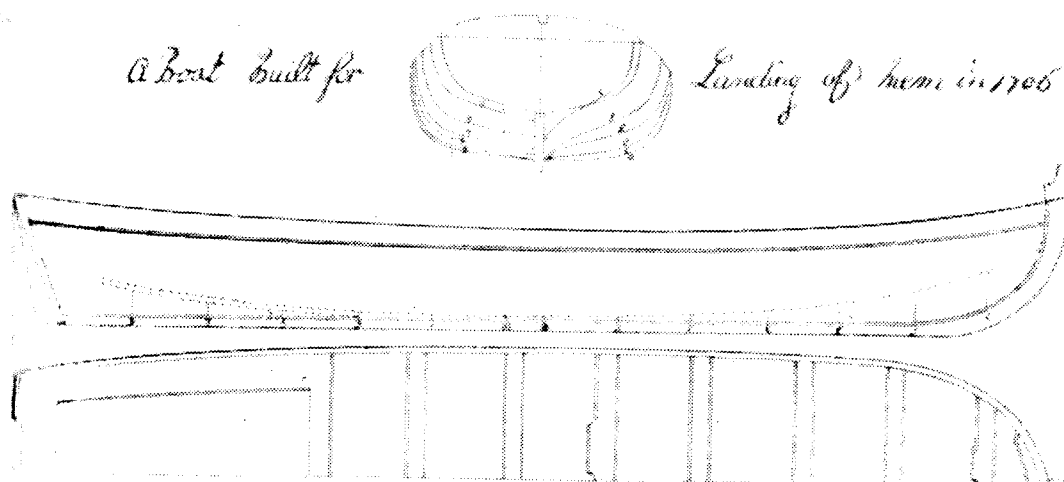
Figure 5. "A Boat built for Landing of Men in 1706."  
(Courtesy of the National Maritime Museum.)

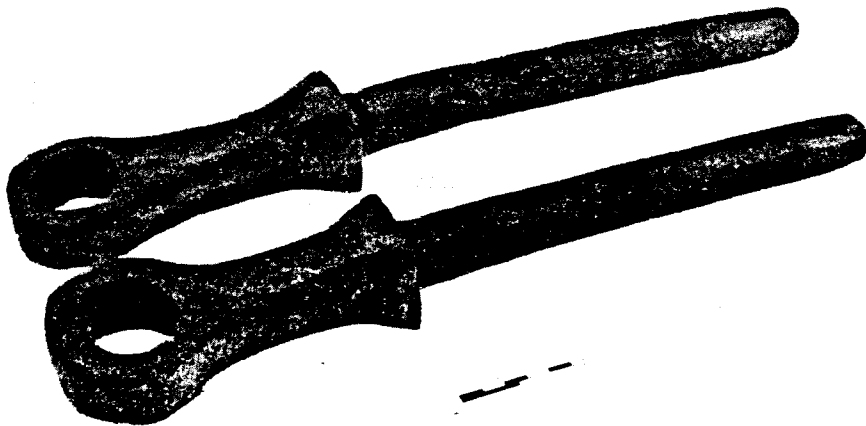
from within the hull. Artifacts recovered amidships included two fragments of chainplates as well as two forelocked eye-bolts (Fig. 9).

Figure 9. Forelocked eye-bolts from the midship beam of the Browns Bay Vessel. (Photo by the author.)

the artifact collection of Parks Canada (see Fig. 9, p. 21). The 15-inch-long and 1-1/4-inch-diameter bolts were drifted vertically through the beam, and their lower ends secured by small iron wedges, called fore-locks, driven through slots in the shafts. The upper ends of the bolts extend 2-1/4 inches above the beam, becoming rectangular in section, and are bisected by 1-3/4 inch holes. At least one of the bolts is stamped with a British broad arrow, indicating government ownership.

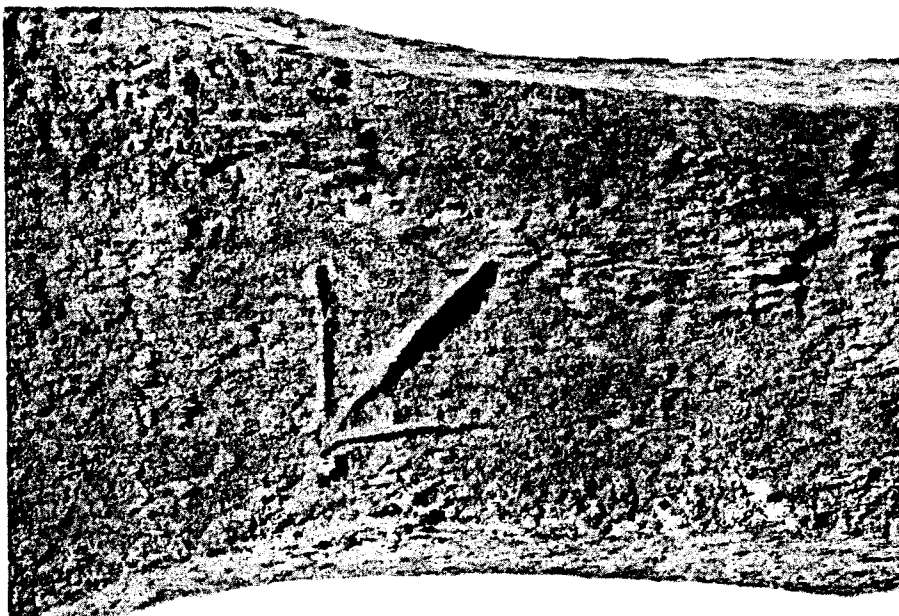
The bolts are identical to two bolts fastened through the midship beam. One eye-bolt is stamped with a British broad arrow denoting naval origin (Fig. 10). Also recovered amidships were three single sheave blocks, their shells cut from a single block of wood, and a sheave (Fig. 11).

Figure 10. Broad arrow stamped in an eye-bolt from the Browns Bay Vessel. (Photo by author.)

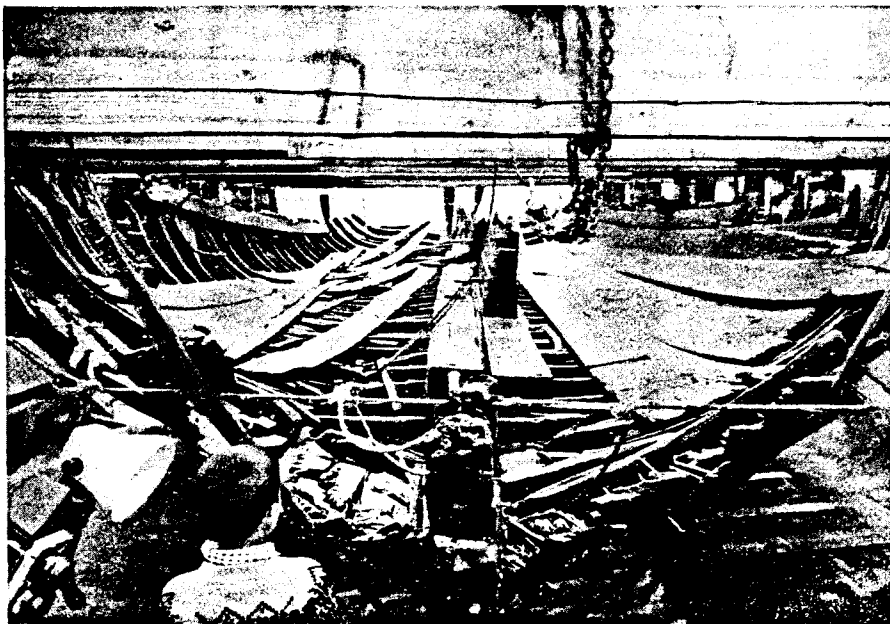
During the spring of 1967, a wooden cradle was prefabricated and fitted over the wreck. Six slings were passed through tunnels cut through the clay beneath the hull. The structure was made buoyant and towed 2-1/2 miles upstream to Mallorytown Landing. There the structure, weighing an estimated 22 tons, was lifted from the water and set on a gravel pad (Fig. 13).

Figure 13. The hull of the Browns Bay Vessel slung beneath a cradle, soon after raising. (Courtesy of Archaeological Research Division, National Historic Parks and Sites Branch, Parks Canada.)

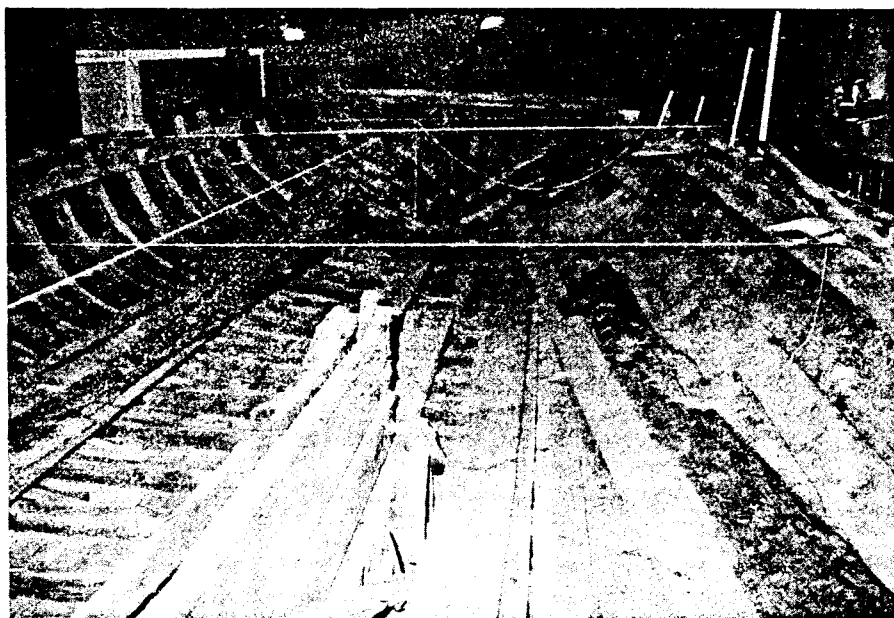
A string was stretched along the approximate centreline of the vessel and levelled. This acted as the base plane to which the sections could be related. Strings were stretched to opposite timber heads, perpendicular to the base line, where sections were to be taken (Fig. 15). These were levelled and a tape was run along each string. The lowest point of each plank overlap was located by measuring the distance vertically to the cross hull string and horizontally to the base line. The point was then plotted directly on gridded paper at a 1-1/4 inch to 1

Figure 15. The stern of the Browns Bay Vessel showing levelled strings used for taking hull sections. (Photo by the author.)

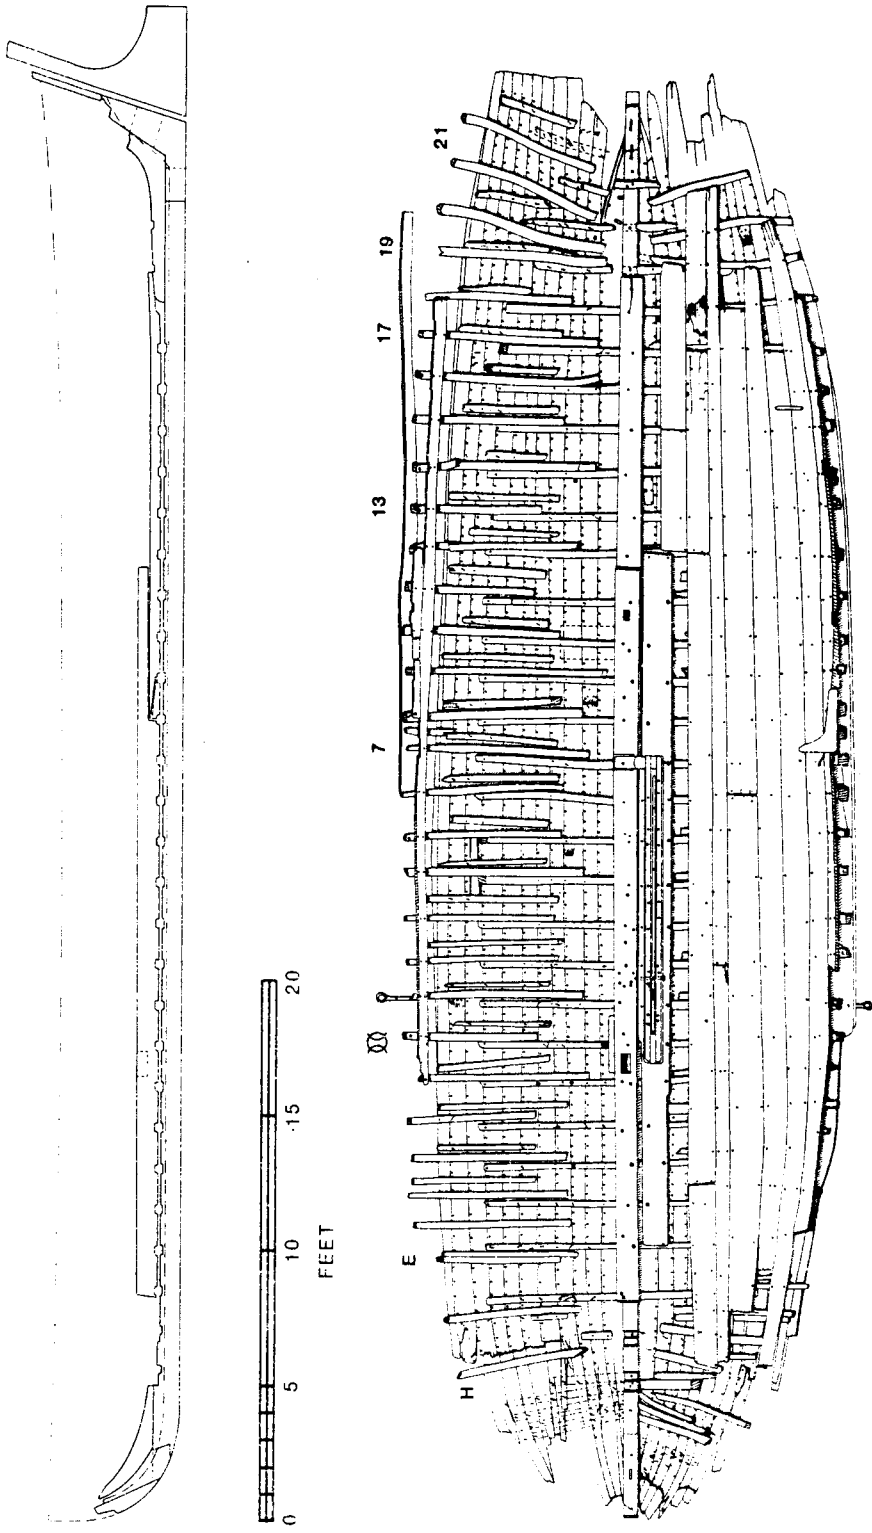
lines of the drawings. The revised wreck plan (Fig. 16) was produced in this way by adding information to and redrawing the underwater wreck plan.

Figure 16. The revised wreck plan of the Browns Bay Vessel. (Drawing by the author and C. Piper.)

Iron nails, 1/4-inch square in section, project 2 to 2-1/2 inches along the chainwale's upper edge. Below this, several eroded holes indicate positions of bolts and at least one chainplate. The chainplate is still attached near the starboard head of frame 1 (see Fig. 16, p. 35).

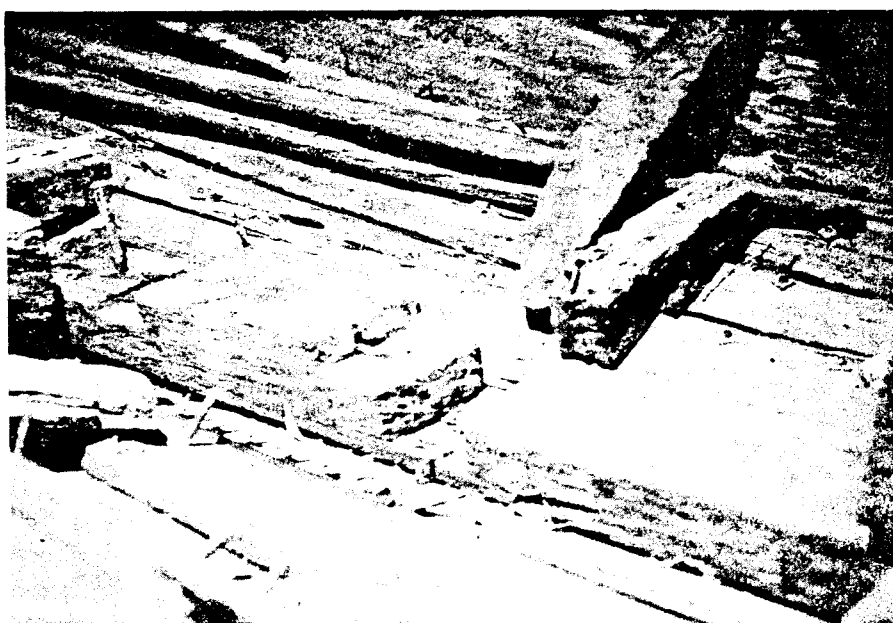
Because of the integral nature of the keel, floor timbers and keelson, direct observation of the upper face of the keel could be made only at the forward two floor locations. At frame locations G and H, a second, shallower notch had been cut forward of the forward face of each floor notch (Fig. 17). These notches measure 1 inch deep by 3 inches long at G, and 2 inches deep by 5 inches

long at H. Between them the keel's moulded dimension increases to 10 inches, and forward of H to nearly 12 inches. The forwardmost notch is pierced by two 5/8-inch iron bolts, one of which protrudes above the keel, its peined end almost level with the upper surface of the apron (see Appendix B for nail and bolt descriptions).

Figure 17. The notched upper surface of the keel of the Browns Bay Vessel at frames G and H. (Photo by the author.)

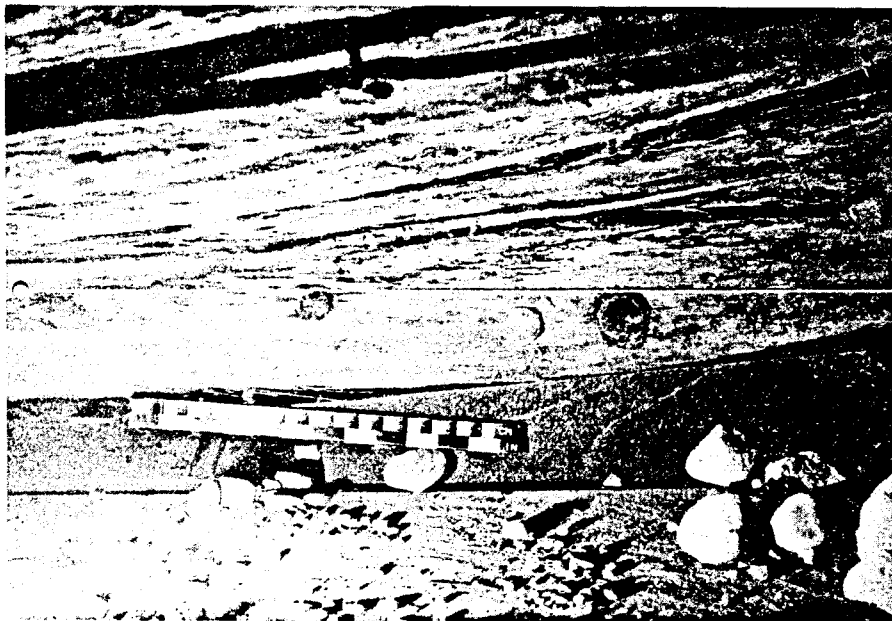
others may have been inserted to replace knots. Two 3/4-inch iron bolts bisecting the moulded surfaces of the keel held together and strengthened the keel where it had split aft of the lower seam of the stem scarf. A 1-5/8 inch treenail, located between the two bolts, plugged a hole, probably once used to facilitate hauling the vessel (Fig. 18).

Figure 18. A view of the starboard side of the Browns Bay Vessel's keel, near the bow, showing bolts and treenails. (Photo by the author.)

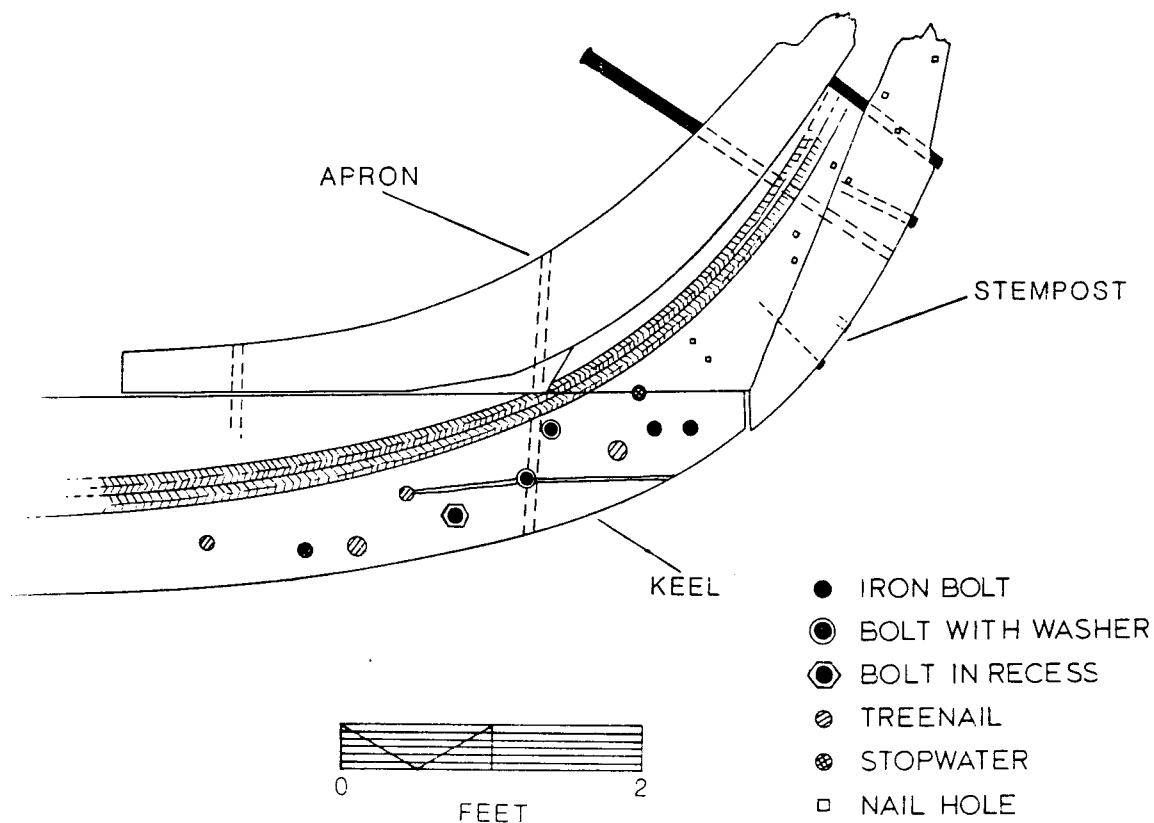
The stem consists of a stempost and an apron. Only the lower 3 feet of each timber have survived, representing over half of the original height of the stem (Fig. 19).

Figure 19. The stem of the Browns Bay Vessel.  
(Drawing by the author and C. Piper.)

aft end. It is sided 5-1/2 to 6 inches, while the moulded dimension thickens from 3 inches at its aft end to 6 inches atop the stempost. The forward face sits against and mirrors the interior curve of the stempost, while the after 18 inches of the timber is flat to facilitate seating atop the keel. At the transition from curve to flattened base a space was formed, as the stempost has a greater moulded dimension than the keel at that point. A bolt used to fasten the apron to the keel passes through this space (see Fig. 19, p. 40).

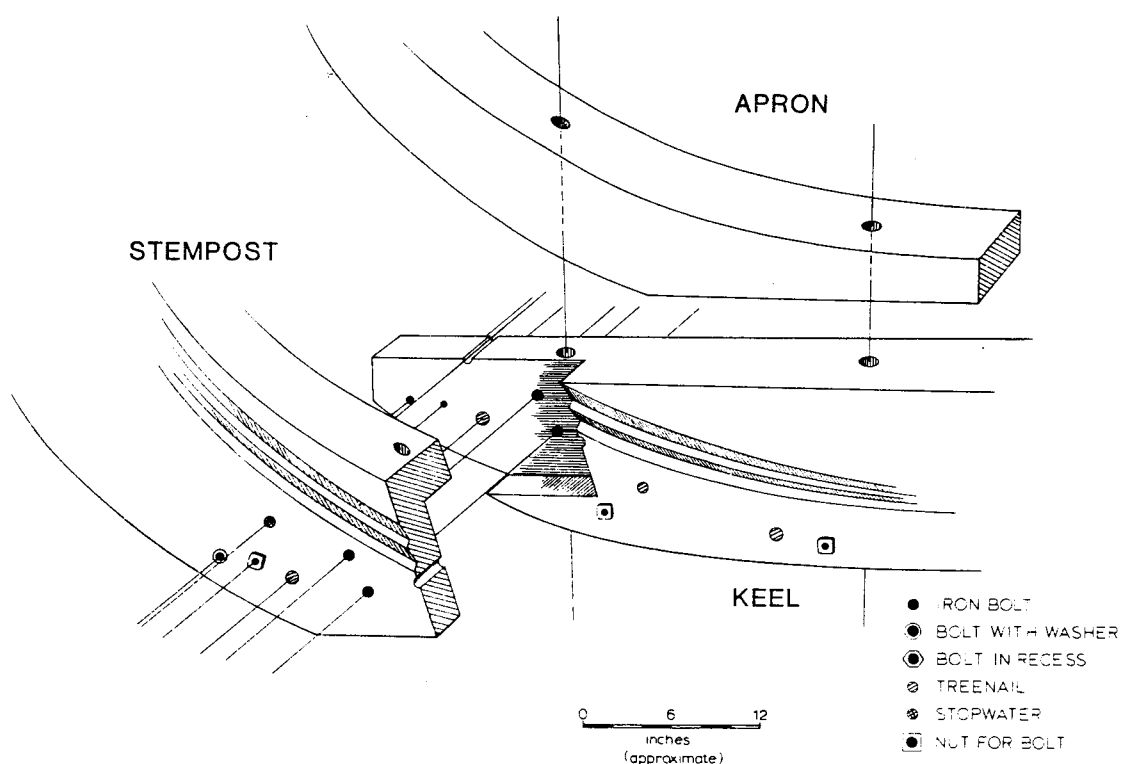
The stempost is joined to the keel by an elaborate scarf having both horizontal and vertical tables (Fig. 21). Four iron bolts clamp the scarf athwartships: three 3/4-inch bolts peined over 1-1/4 inch washers, and a 3/4-

Figure 21. Exploded view of the stem scarf of the Browns Bay Vessel. (Drawing by C. Piper.)

inch threaded bolt with a 1-1/4 inch square nut, which was probably a later addition to strengthen the structure. A 1-1/4 inch treenail with a cross cut into its starboard end also bisects the scarf (Fig. 22) (see Appendix B for nail and bolt descriptions).

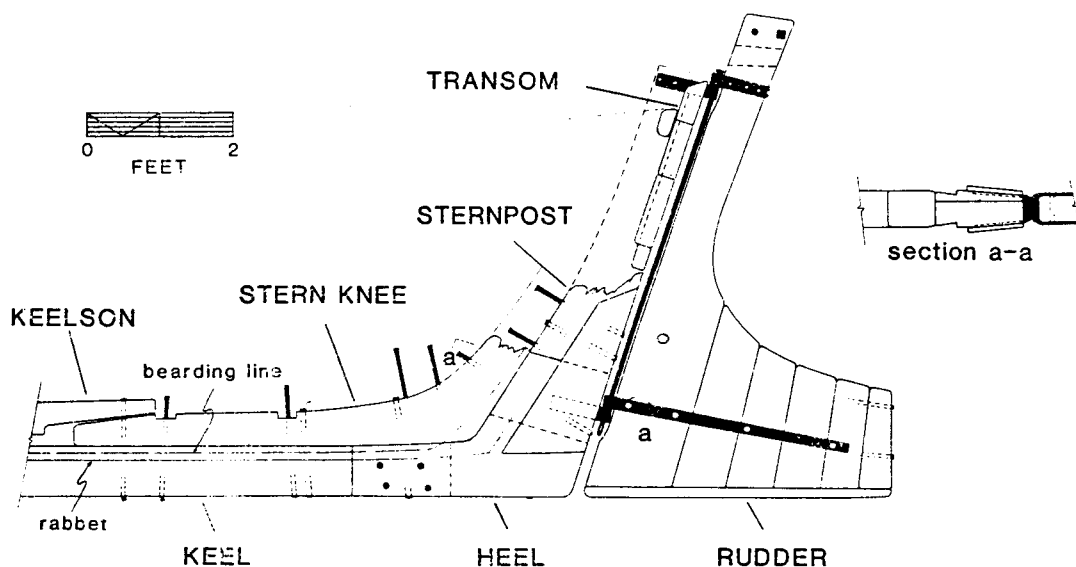
The stern of the vessel is more complete than the bow. Surviving timbers include the heel, sternpost, stern knee and transom (Fig. 23).

Figure 23. The stern of the Browns Bay Vessel. (Drawing by A.E. Wilson [Parks Canada], and the author.)

A large head at its upper end prevented the rod from slipping down through the holes, while an iron wedge, inserted in a 1-1/2-inch-long slot in the lower end of the rod prevented it from lifting out of the holes (see Fig. 23, p. 45).

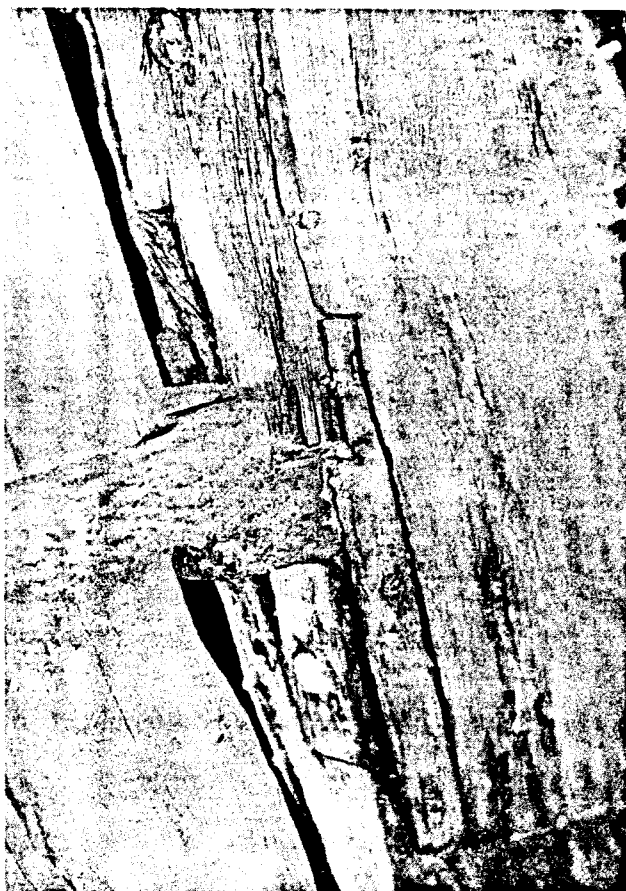
The vertical arm of the heel is 1 foot, 11 inches long and terminates at its upper end in a vertically placed scarf, which facilitates attachment of the sternpost (Fig. 24). The shipwright cut the 1-foot-long tables of the scarf at a slight angle to the grain of the timbers to prevent splitting, and to give more bearing surface to the scarf. He also offset the scarf seam to one side, allowing a 1-inch upper nib on the port side and a 2-1/4 inch lower nib to starboard. One of the bolts fastening the stern structure terminates near the bottom of the scarf, but is clear of the scarf seam. Apparently stopwaters were not considered necessary in this scarf.

The sides and forward seam of the scarf were not examined due to the presence of a panel of oak sheathing covering either side of the sternpost. From incomplete observation, mostly by touch, it was concluded that the seams were caulked and the scarf fastened in a manner similar to that of the keel/heel scarf.

Figure 24. The heel/sternpost scarf of the Browns Bay Vessel. (Photo by the author.)

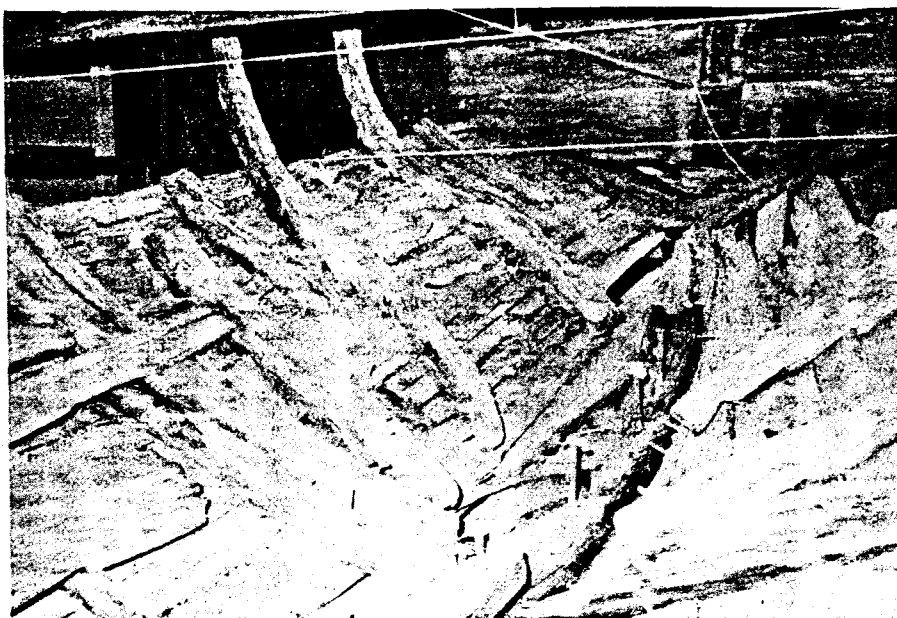
The stern knee of larch (Larix spp.), and seated atop the keel, served as a support between the keel and sternpost (Fig. 26). This important timber was chosen for its natural curvature, which was matched to the rake of the forward surface of the sternpost--approximately 34 degrees. The surfaces of the knee are severely eroded and

Figure 26. The stern knee and timbers in the starboard quarter of the Browns Bay Vessel. (Photo by the author.)

much dry rot is evident. The base survives along its entire 5 foot, 6 inch length, while only the lower 18 inches of the vertical arm remains. The upper end appears to have been broken off, possibly at the same time as the sternpost. It is moulded 3-1/2 inches at its forward end, 8 inches where the timber begins its upward sweep, and 7 inches near its eroded upper extremity. The knee is sided 6 inches.

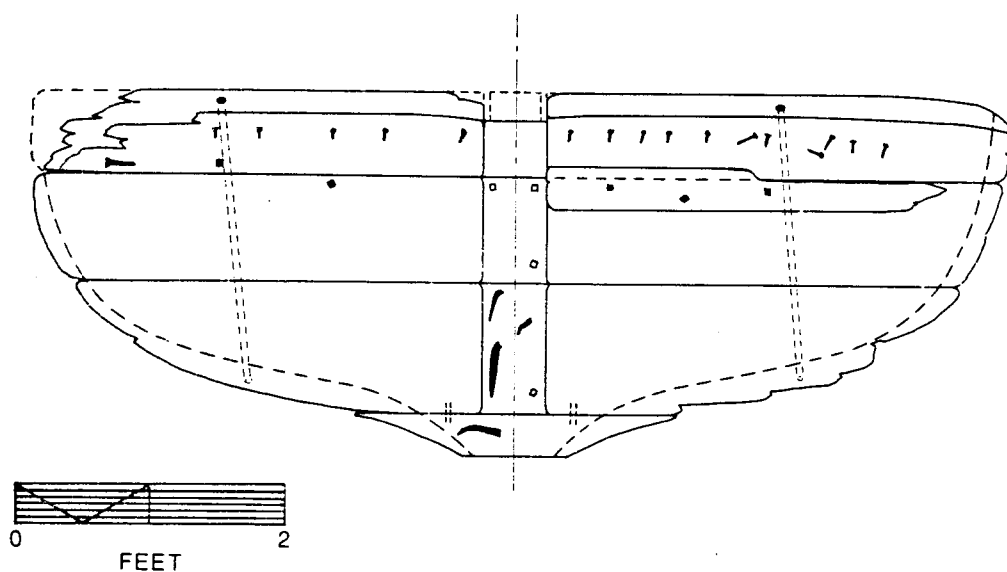
The transom is essentially complete (Fig. 27). At its widest point it is 7 feet, 6 inches and measures 2 feet, 9 inches in height. It is made up of three planks, each 3-1/2 inches thick, which are edge-joined by two 5/8-inch iron drift bolts. The bolts pass vertically through all three planks and are peined at their ends. A lower 2-1/2 inch-thick plank is fastened to the one above by 1-inch treenails.

The upper edge of the transom is finished with a forward sloping bevel approximating the vessel's sheer. Two and one-half inches below this, a row of 1/4-inch iron nails diagonally enter the inboard face of the structure. These appear to have been used to secure deck planks to the transom. The plank ends rested on two 2-inch by 4-inch timbers which extended the full width of the stern

Figure 27. Inboard view of the transom of the Browns Bay Vessel. (Drawing by A.E. Wilson and the author.)

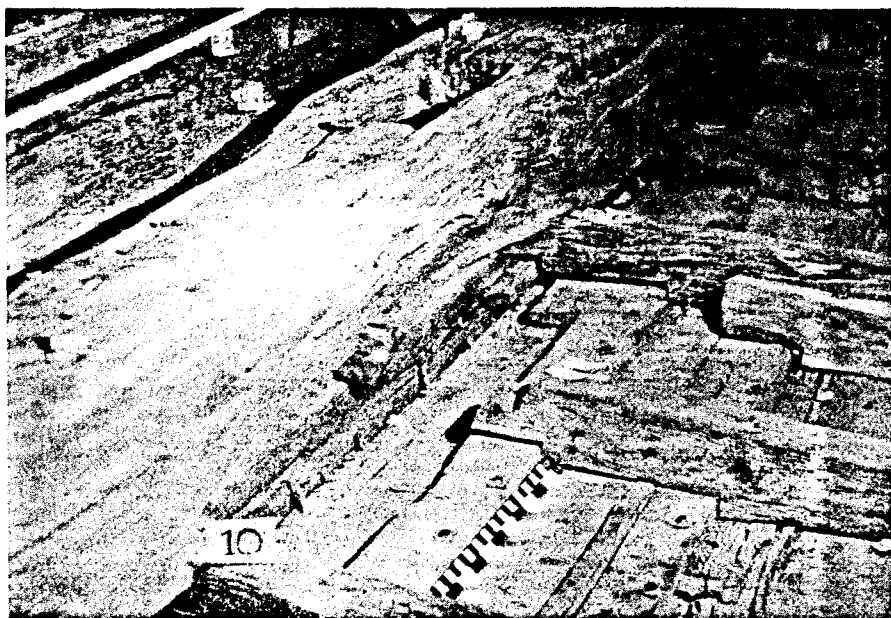
The inboard 5 inches of the starboard side of the midship floor timber were cut away during, or subsequent to, the refit (Fig. 31). Part of an added keelson was cut out at this frame, and a section of the original garboard removed.

This appears to have been done to provide access to the bottom of the vessel at its lowest point in order to facilitate the removal of bilgewater (Zacharchuck and Rick, 1969: 10). The midship floor timber and floor timbers 1 to 7 were cut through on the <sup>Port</sup> ~~starboard~~ side to facilitate the installation of a centreboard.

Figure 31. View of cut midship floor timber, starboard garboard and gouged out keelson. Note cut out garboard from the inner planking layer and nails terminating in side of keel. (Photo by the author.)

In two places the garboards had been modified. On the starboard side, where the midship floor timber was cut away, the inboard half of the garboard had been cut and removed for a length of 26 inches (see Fig. 31, p. 58). The outboard half of both inner and outer port garboards, as well as half of the second strakes, had been cut through for a length of approximately 11 feet when the centreboard was installed.

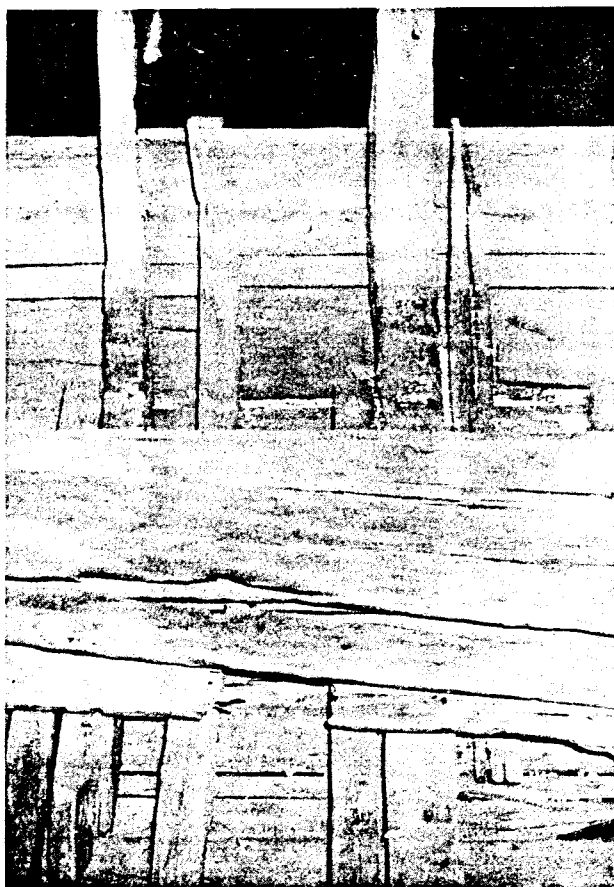
The upper ends of the original futtocks were sawn off at the eleventh strake, the uppermost clinker plank, which formed the transition from the clinker-planked lower hull to the carvel planks of the vessel's sides (Fig. 33). This modification was made presumably during a refit, when a second set of futtocks was added. The ends of many of the futtocks are severely eroded and several have split along the grain. The exterior surface of each futtock is

Figure 33. View of original futtocks which were cut off at the 11th strake. (Photo by the author.)

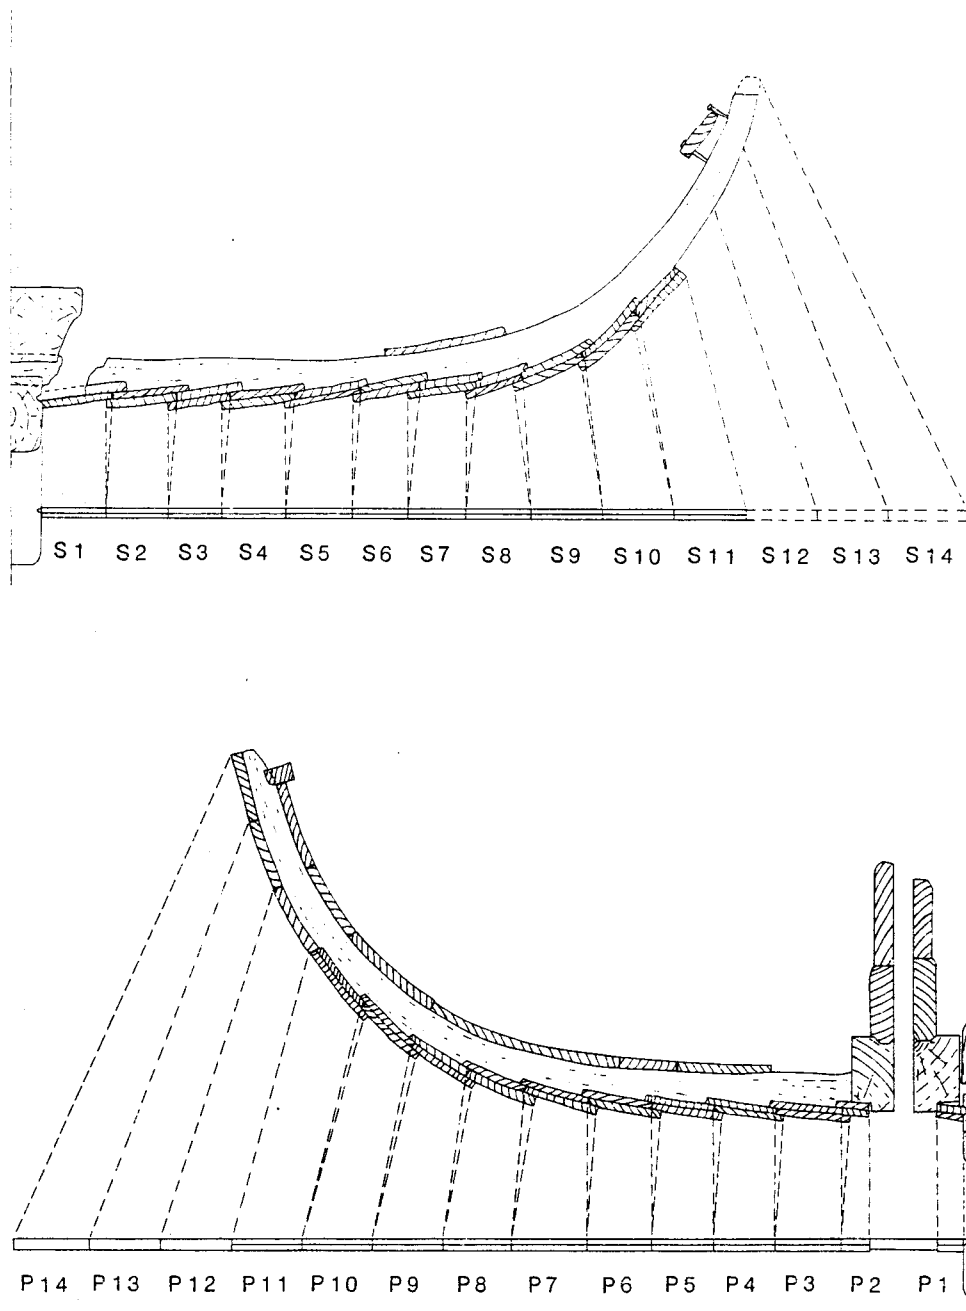
Figure 36. The development of the strake plans from the curved hull of the Browns Bay Vessel. Starboard (top) and port (bottom). (Drawings by the author and C. Piper.)

Due to the lengths of strakes required to plank the hull, many in excess of 55 feet, the shipwright had to make each strake from more than one plank (Figs. 36 and 37). Three scarfs were observed in the starboard strakes, each a flat vertical scarf approximately 4 inches long and fastened by a number of rivets (Fig. 38). As one of the scarfs was partially obscured by frame members, it is likely that more scarfs are present which are completely covered by frames.

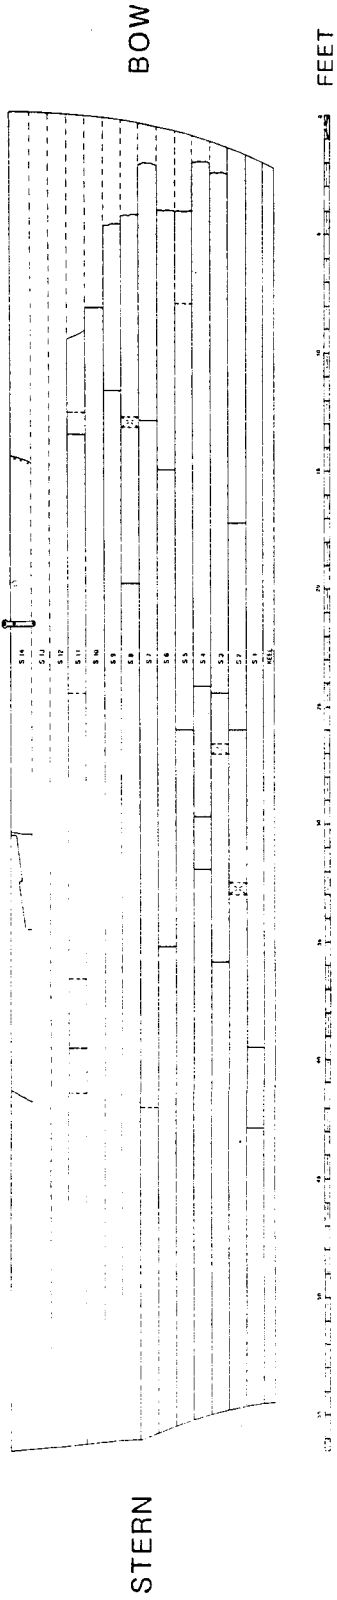
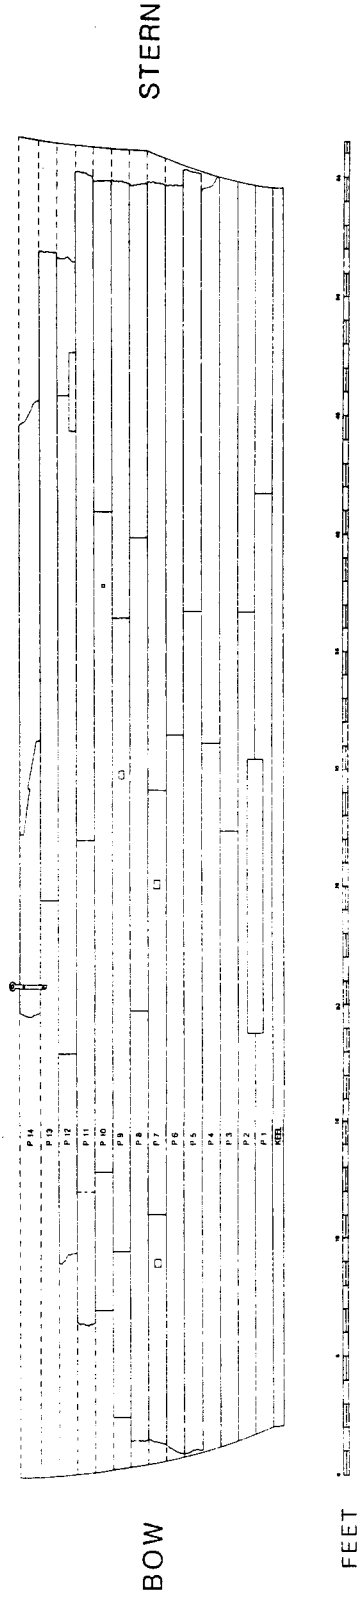
# STARBOARD STRAKE PLAN

Figure 37. Strake plans of the Browns Bay Vessel. Starboard (top) and Port (bottom). (Drawings by the author and C. Piper.)

from several eroded planks stored in the hull. The fragments were graphically reconstructed and repositioned on the hull, using bolt holes and nailing patterns as a guide. The surviving plank and plank fragments represent a 30 foot-long section, 9 to 10 inches wide and 1-1/2 inches thick. Evidence indicates that this strake was made up of two planks joined by a four-foot-long hook scarf and fastened in the same manner as the port chainwale. A third plank also went into the forming of the strake, as evidenced by an eroded butt end on the surviving plank (see Fig. 37, p. 69).

Strakes are made up of two to four planks butt-joined over frames (see Fig. 37, p. 69). Planks are fastened to frames by 1/4-inch iron nails, three at butt ends and two at other frame locations. A total of 56 planks were used to plank the outer hull up to the transition strake. A further 14 planks were probably used to complete the hull to the gunwales. Thus the vessel once contained approximately 70 planks in her outer hull layer.

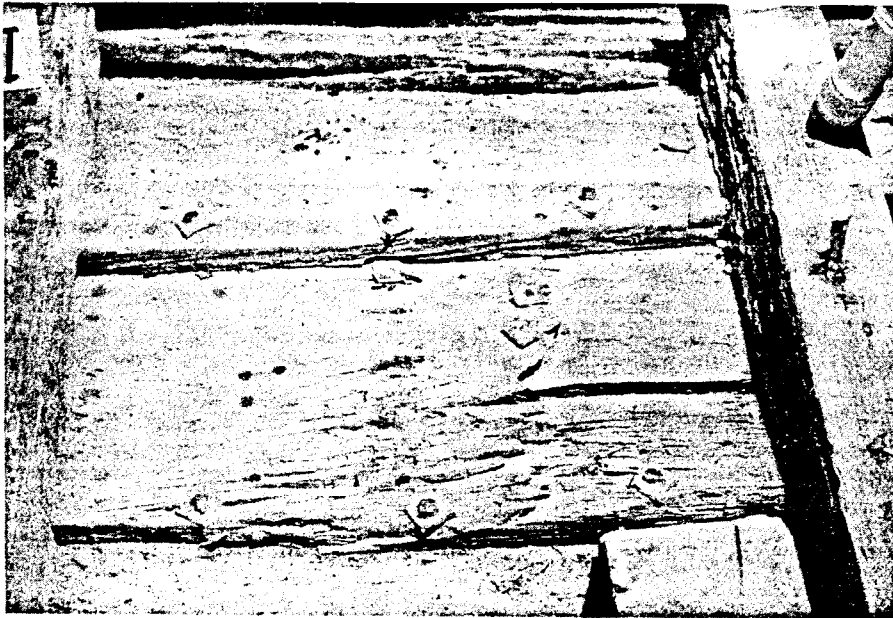
Figure 38. View of flat scarf in a clinker plank of the inner planking layer. (Photo by the author.)

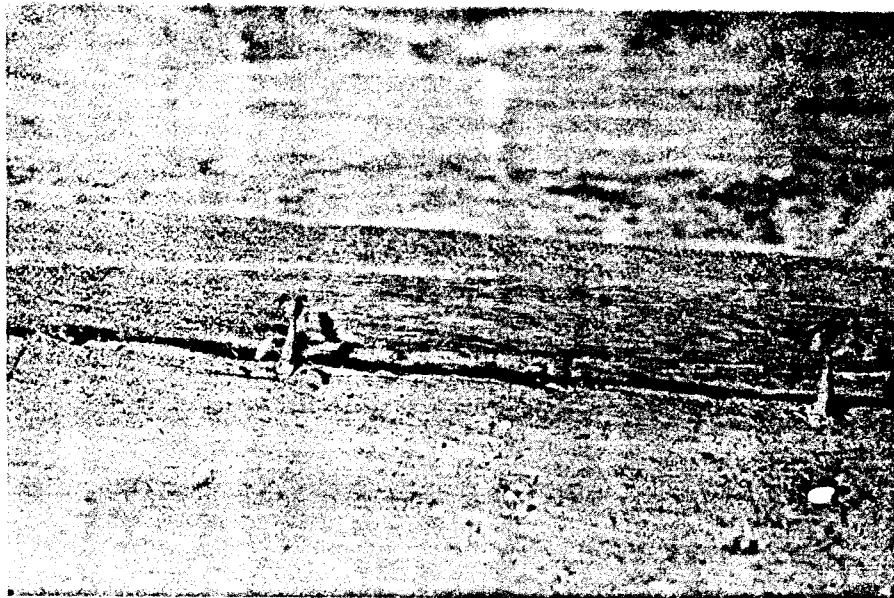
Figure 41. Detail of inboard ends of nails used to fasten the outer garboards to the hull. (Photo by the author.)

The outer garboards are fastened at their inboard edges to the inner garboards and to floor timbers using 3/16-inch iron nails. Many of the nails terminate in the side of the keel, perhaps as a substitute for clenching which was not used during the modifications to the vessel (Fig. 41). The inboard edge of the second strake laps the

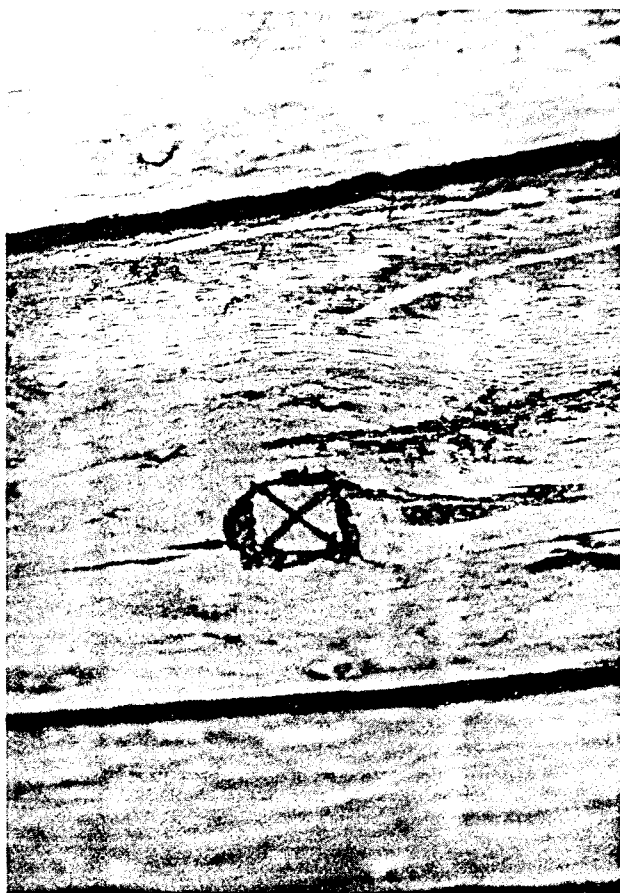
Figure 43. Detail of insert used to replace a knot in port outer strake 10. (Photo by the author.)

During the 1985 season, three rectangular wooden inserts were observed in the port strakes, P7 and P9, at the turn of the bilge. Each was set into the strake and nailed through to the inner planks, evidently to check splits in the outer strakes. A fourth smaller insert in P10 was used to replace a knot (Fig. 43). The space between the plug and the knot hole had been filled with tar and an X carved into the insert, similar to that on a treenail in the keel near the stem. No inserts appear on the starboard strakes.

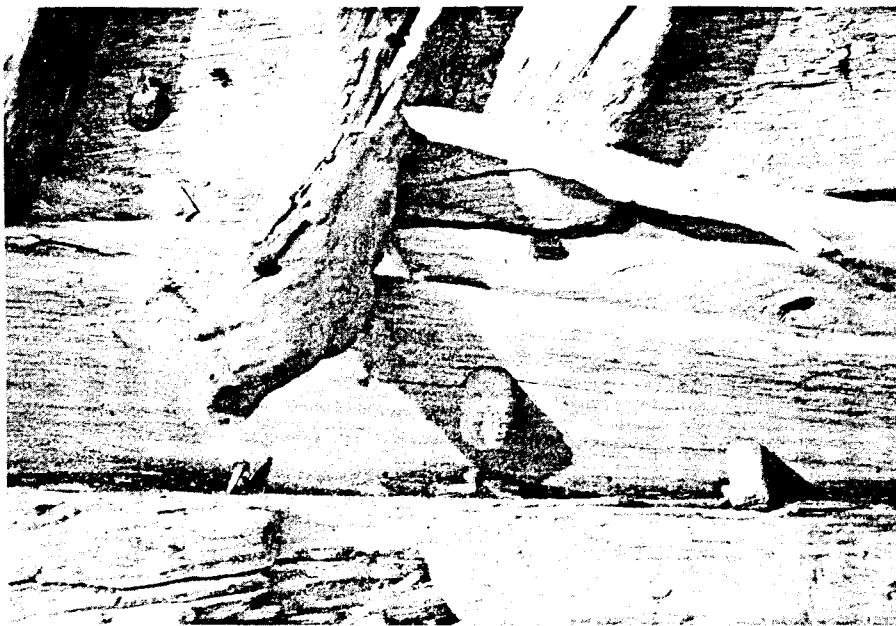
Figure 44. Probable drain hole plugs in the starboard garboard and second strake at the stern of the Browns Bay Vessel. (Courtesy of the Archaeological Research Division, National Historic Parks and Sites Division, Parks Canada.)

diameter protrude from the inboard surface of the hull planks. Five of these, in the stern, plug holes in the garboards and second strakes of both quarters (Fig. 44). At least two holes penetrate both planking layers. The evidence suggests that these were drain holes and that some were used prior to the vessel's being replanked. Farther forward between frames 13 and 14, a plug and a

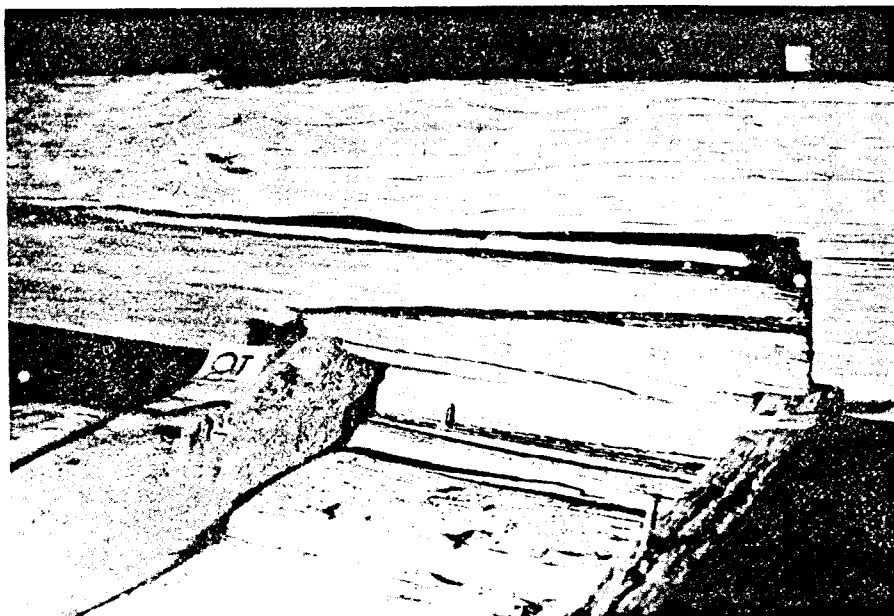
Figure 45. Scarf in the original keelson and the overlying section of the new keelson. (Photo by the author.)

keelson is thinned and overlaps the forward end of the stern knee, to which it is bolted. The forward section of the original keelson has been cut and removed forward of an 18-inch-long flat scarf, which joins it to the aft section (Fig. 45). Three iron nails fasten the forward 1-

inch nib of the scarf to the lower scarf table, while bolts at the two frame locations spanned by the scarf provide the main clamping of the scarf. In overall length, the original keelson would have been approximately 42 feet; its forward end apparently butted the aft end of the apron.

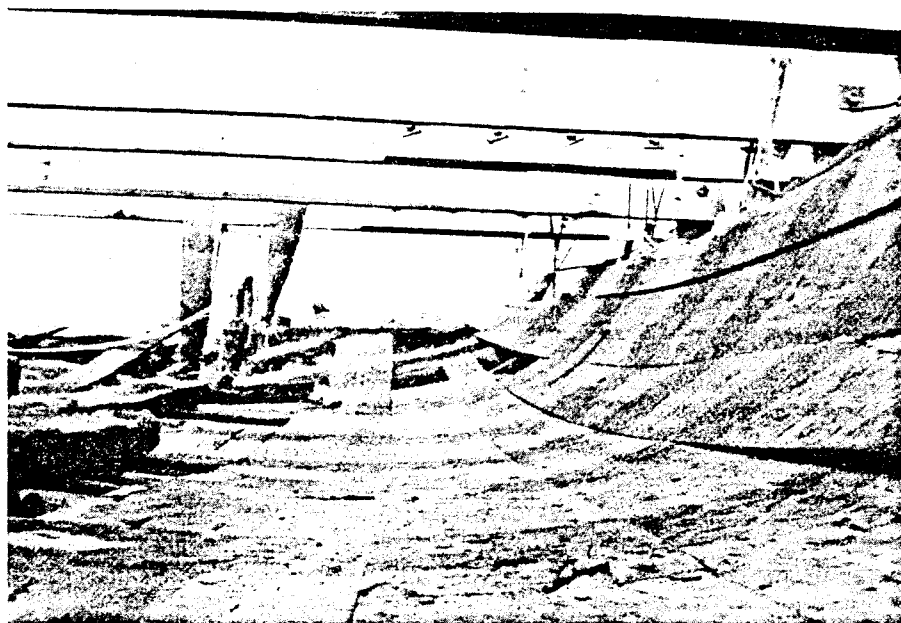
Figure 47. Ceiling planking on the port side of the Browns Bay Vessel. (Courtesy of the Archaeological Research Division, National Historic Parks and Sites Branch, Parks Canada.)

Sixteen ceiling planks or plank fragments were still attached to the frames in 1985. Most of the ceiling planking on the port side remained intact, although pieces

in the bow and stern were either missing or degraded (Fig. 47). Seven strakes were represented by thirteen planks,

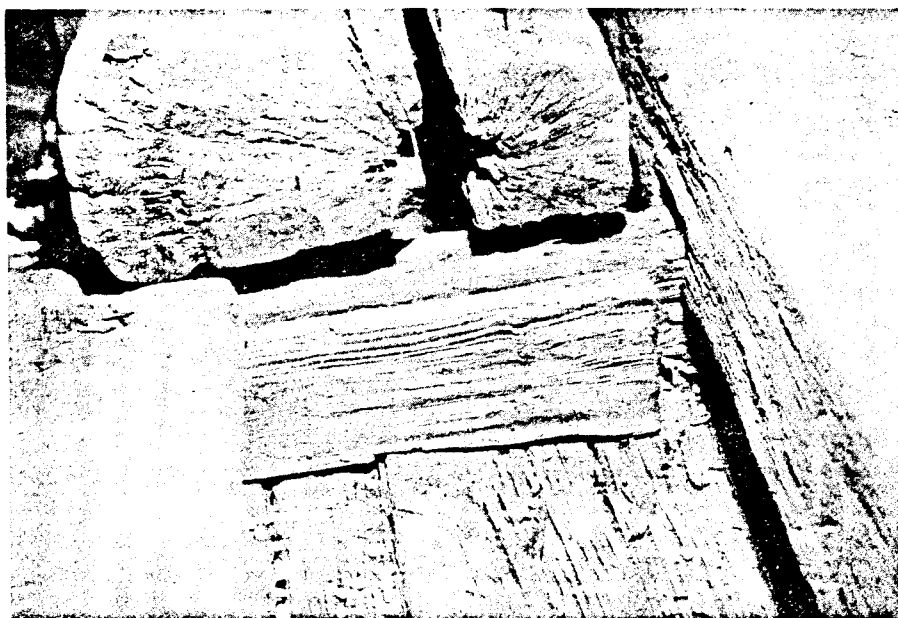
Figure 48. Detail of short plank set against frame 12, used to support ceiling plank ends. (Photo by the author.)

Planks are generally butt-joined at frames and fastened at each frame by one or two 1/4-inch iron nails. In one instance, the shipwright felt it necessary to increase the sided dimension of floor timber 12 near the keel to better support the ends of two port ceiling planks. He set a short plank on edge against the aft side of the floor timber and notched it over the first two hull strakes (Fig. 48).

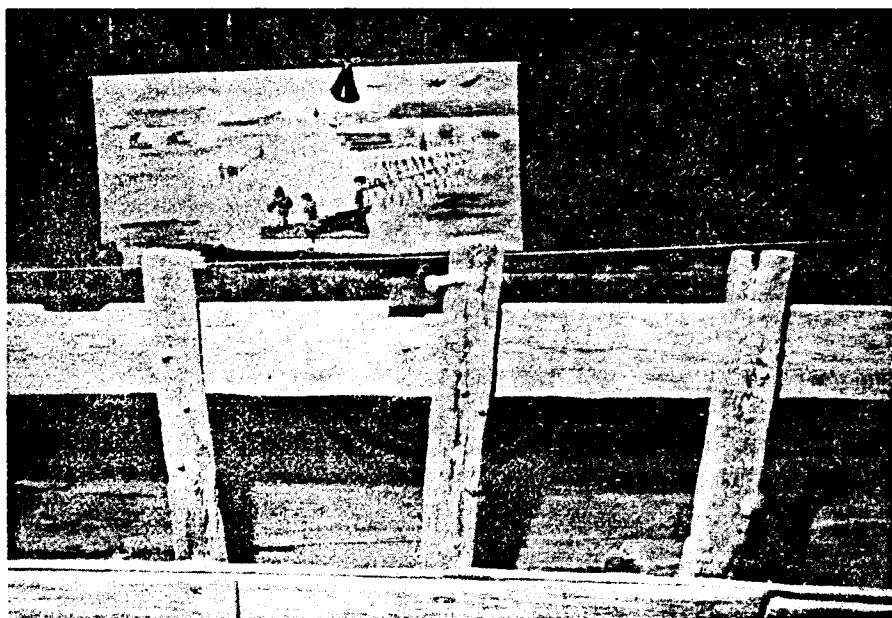
Figure 49. Beam notches in starboard shelf clamp.  
(Photo by the author.)

The upper surface of each shelf clamp was notched at intervals along its length to accept the ends of deck beams (Fig. 49). The notches range in length from 3-1/2

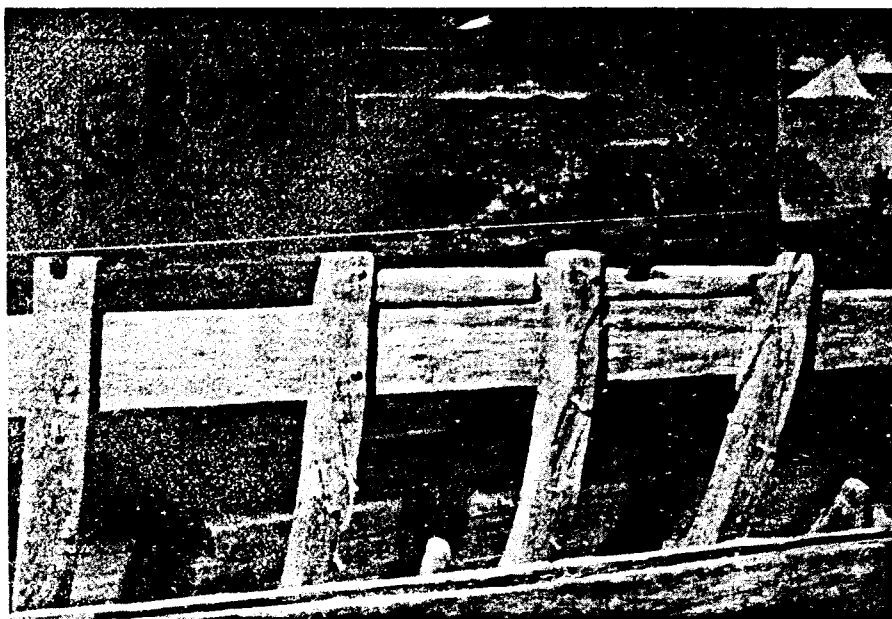
Figure 50. Short, notched timber between frames 10 and 12, used to support beam ends. (Photo by the author.)

sions of opposing notches on port and starboard shelf clamps are similar, reflecting the dimensions of the beams they once supported. Between frames 10 and 11, short timbers, 2-1/2 inches high by 3 inches thick, are nailed to the upper surface of each shelf clamp. The upper surface of each timber is notched; their purpose was probably to compensate for beams whose dimensions did not reach the level of the deck (Fig. 50). A single short timber of similar dimensions on the port shelf clamp, although lacking a notch, may have served a similar function.
