**THE CONSTRUCTION OF THE BROWNS BAY VESSEL**

A Thesis

**CHRISTOPHER FRANCIS AMER**

The Construction of the Browns Bay Vessel.

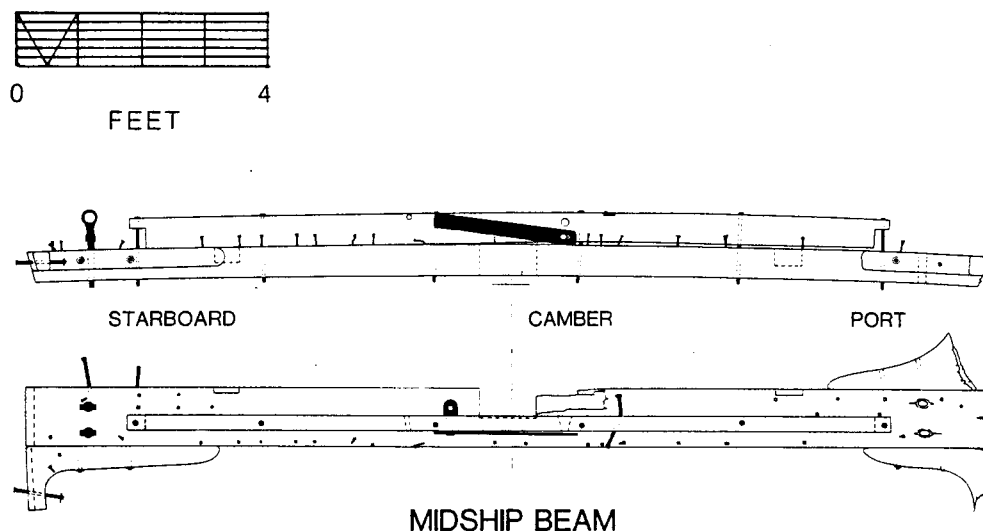
Figure 51. Midship beam of the Browns Bay Vessel. (Drawing by A.E. Wilson [Parks Canada].)

The midship beam is a single white oak (Quercus spp.) timber 15 feet, 7-1/2 inches long, 11-1/4 inches sided and moulded 6 inches (Fig. 51). It is slightly curved throughout its length, and is 1-3/4 inches higher at the centre than at its ends. An 11-inch-long by 5-1/2-inch-

deep notch is cut out of the aft side of the beam at its centre.

A 12 foot, 3-inch-long timber is fastened along the top of the beam with 5/8-inch iron drift bolts, 13 inches long. Placed just forward of the notch, the timber is 6 inches high and 3 inches wide. The lower corners of each end of the timber are cut out for a length of 3 inches, thereby forming an overhang at each end. Each overhang is bisected vertically by an iron drift bolt.

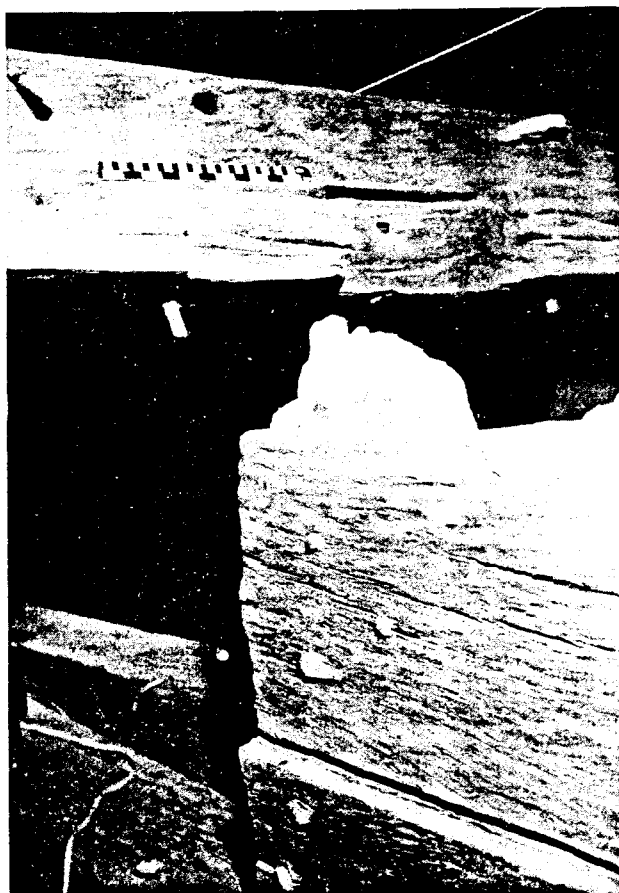
Figure 52. Mortices in the aft edge of the midship beam. Note forward end of centreboard trunk (below beam). (Photo by the author.)

Directly to port of the mast notch, a mortice 14 inches long, 4 inches wide and 2 inches deep was cut from the upper after edge of the beam (Fig. 52). An 8-inch long notch had also been cut out of the aft face of the beam within the mortice. Centred above the forward end of the centreboard trunk, the mortice and notch appear to have served a function in the support of that structure. No evidence of fastenings was found within the eroded mortice.

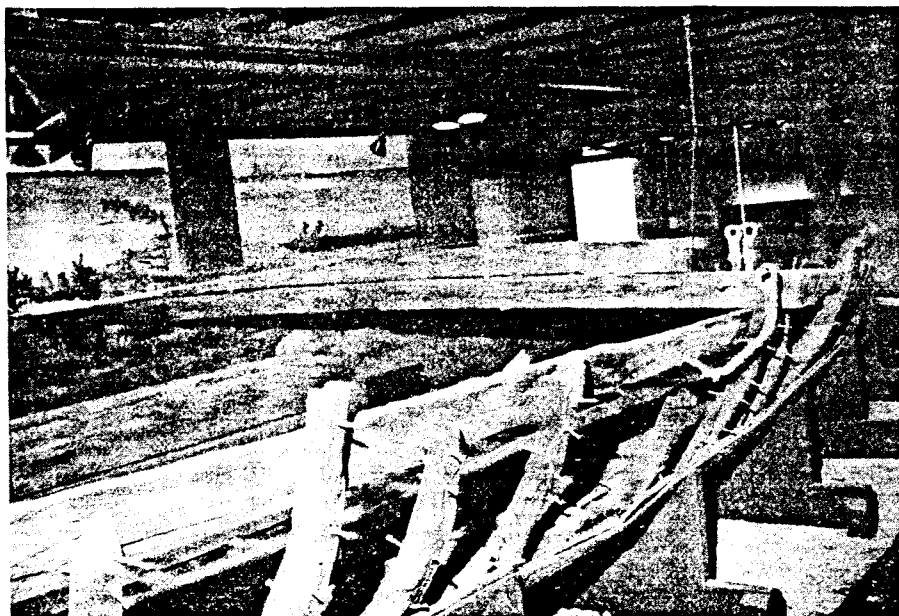
Figure 53. View of starboard side of the Browns Bay Vessel. Note the forelocked eye-bolts in the starboard end of midship beam and the chainplate attached to the starboard shelf clamp. (Photo by the author.)

Four eye-bolts were once secured near the ends of the beam. Two of these remain fastened near the starboard end (Fig. 53), while those from the port end are presently in

the artifact collection of Parks Canada (see Fig. 9, p. 21). The 15-inch-long and 1-1/4-inch-diameter bolts were drifted vertically through the beam, and their lower ends secured by small iron wedges, called fore-locks, driven through slots in the shafts. The upper ends of the bolts extend 2-1/4 inches above the beam, becoming rectangular in section, and are bisected by 1-3/4 inch holes. At least one of the bolts is stamped with a British broad arrow, indicating government ownership.

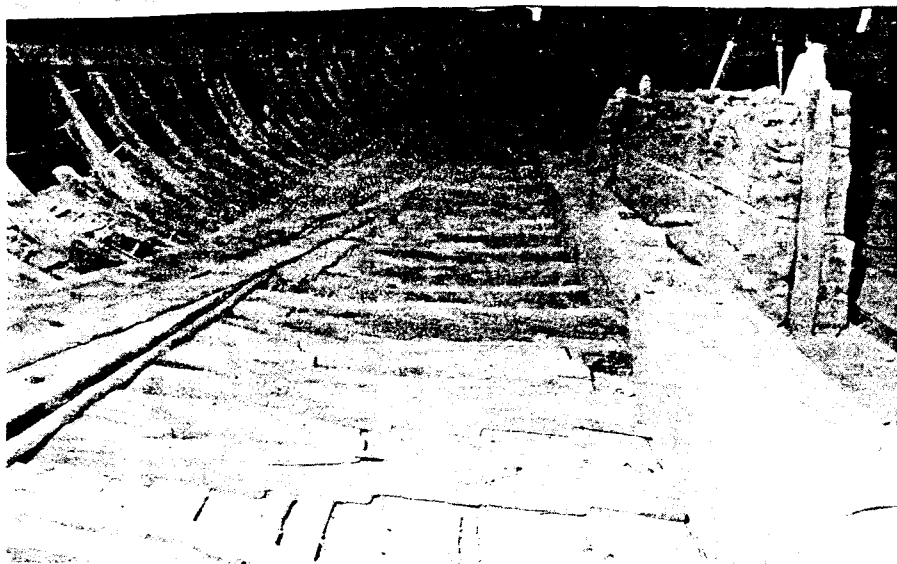
Figure 54. View of centreboard trunk and new keelson. Note centerboard pivot pin projecting from starboard side of the trunk. Ceiling planing was removed to gain access to the hull. (Photo by the author.)

The vessel was fitted with a swing-type centreboard designed to increase lateral resistance and reduce leeway while under sail. It was installed against the port side of the keelson and located aft of the midship beam (Fig. 54). The centreboard structure consists of three components: the beam, the trunk and the centreboard (Fig. 55).

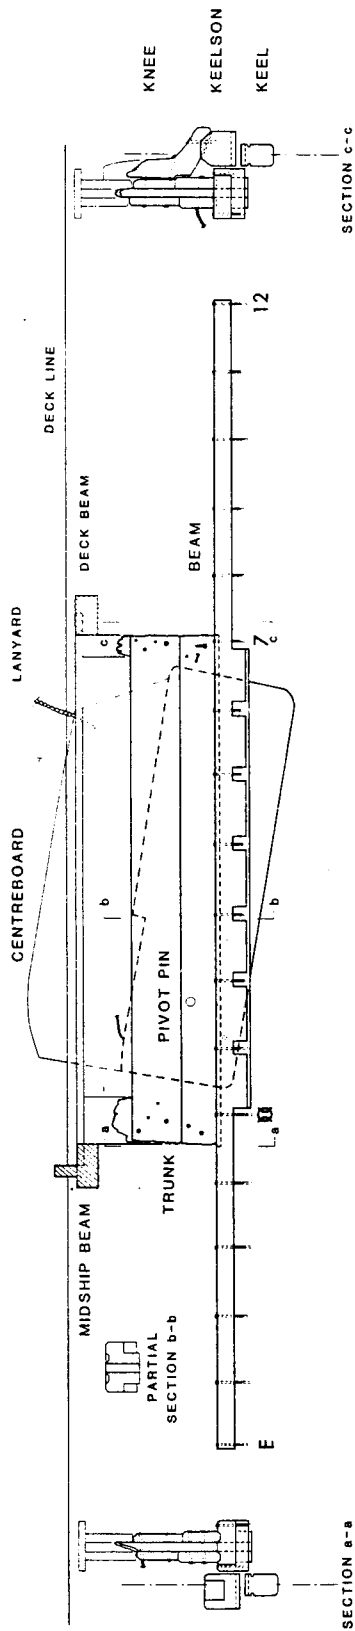
CENTREBOARD RECONSTRUCTION

Figure 55. Partial reconstruction of the centreboard structure of the Browns Bay Vessel. Reconstructed portions are in thin lines. (Drawing by the author, A.E. Wilson [Parks Canada] and C. Piper.)

The centreboard structure reconstruction (see Fig. 55, p. 97) is based on the best available evidence, and is discussed in the following chapter.

The nearly flat bottom of the vessel necessitated the addition of a centreboard to reduce leeway when sailing close to the wind. The swing-type centreboard was ideally suited to the navigation of shallow waters and beaching to load and unload cargo. When lowered it provided good lateral resistance for sailing. The reconstructed structure suggests an open-topped trunk extending to the level of the midship beam. Its forward end was set into a mortice in the aft side of the beam and its aft end was supported by a standard knee fastened to the keelson. The upper extremity of the aft end of the trunk also may have been secured to a deck beam which apparently spanned the hull just aft of the trunk (see Fig. 55, p. 97).

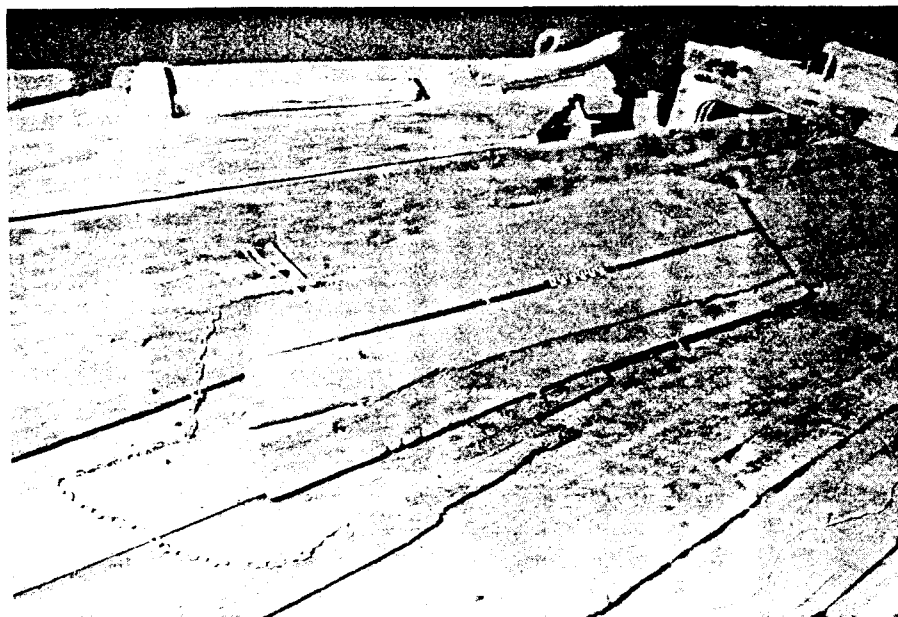
Figure 57. Broken section of the centreboard with attached chain lanyard. (Photo by the author.)

The aft section of the centreboard was identified from

among the planks stored on the port side of the hull (Fig. 57). It was found jammed within the centreboard trunk

during the 1967 excavation of the vessel, but was subsequently removed (Zacharchuck, 1986, pers. comm.). The section is 9 feet long, 1-1/2 inches thick and approximately 2 feet wide. It is made up of two planks edge-joined by 1/2-inch drift bolts. One end is cut at an angle and the outer edge of one plank is bevelled. A 72-inch length of chain, made up of 1/2-inch links, is attached to an iron U-shaped bracket rivetted near the angled end of the board. This represents the lanyard,

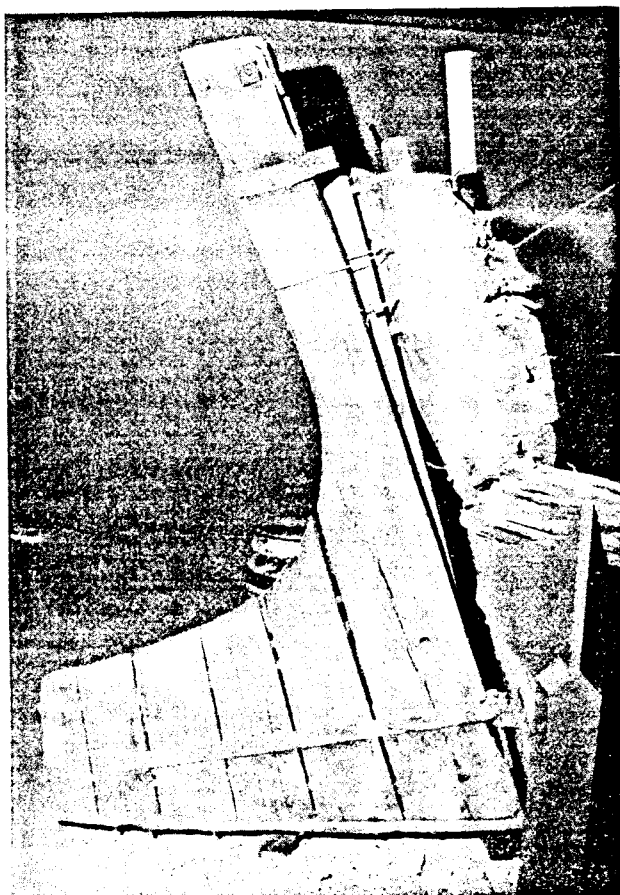
Figure 58. Starboard view of the rudder of the Browns Bay Vessel. (Photo by the author.)

The rudder survived in its entirety (Fig. 58). It measures 7 feet along the stock and 4 feet, 3 inches along the sole piece. The blade is made up of four 2-1/2 inch thick planks, and a plank which forms the transition to the stock, which is 4-1/2 inches thick at its lower end. These planks are edge-joined by 3/4-inch iron drift bolts, only one of which appears to pass through every component.

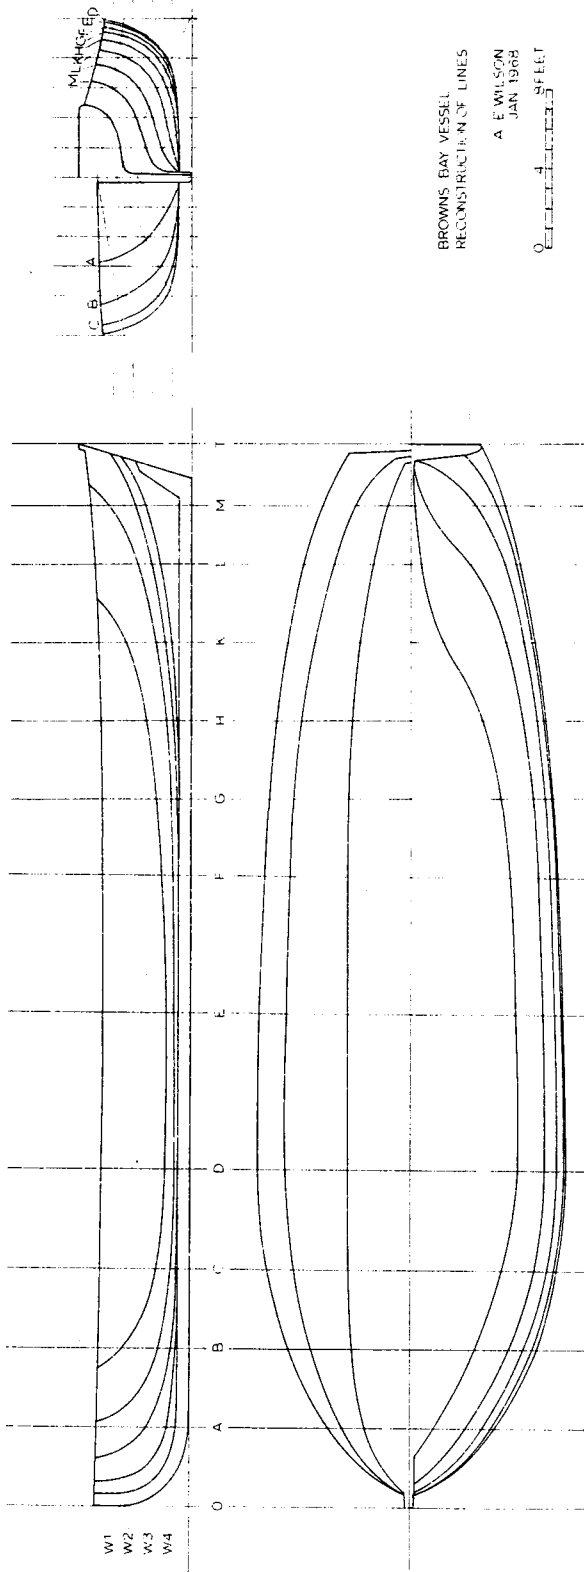
BROWNS BAY VESSEL  
RECONSTRUCTION OF LINES

Figure 59. Browns Bay Vessel. Reconstruction of Lines. (Drawing by A.E. Wilson [Parks Canada] and C. Piper.)

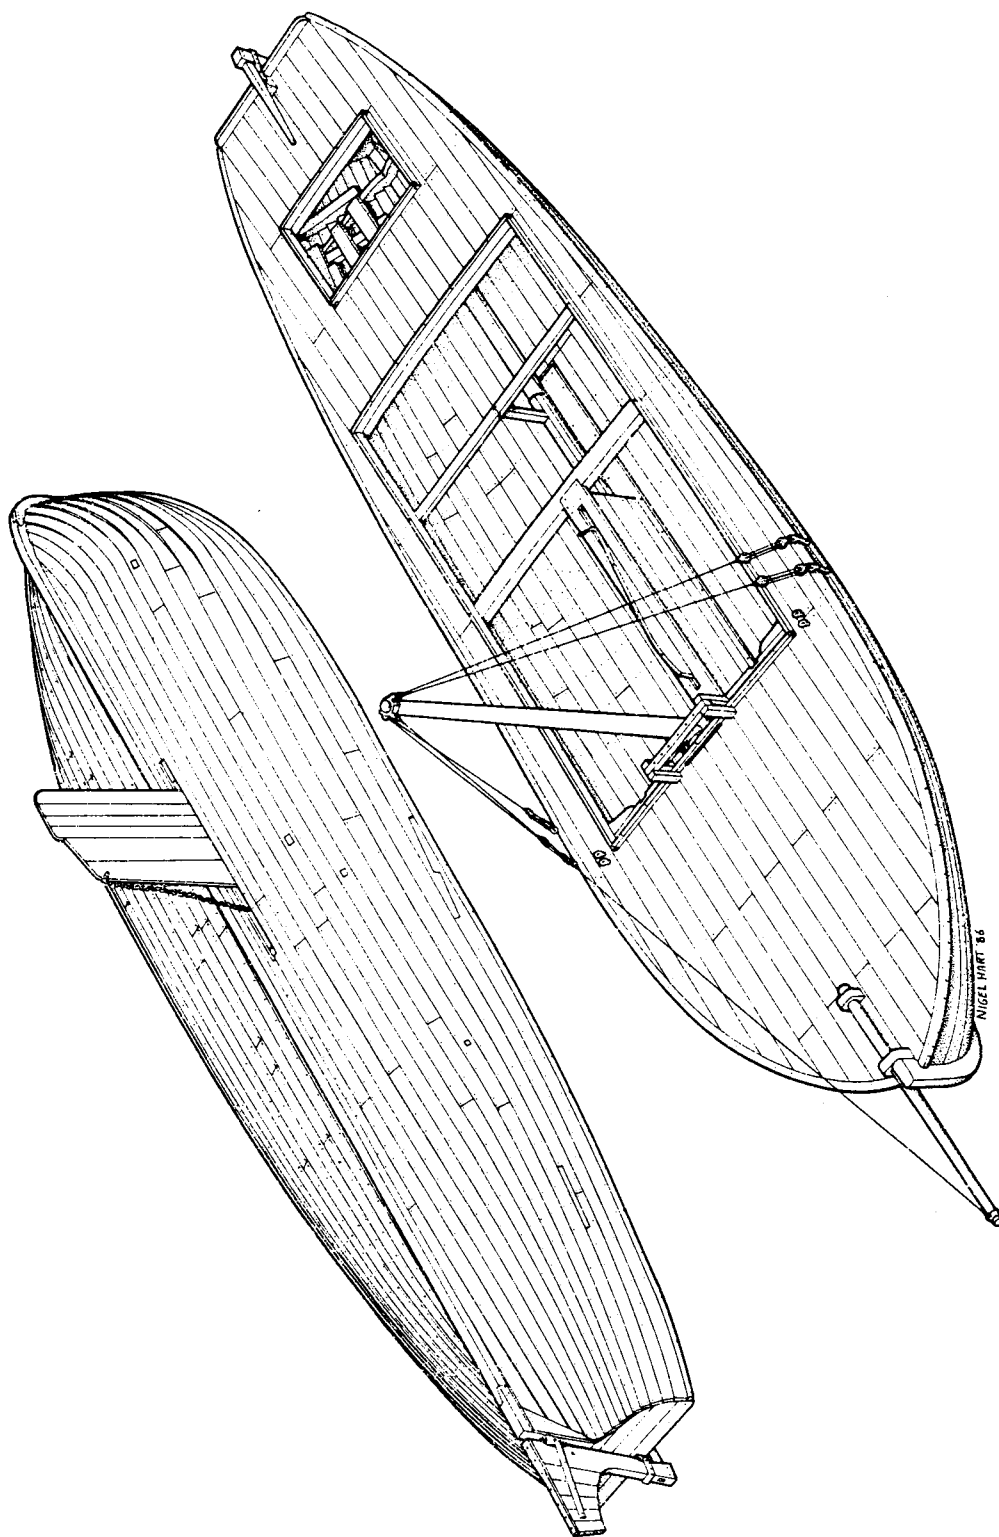
Figure 60. Reconstruction of the Browns Bay Vessel. (Drawing by N. Hart.)

The existence of nail holes in the upper surface of the midship beam suggests that the vessel had a foredeck from gunwale to gunwale (Fig. 60). The midship beam, which supported the after end of the deck, has an arch of 1-3/4 inches in 15 feet. This would have given a camber to the deck, enabling it to shed water. A small poop deck about 6 feet, 6 inches long ran from the transom to the extant beam in the stern. This beam had little or no arch to it, but the deck apparently sloped forward following the sheer line of the hull. However, there must have been some provision to direct excess water overboard.

Artifacts found in the stern of the hull related to the preparation and consumption of food suggest the presence of a small galley area (Zacharchuck, 1981, manuscript). It is likely that a bulkhead separated this area from the cargo hold, although no evidence for this was found. A small deck, running the full width of the vessel, may have existed between the galley and the main hatch, as evidenced by the positions for deck beams at frames 14, 15/16, and 17/18 (see Fig. 60).

Two iron chainplates, once used to secure the mast shrouds to the sides of the hull, are still attached to the futtock heads. Each is located approximately two feet aft of the maststep on port and starboard sides. Fragments of two more iron chainplates were recovered, but their positions on the hull have not been determined. On the reconstruction drawings, two chainplates per side have been used, both aft of the mast (see Fig. 60, p. 118).

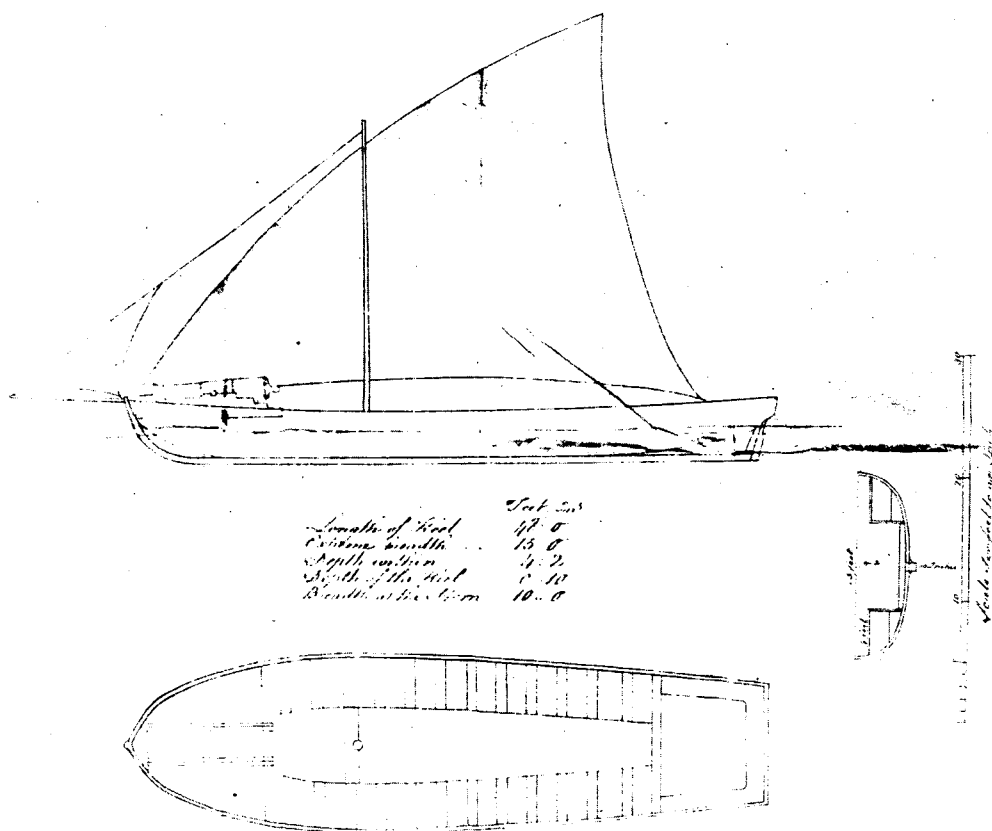
Figure 61. Plan of a lateen-rigged British gunboat used on Lake Ontario, c. 1794. (Courtesy of the Metropolitan Toronto Library Board, Q3-75a.)

cates that a lateen rig was favoured in the early 19th century on British and American gunboats (Lyon, 1985, pers. comm.). This rig "required little gear and would interfere very little with the men at the sweeps" (Chappelle, 1935: 74) (Fig. 61). Contemporary illustrations of British gunboats with this rig often show a headsail set on a bowsprit (Fig. 62).

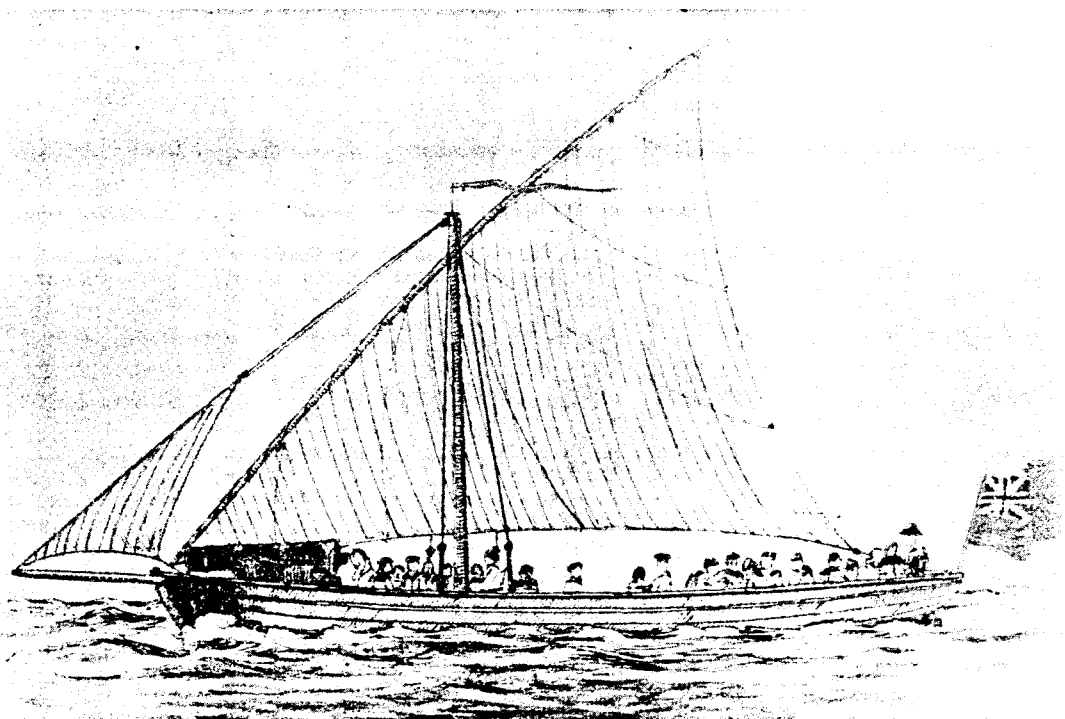
Figure 62. Lateen-rigged British gunboat, c. 1794, showing a headsail. (Courtesy of the Metropolitan Toronto Library Board, Q3-84a.)
