WATERSCHIP NZ421: A LATE MEDIEVAL FISHING VESSEL  
FROM FLEVOLAND, THE NETHERLANDS

A Thesis

MASTER OF ARTS

May 1991

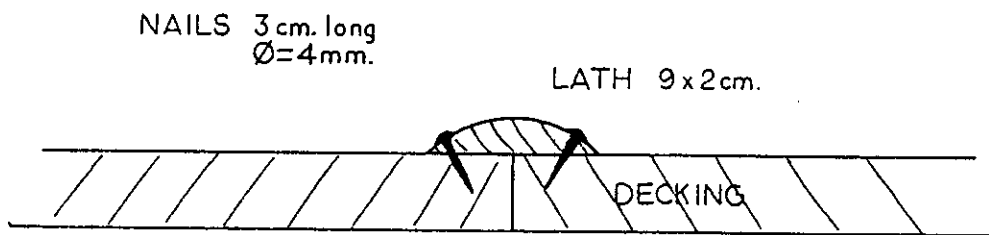
Figure 29. Detail of the caulking laths on the stern deck. The shapes of the laths and nails are reconstructed. (Not to scale).

While the other decks were sinteled, the seams on this deck were sealed with rounded laths 9 cm. broad and 2 cm. thick (Fig. 29). These were nailed to the planks along both edges. Whether the laths were caulked with moss is not known, but this can be assumed, since this would be necessary to create a watertight seal.

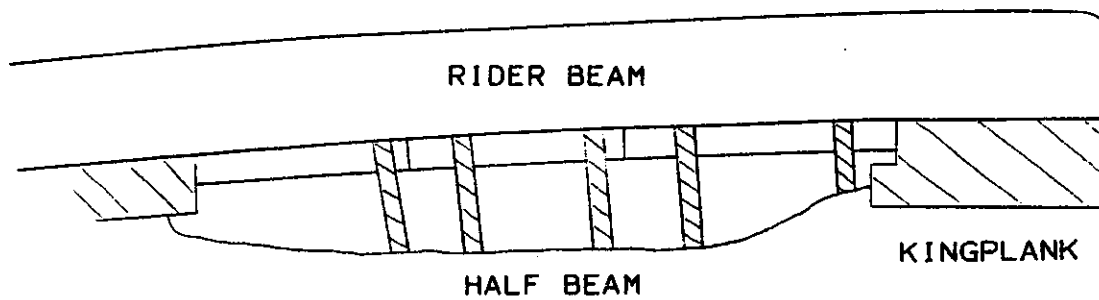
Figure 30. Drawing of a half beam and associated timbers.  
(Not to scale).

In contrast, the three half beams sat directly against the underside of the decking (Fig. 30). Their outer ends were notched on the upper face to fit the underside of the waterway, while their inner ends were notched on the

under side to sit in the rabbet in the kingplank. The half beams were not fastened on either end and were held in place only by their fastenings to the decking. This indicates the two men were needed to set the half beams: one to hold the beam in place and another to bore the treenail holes and insert the treenails.

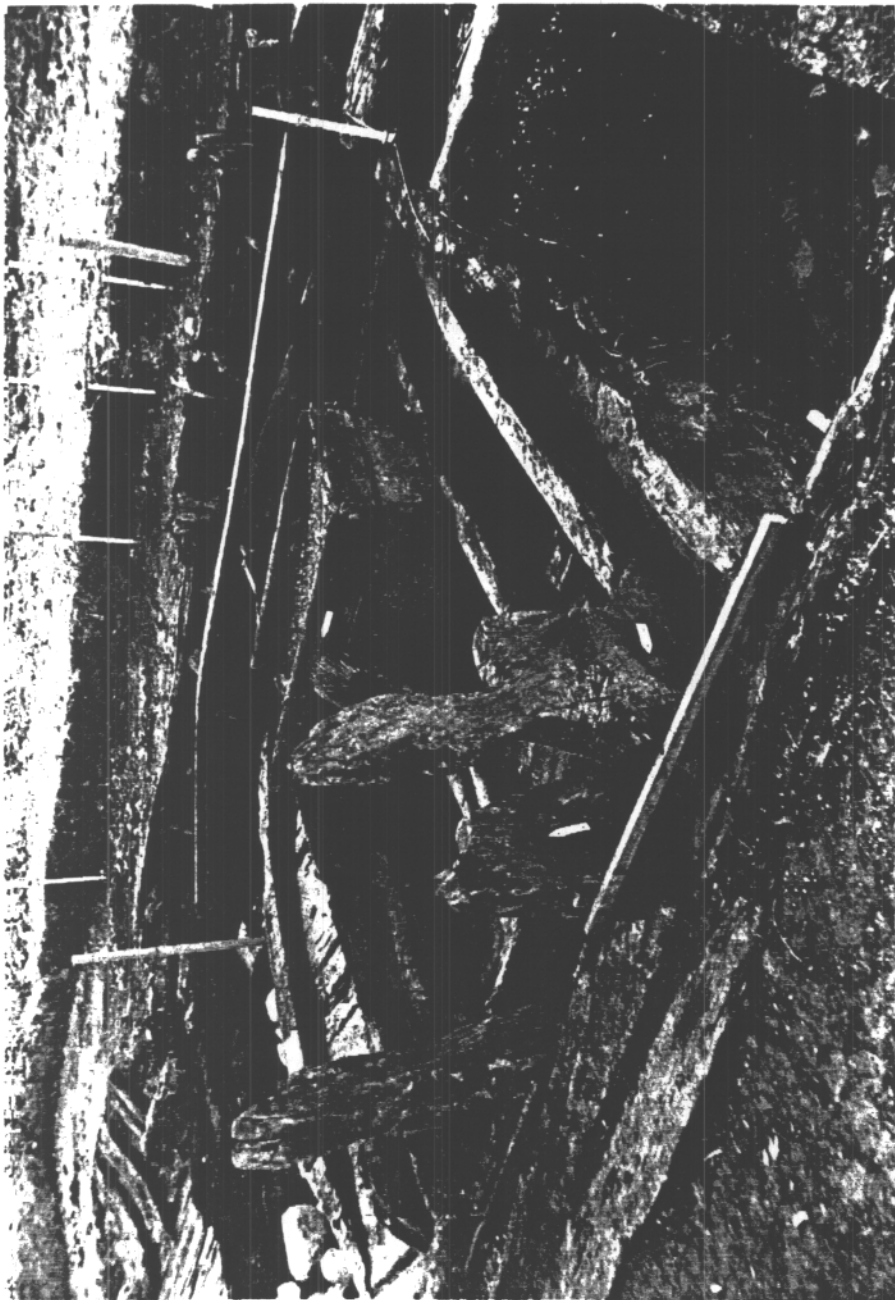
Figure 32. The fishwell deck viewed from starboard with the starboard knees set back in place. Note the nearly intact top of the knee on left (courtesy of RIJP).

The fishwell deck (Fig. 32) had collapsed but otherwise remained intact. The decking originally rested on the three bulkheads and on four thin deck beams. The sided by molded dimensions of the beams were, from forward aft, 11.5 cm. by 9 cm., 9.5 cm. by 8 cm., 11.5 cm. by 9 cm., and 9.5 cm. by 8 cm. Their ends were notched to fit in notches on the frame tops like that on frame B (p. 49). The decking, as seen in the stereophotograph of the decks (Fig. 3), consisted of 12 longitudinal planks, each approximately 5 cm. thick. Their widths ranged between 34 cm. and 44 cm.

In the middle of the deck was an opening for access to the fishwell (Figs 32, 33). This opening was 1.25 m. long by 78 cm. wide. Four walls stood around the opening forming a trough 61 cm. high. Each of the four walls consisted of an upper and a lower component. The walls forward and aft stood between the side walls with their tops joined as shown in Fig. 33. The lower components were 6.5 cm. thick and 45 cm. high, while the upper ones were 5 cm. thick and 16 cm. high. The components of the forward and after walls were of the same heights as the side walls but were thinner with a thickness of 6 cm. for the lower members and 4.5 cm. for the upper ones. The wall components were joined on edge by thin treenails hammered in from the top edge of the wall. These treenails extended into the lower pieces approximately 12 cm. The corner joints were fastened with iron nails, one in the upper pieces and two in the lower ones. The forward and aft walls sat in rabbets in the decking, while the sidewalls were nailed into the edges of the decking.

Most of the knees and futtocks were partially decayed, with the ones on starboard displaying greater deterioration. An exception to this was the futtock of the central starboard rider beam (Fig. 32). This timber had become detached early in the decomposition of the vessel and was therefore virtually intact. When this timber was reset it stood approximately 1.1 m. above the deck. Except for the top of the rabbet on the stem, this height was the only indication of the top of the sheer strake. In addition, the top of this timber was notched to receive the sheer clamp.

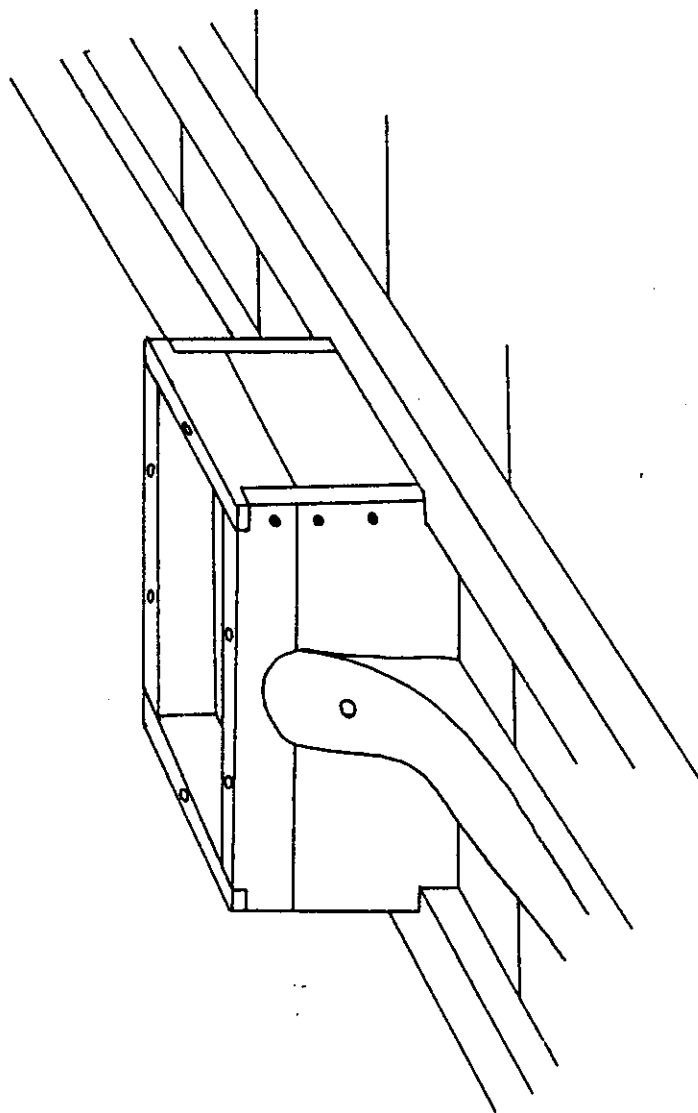
Figure 33. Drawing of the trough (after a drawing by RIJP).

In addition to these two central rider beams, there were two rider beams between the trough and the forward bulkhead and three aft of the trough. Unlike the central rider beams, these ran from side to side and were lighter, each approximately 13 cm. sided and 15 cm. molded. Each rider beam sat over a deck beam except for the aftermost which rested over the after bulkhead. The rider beams immediately forward and aft of the middle bulkhead were rabbeted along one side to fit around the ends of the trough (Fig. 33). All the rider beams were

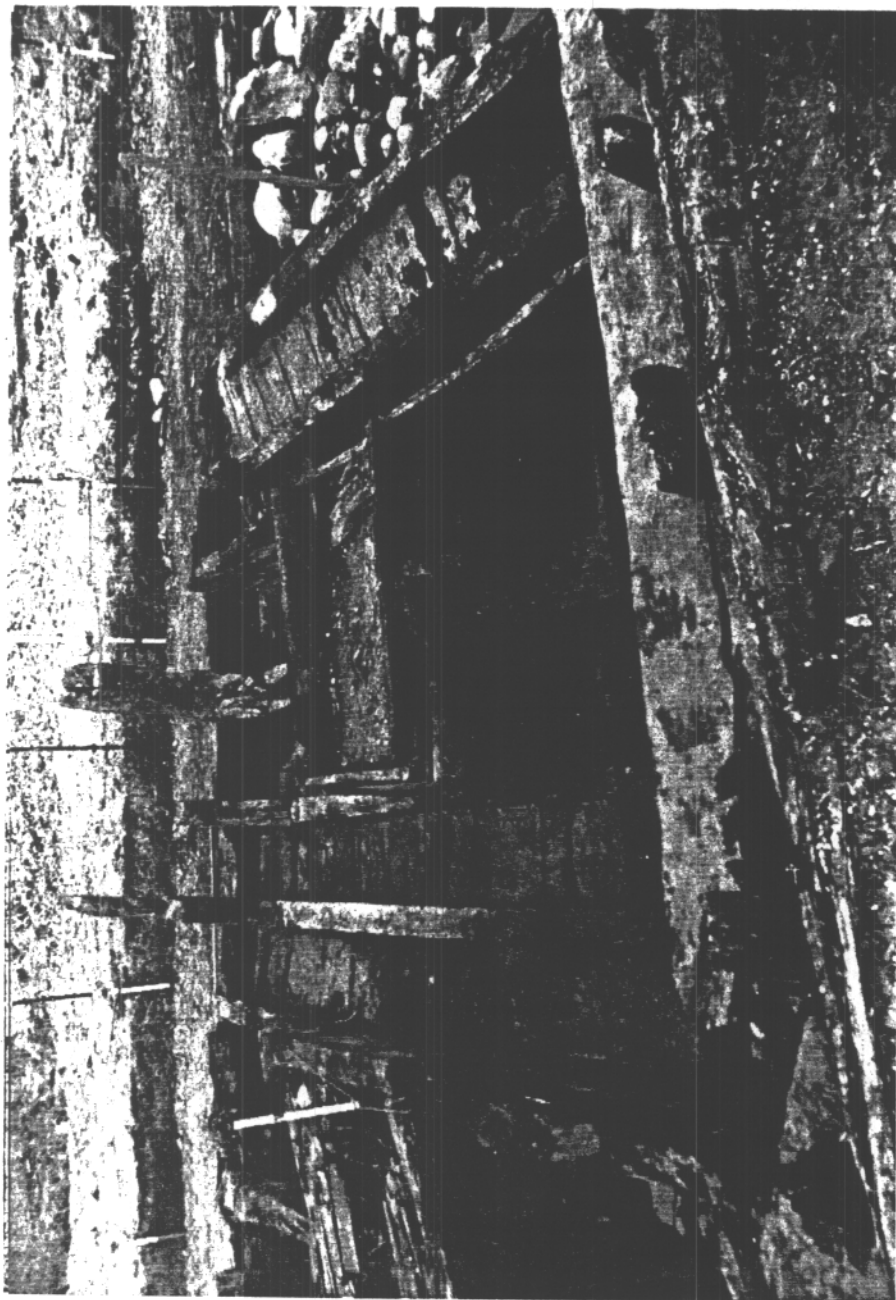
Figure 34. The fishwell deck viewed from port. Note the large riders supporting the trough (courtesy of RIJP).

trough. As can be seen in Fig. 34, this timber was nailed onto the central rider beam and had a rounded or chamfered upper forward edge. The piece passed under the thin bulkhead on the rider beam and came out on the bulkhead's after side. There was no similar feature to starboard.

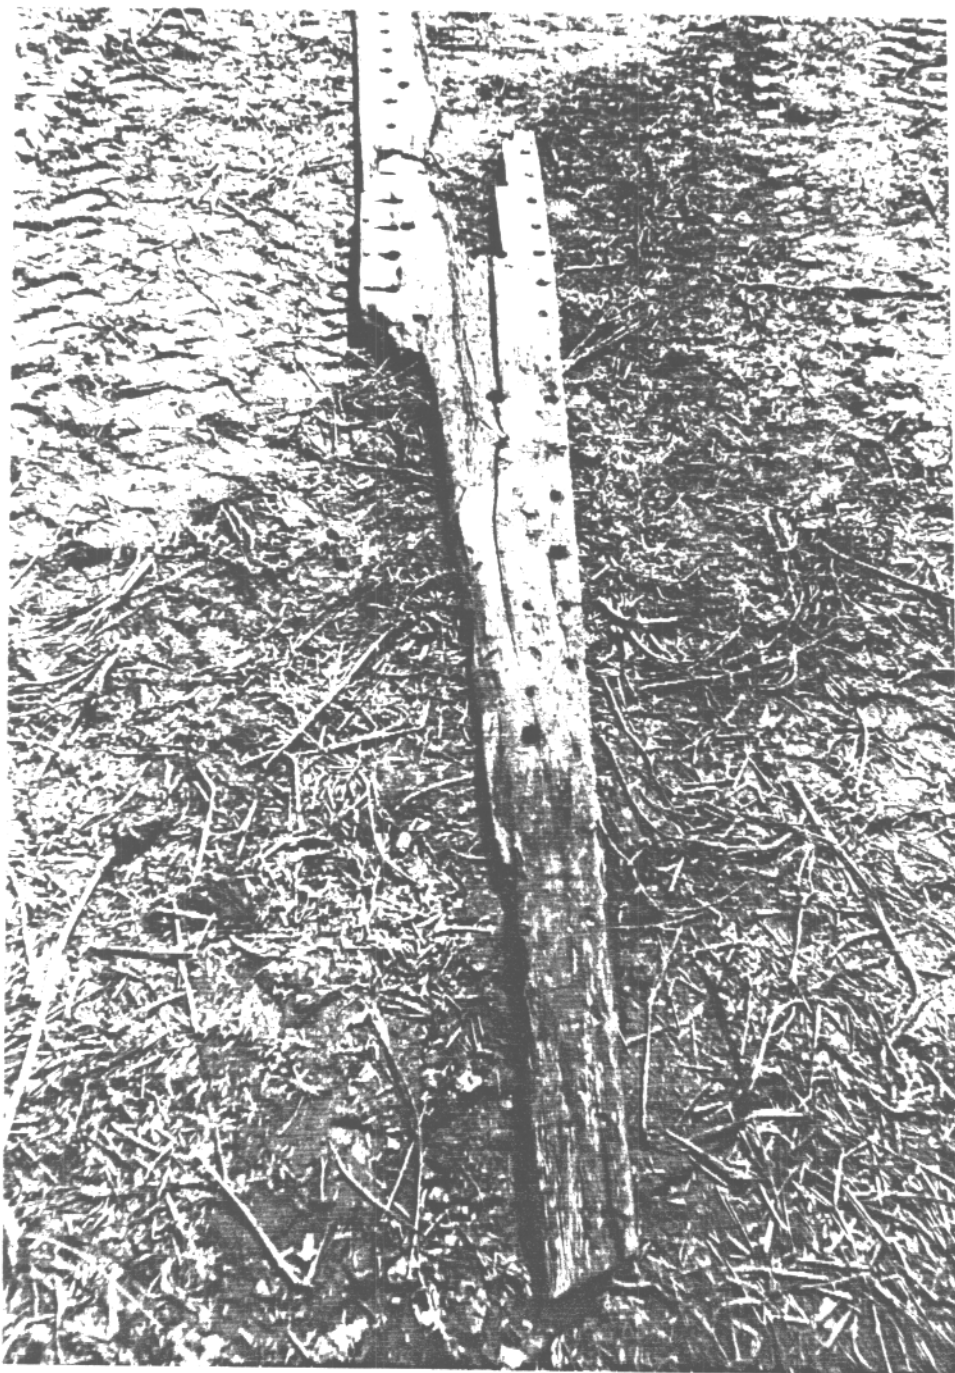
Figure 35. A plank with an apparent hood end, treenail holes and nail holes (courtesy of RIJP).

There was an additional plank fragment for which there is only photographic evidence (Figs 35, 36). This plank had nail holes spaced approximately 15 cm. apart along both edges. It also had an end which was angled in such a manner that it might have been a hood end. There were also eight large holes in the plank which were probably for the framing treenails.

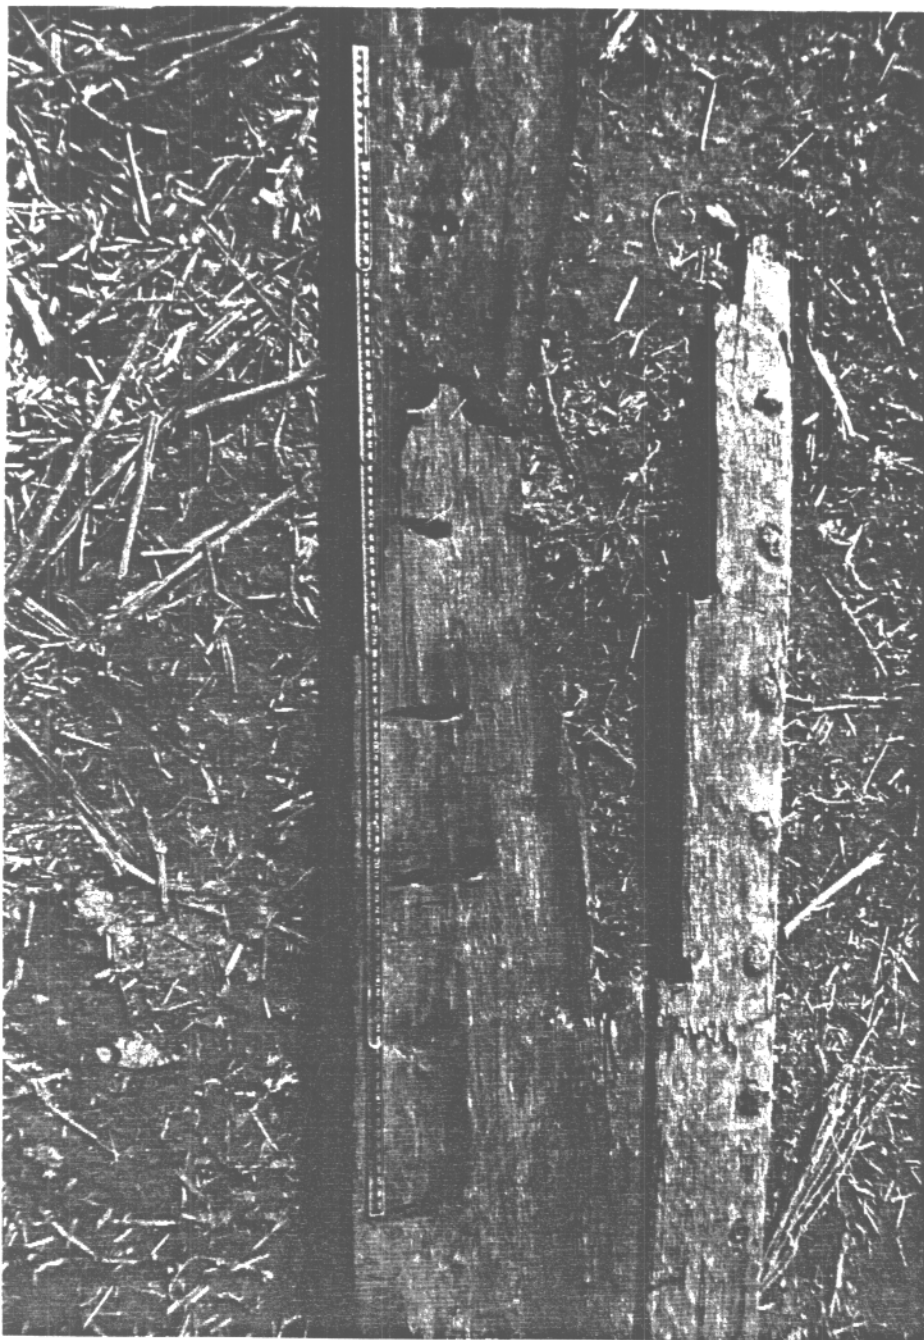
Figure 36. Detail of Fig. 35 (courtesy of RIJP).

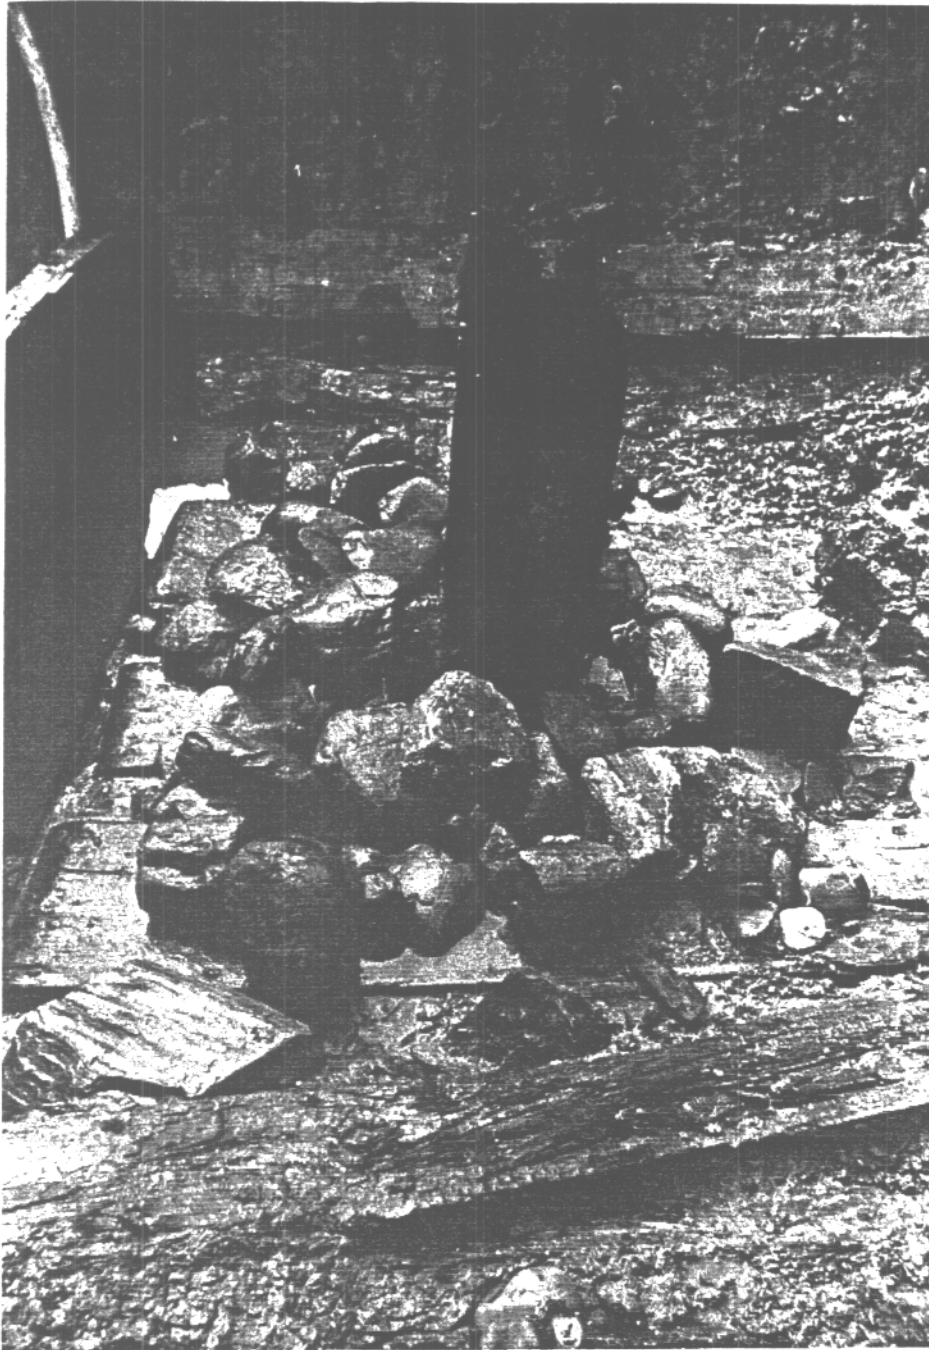
Figure 37. The mast foot with its supporting ballast pile (courtesy of RIJP).

were rounded. In the stern, the ballast laid on the ceiling in the cabin area, although a few stones had rolled off the ceiling and onto the strakes. In the bow, the ballast was stacked around the foot of the mast in a pile 30 cm. high which helped preserve the mast foot (Fig. 37). There was one additional boulder lying in the gutter aft of the mast.

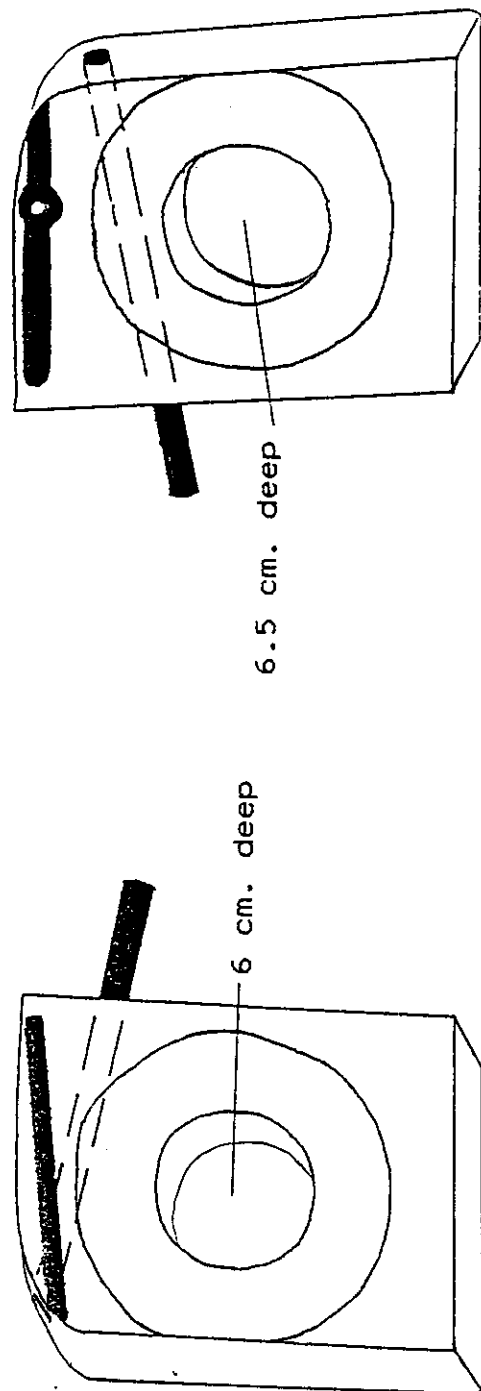
Figure 38. The pieces of the winch (after a drawing by RIJP).

Several artifacts belonged to the ship's fishing tackle. Two of these were the side pieces of a winch (Fig. 38), found in the aft section of the wreck. These pieces both measured 45 by 55 cm. although one was 14 cm. thick and the other 10 cm. thick. Both had an iron bolt or spike passing through the piece and protruding from the back

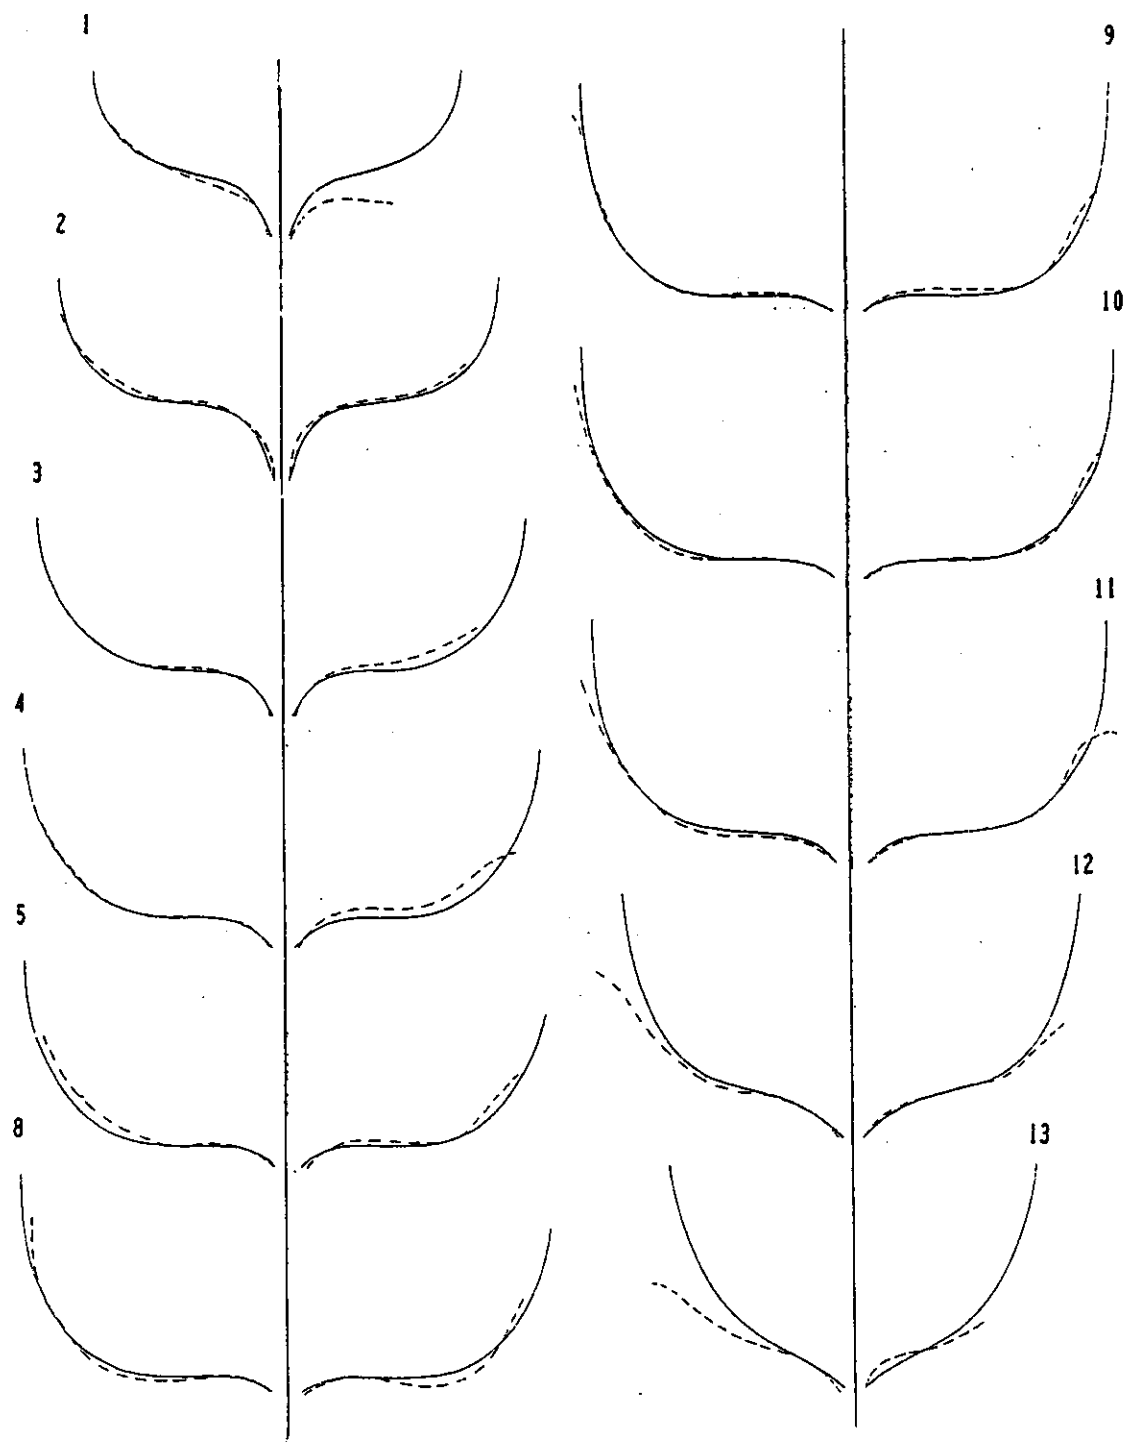
Figure 39. Comparison between reconstructed and actual sections of the wreck (dotted line).

Once the keelplank was adjusted, the vessel's lines were begun. The port side was chosen for reconstruction since it was the better preserved. The central part of the wreck was reinforced with the fishwell bulkheads, and it was assumed that this section was the least distorted. Thus, the bulkheads were used as the basis for determining the shape of the vessel. This assumption proved to be somewhat correct. As seen in a comparison between the reconstructed sections and the actual ones of the wreck (Fig. 39), the distortion is greatest towards the ends although many of the sections display only slight distortion.

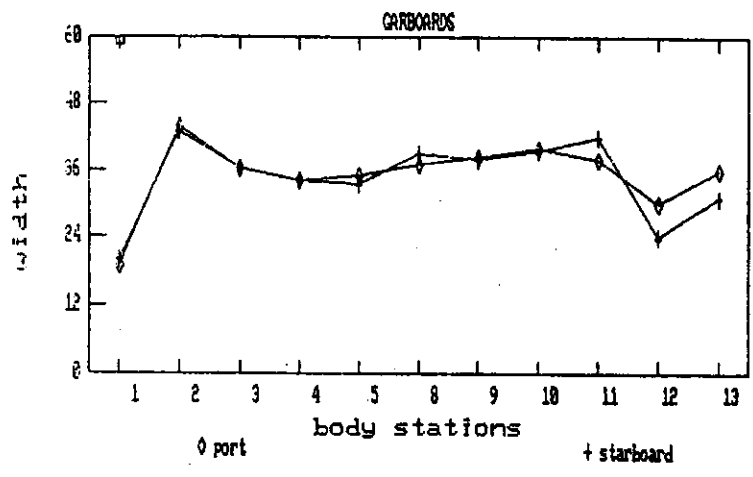
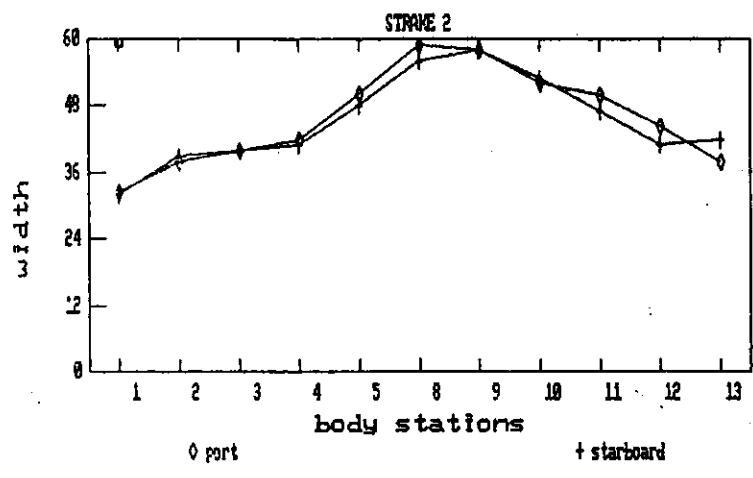
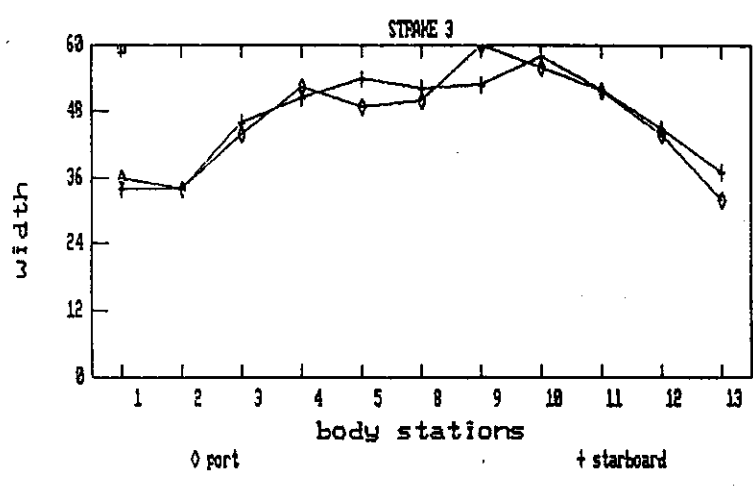
Figure 40a. Graphs of the widths of the first through third strakes on both sides of the vessel.

Since one side of a vessel will usually yield an accurate picture of the appearance of the entire vessel, only one side needs to be reconstructed. This is particularly true of clinker-built vessels where each side of the vessel is planked in a similar manner (Leather, 1973: xv). This concept is illustrated in Figs 40a and b, which show the similarity of the planking widths of NZ421 on both sides. The graphs display the widths of the six strakes on port and starboard from body stations one through thirteen. Not only are the similarities of the planking widths illustrated, but the similarities between the shapes of the port and starboard strakes are also demonstrated. This resemblance enabled the reconstruction of widths where the planking did not survive. Additionally, the reconstruction of the widths of missing starboard planks could be made based on the extant port widths. Also, the missing width of a plank could be estimated by following the graph line.

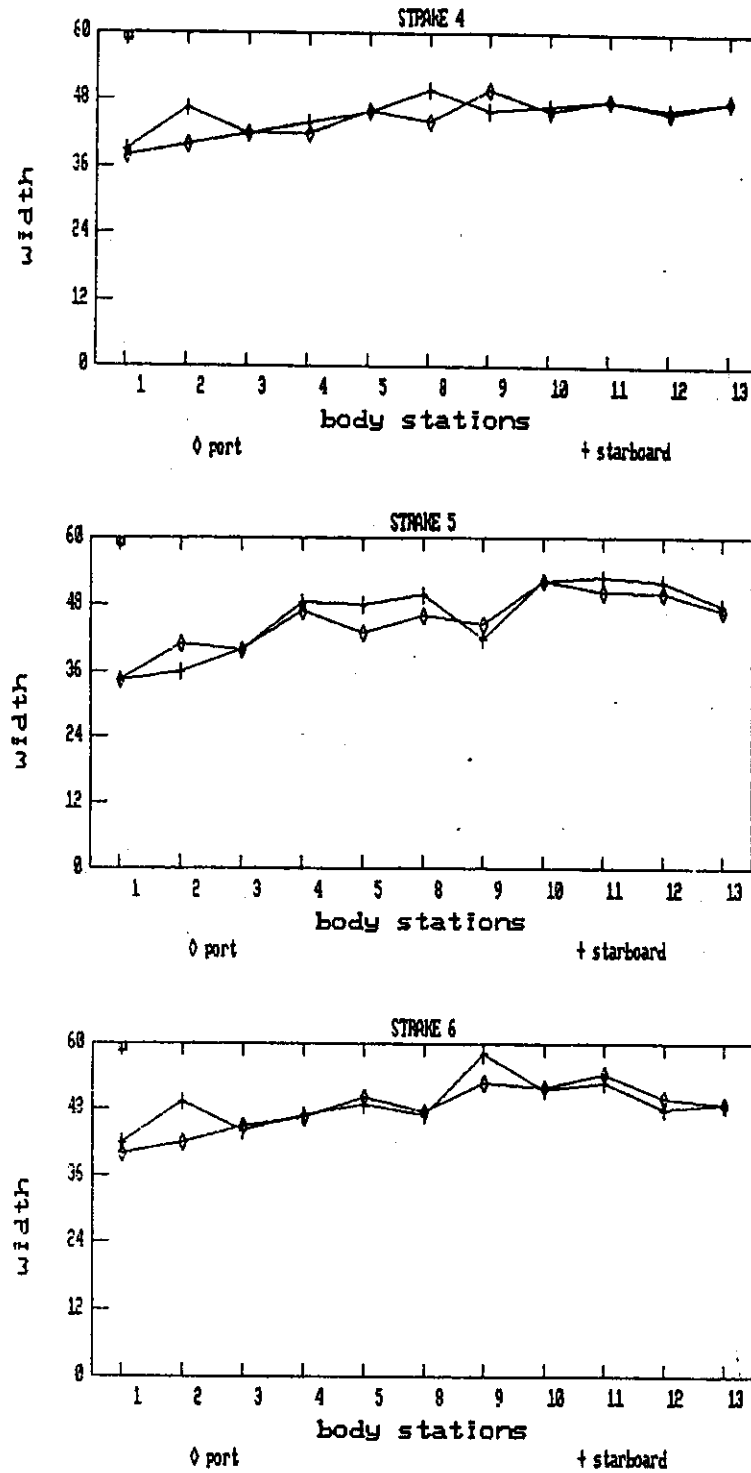
Figure 40b. Graphs of the widths of the fourth through sixth strakes on both sides of the vessel.

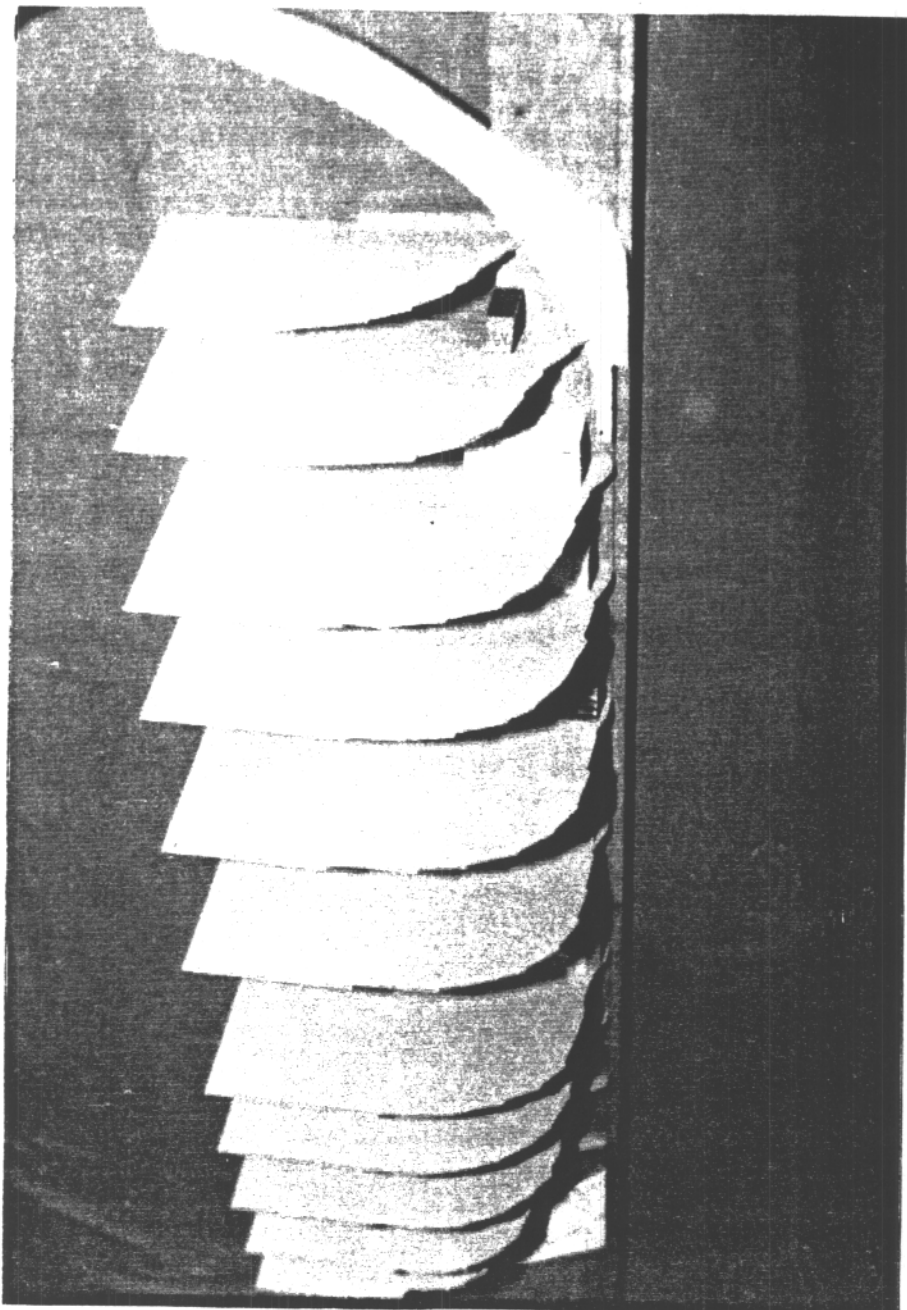
Figure 41. The model before planking.

The stations were cut on a band saw, and fastened onto the base with glue. Thus, a series of molds was created exhibiting joggles through at least the sixth strake but no higher than the eighth strake (Fig. 41). The molds extended upwards more than high enough to accommodate any sheer strake.

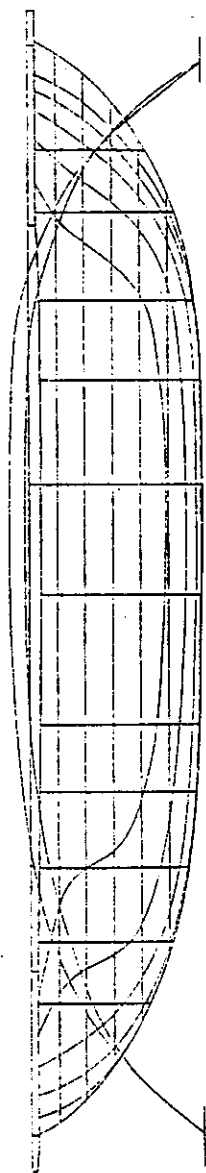
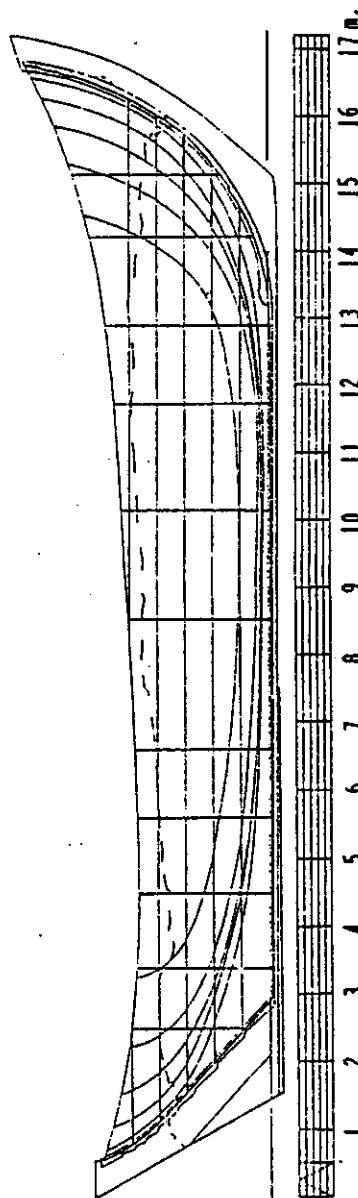
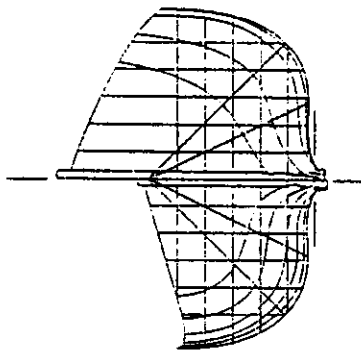
LENGTH TO BEAM RATIO= 3.44:1

DRAWN TO THE INSIDE CORNERS  
OF THE LANDINGS

Figure 43. Lines drawing of NZ421.

When the eighth strake was in place the ninth, or sheer strake was similarly designed and mounted. The completed model is presented in Fig. 42. Offsets were taken from the model, and the sheer line was plotted on the lines drawing, which was then completed. The result is presented in Fig. 43.

factors but by economic ones as well. As is readily seen in the lines drawing, NZ421 is beamiest at the forward bulkhead. The broadness of the fishwell along with the small deadrise increased its volume and therefore its profitability. However, this construction created some planking problems, since the strakes had to be brought into the stem from this wide point. Turning them toward the stem was accomplished through the use of scarfs which can be seen clustered on the second, third and fourth strakes in front of the bulkhead on both sides of the vessel (Fig. 44). A similar clustering of scarfs is found aft of the fishwell.

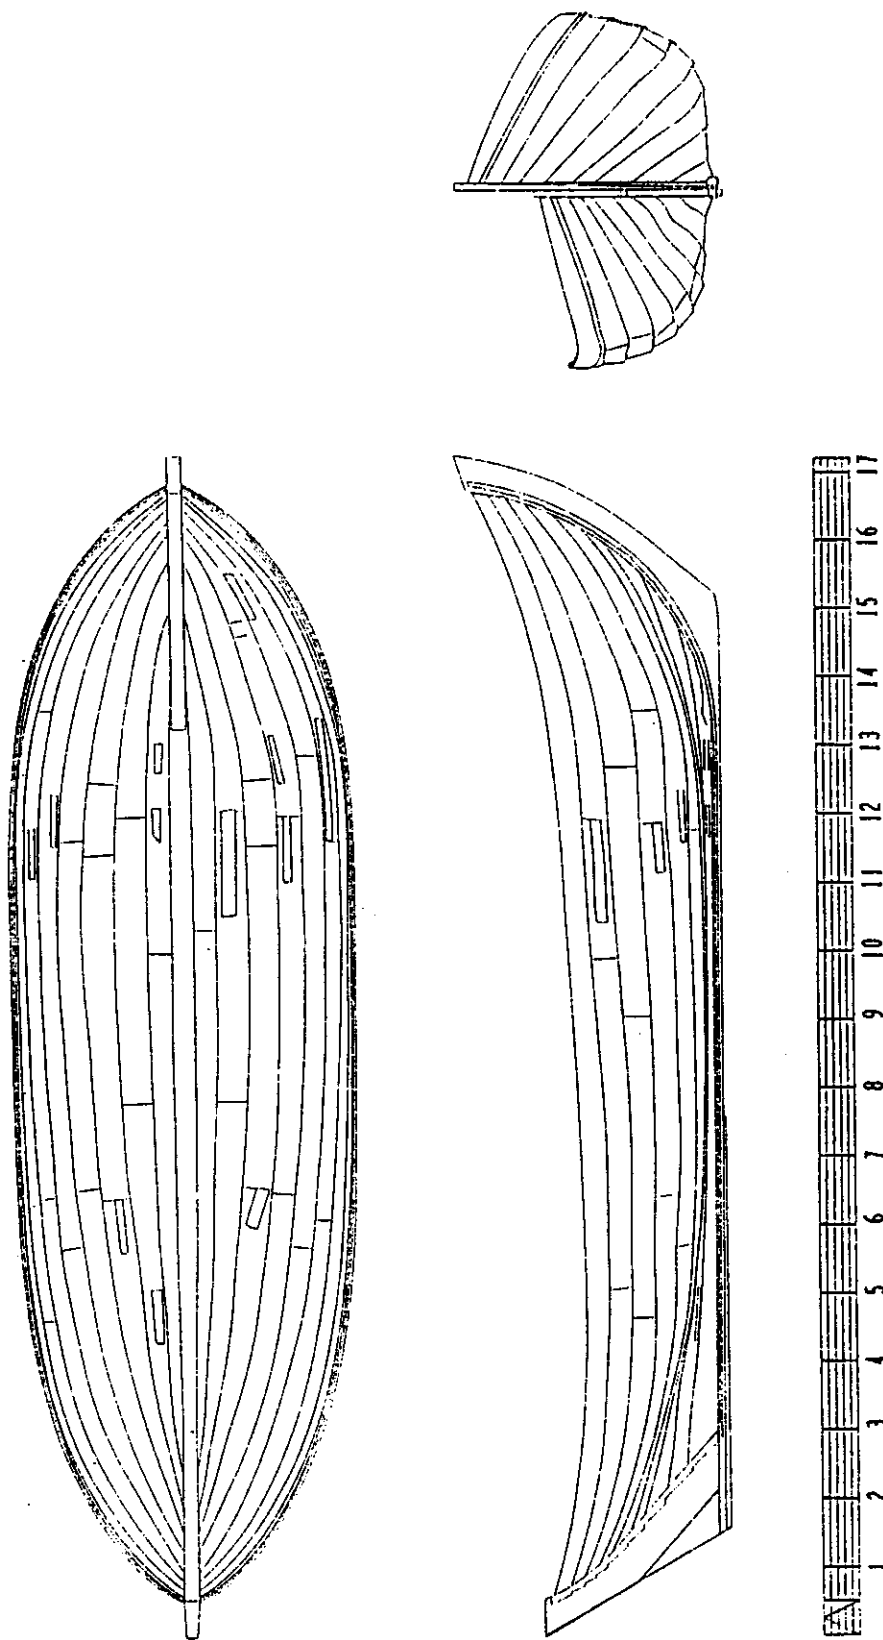
Figure 44. The reconstructed planking of NZ421. Inside port is featured in the sheer plan. Outside port is shown in the end plan.

The plan of the reconstructed planking is presented in Fig. 44. The planking diagram represents the inside of the vessel with the port side featured. Additionally, the end plan depicts the strake landings which are based

on excavation drawings. The repair patches and the scarfs were taken from the stereographic plottings of the body and sheer plans. The end plan was created by using the reconstructed sections.

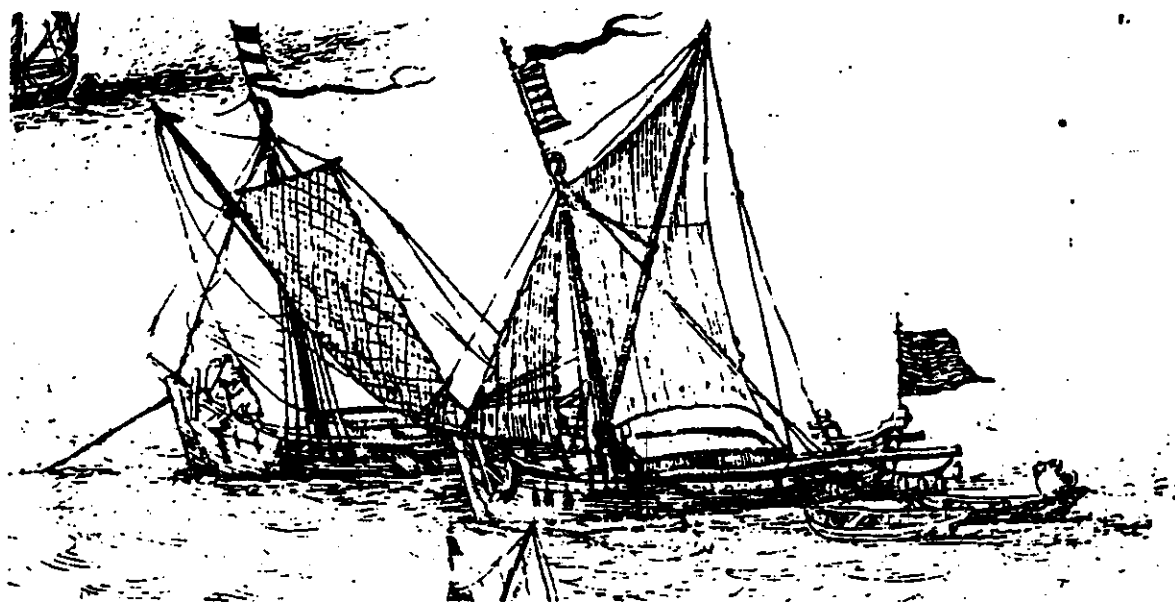
Figure 45. The waterschip as depicted by B. Florisz from his map "Kaart van Amsterdam," 1625 (courtesy of Gemeentelijke Archiefdienst van Amsterdam).

While the shape of the rudder is a matter of speculation, depictions of waterschepen such as the one by Balthasar Florisz (Fig. 45) show the shape of the tiller. While Florisz' drawing is of a later date, the tiller of NZ42i was probably similar, because the downward curve was needed to enable the helmsman to reach it comfortably.

The series of five holes at the stem top were for the attachment of a forestay via a deadeye and lanyards. A similar series of holes was found on wreck W10 (Fig. 60), and the lanyards and deadeye can be seen in Fig. 60. This was a characteristic of the waterschepen called the gordijn (= curtain) (Crone, 1926: 242). As can be seen in Figs 45, 62 and 63, a foresail was attached to the forestay.

There was no evidence on NZ42i for the attachment of the lower end of a backstay. The Florisz drawing (Fig. 45) shows backstays attached somewhere in the area of the

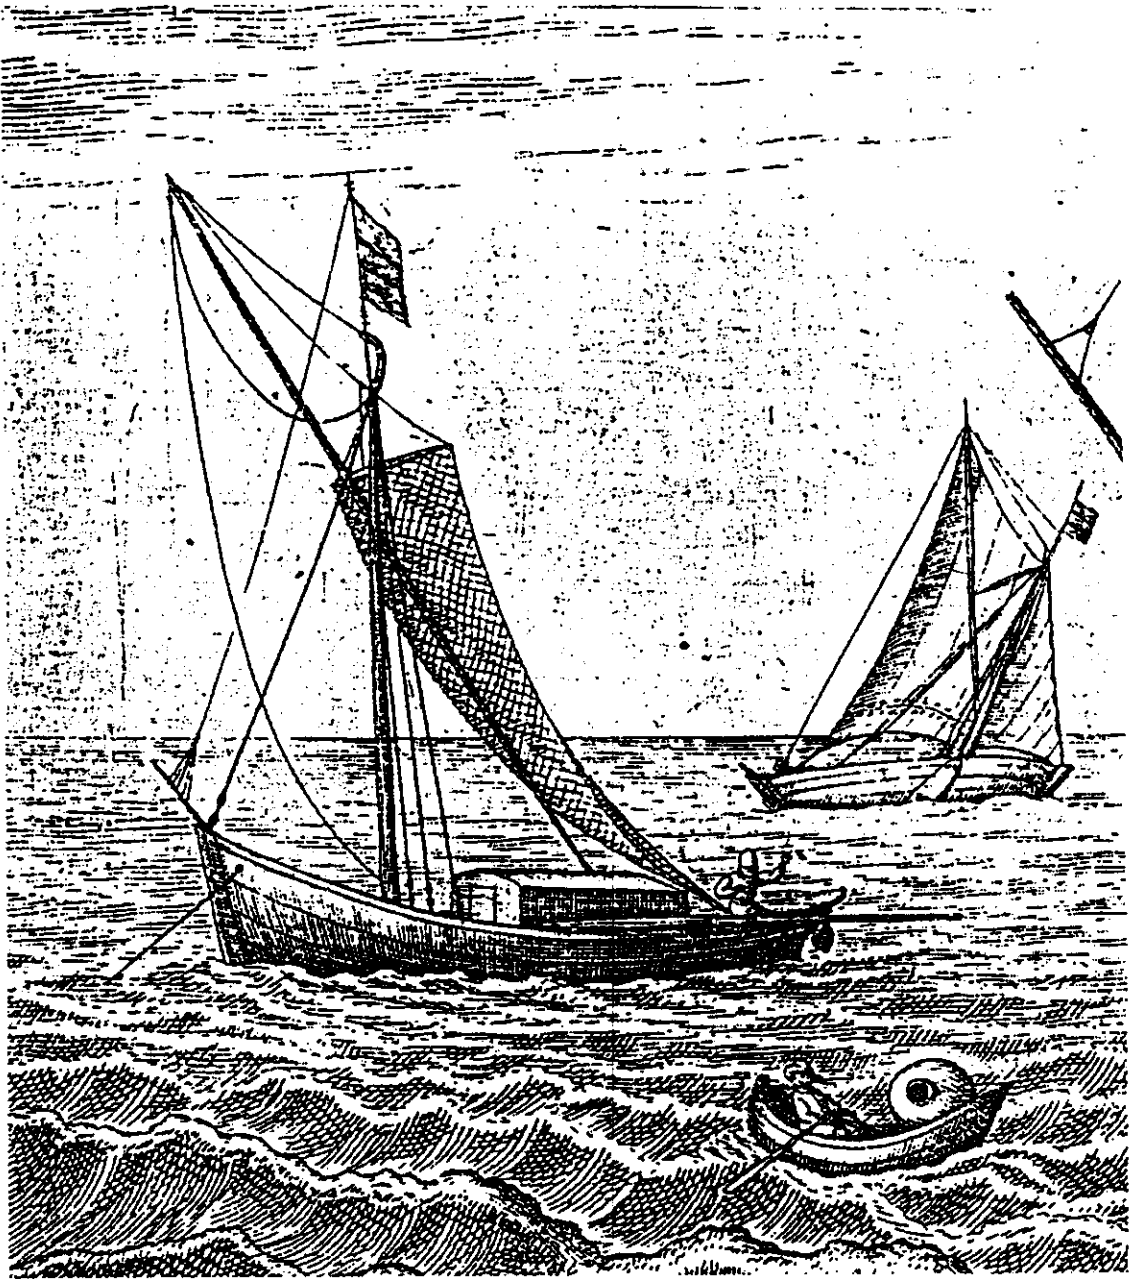
Figure 46. An anonymous engraving of a waterschip from 1600 (courtesy of Rijksmuseum, Amsterdam).

W10 was reconstructed with four shrouds to either side. Florisz depicts seven shrouds to a side, and the anonymous etching from 1600 shows three (Fig. 46). A circa-1655 depiction of a waterschip by Reinier Nooms (Fig. 63) shows four shrouds to a side, while Fig. 62 depicts at least five. Thus it can only be suggested that NZ421 had between three and seven shrouds to a side.

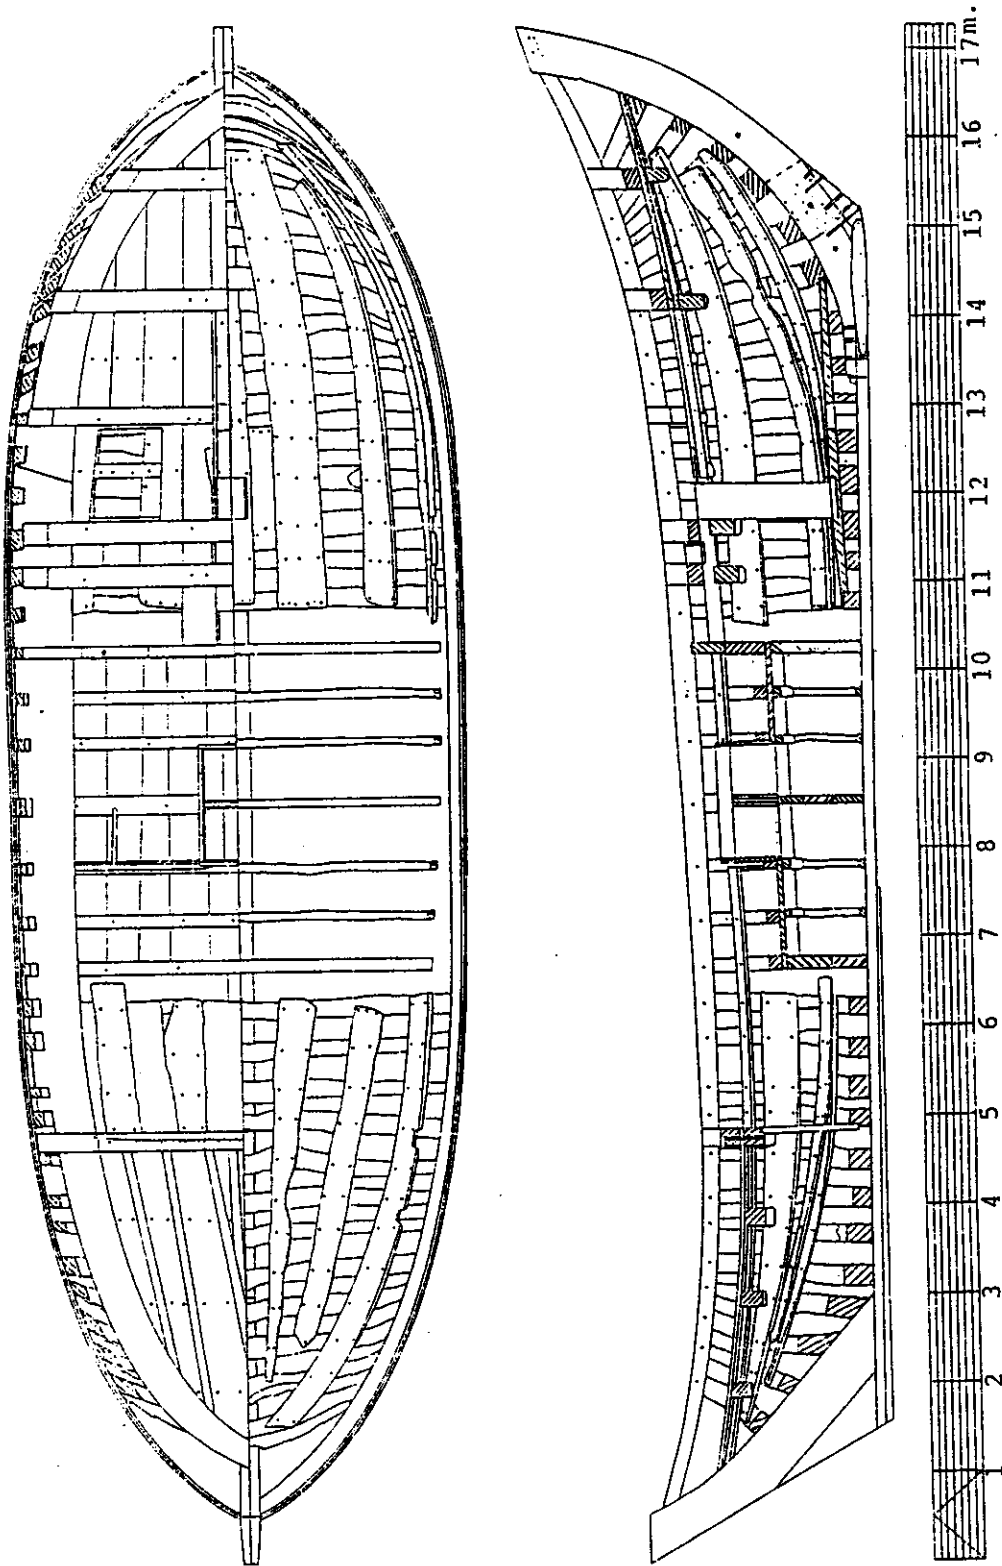
Figure 47. The reconstructed framing of NZ421.

#### The Framing (Fig. 47)

With the shape and the planking of the vessel reconstructed, the proper placement of the framing could be decided. This was achieved through several methods including drawing the framing onto the model; using the stereographic plotting of the framing plan, which was the only record of the placement of the frames; and using a flexible paper model. No details on the planking relevant to the placement of frames were recorded aside from that which was visible in the photographs and the stereographic plotting. The arrangement of the floor timbers along the keelplank was taken from the plotting

The connection between frame Q, the kingplanks and the waterway gave the necessary support to the forward end of the deck as well as tying the stem via these timbers to the bulkhead. The resultant deck position (Fig. 47) then permitted the reconstruction of the full and half beams.

The result was a slightly up-curving deck (Fig. 47), the waterways of which ran parallel to the landing of the seventh and eighth strakes for approximately half their lengths. Then, as the curve of this landing increased, the deck followed a less curving course. It was possible to make the waterways follow the landing of the strakes, but this would have created a steeper deck that would have made it difficult for the helmsman to keep a sure footing. Thus, a flatter deck was chosen to avoid problems at the helm.
