WATERSCHIP NZ421: A LATE MEDIEVAL FISHING VESSEL  
FROM FLEVOLAND, THE NETHERLANDS

A Thesis

MASTER OF ARTS

May 1991

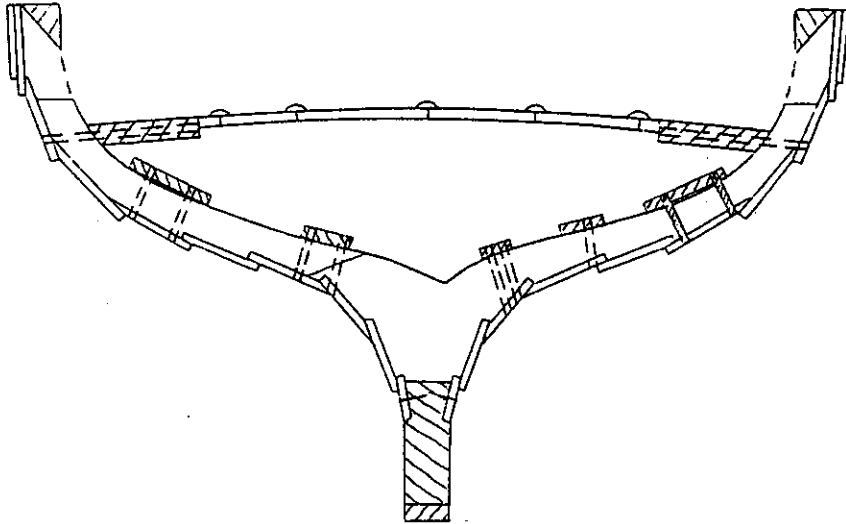
Figure 48. Section 1- a. as found, b. reconstructed.  
(Not to scale).

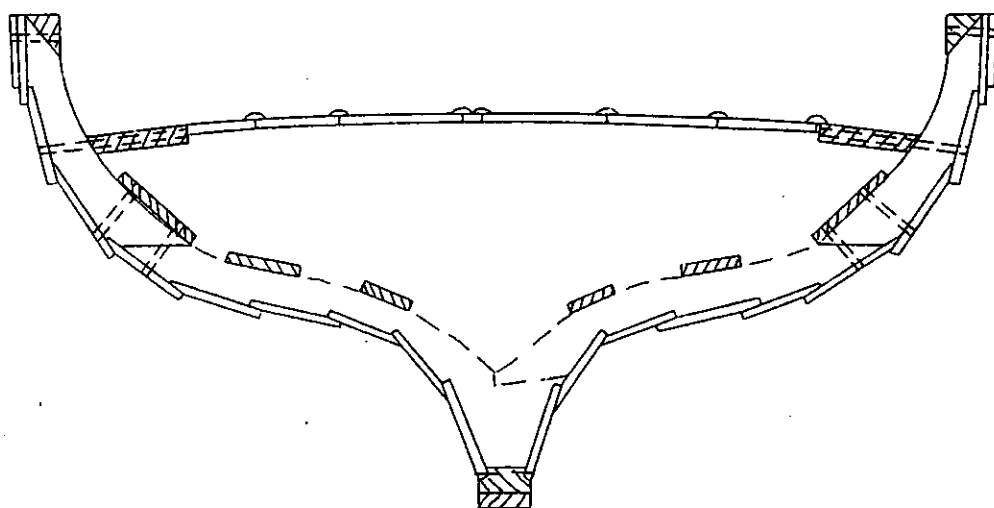
Figure 49. Section 2- reconstructed. (Not to scale).

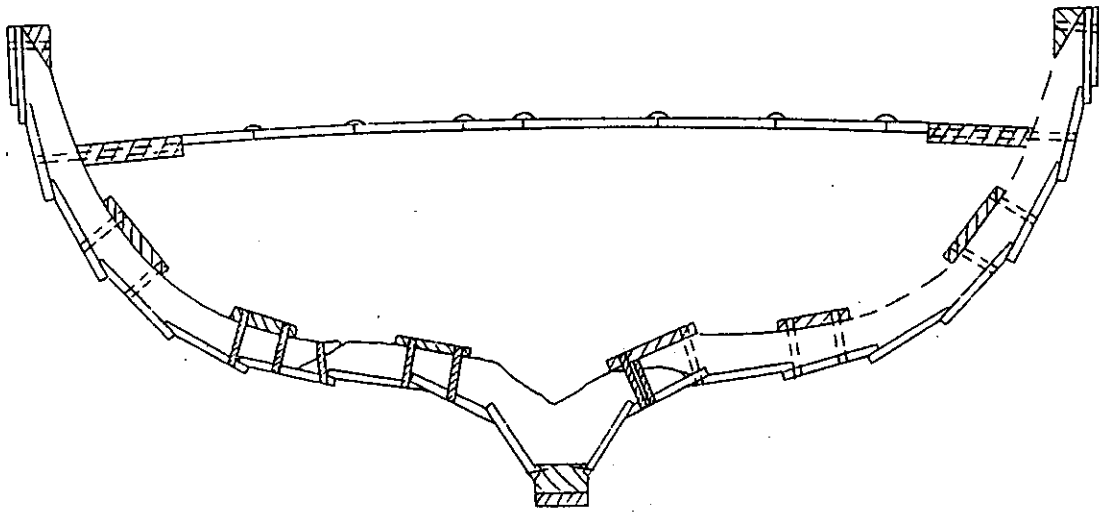
Figure 50. Section 3- reconstructed. (Not to scale).

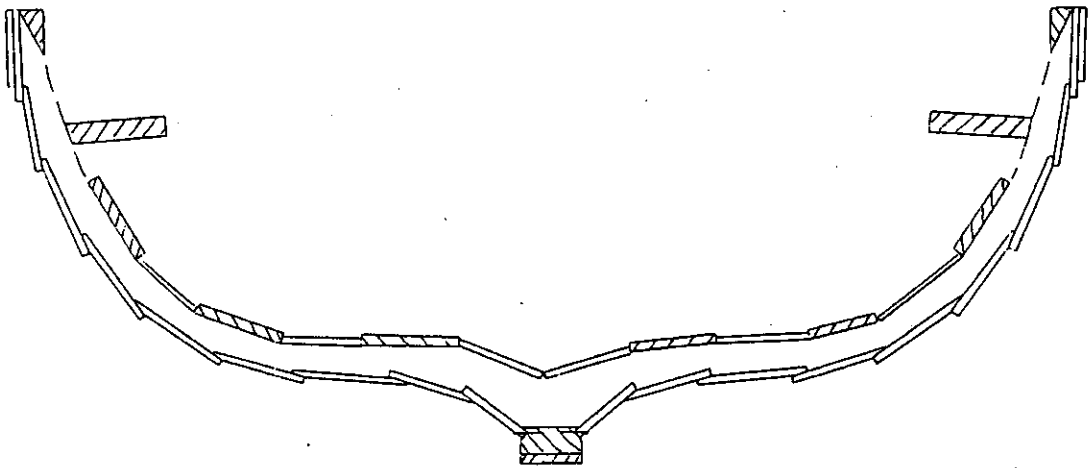
Figure 51. Section 4- reconstructed. (Not to scale).

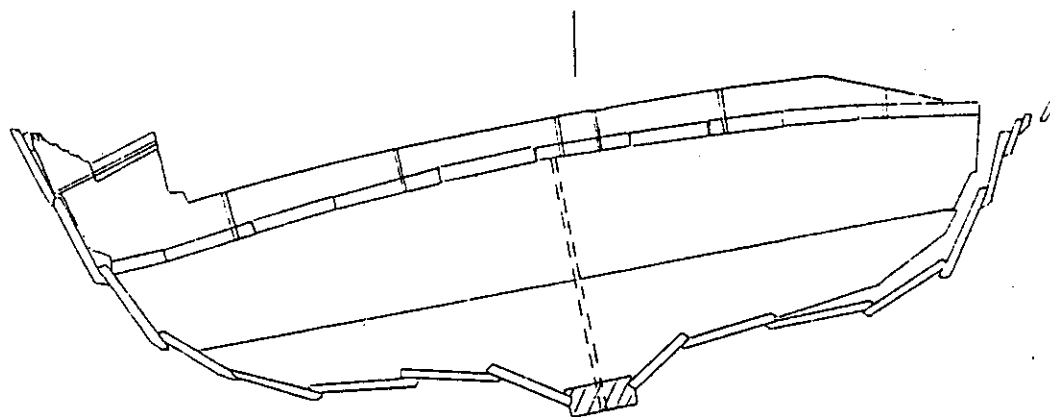
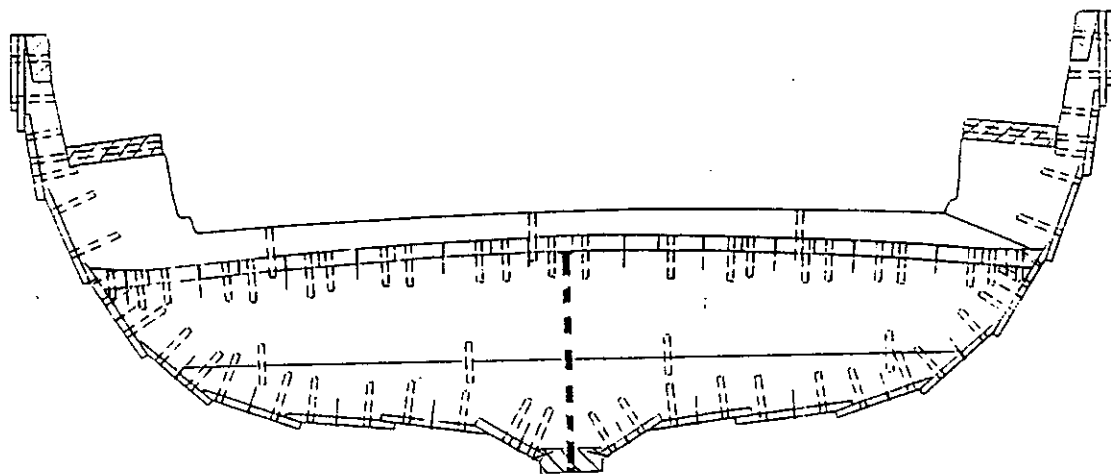
Figure 52. Section 5- a. as found, b. reconstructed.  
(Not to scale).

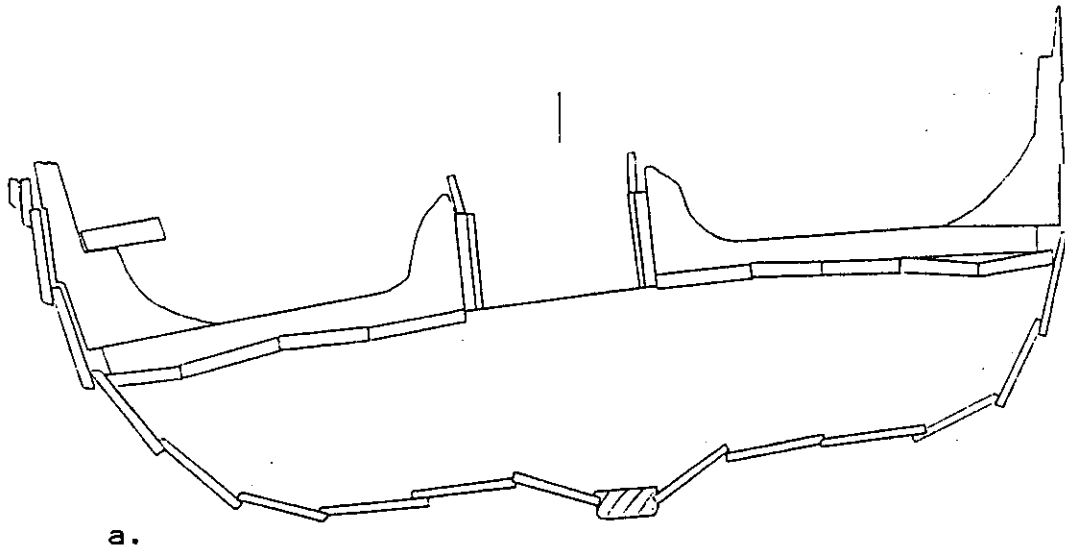
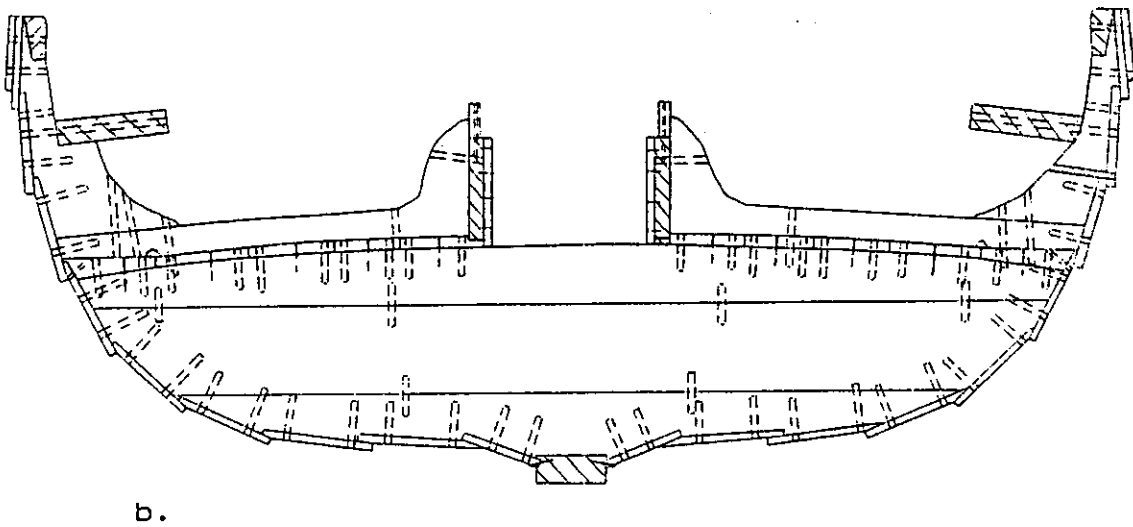
Figure 53. Section 8- a. as found, b. reconstructed.  
(Not to scale).

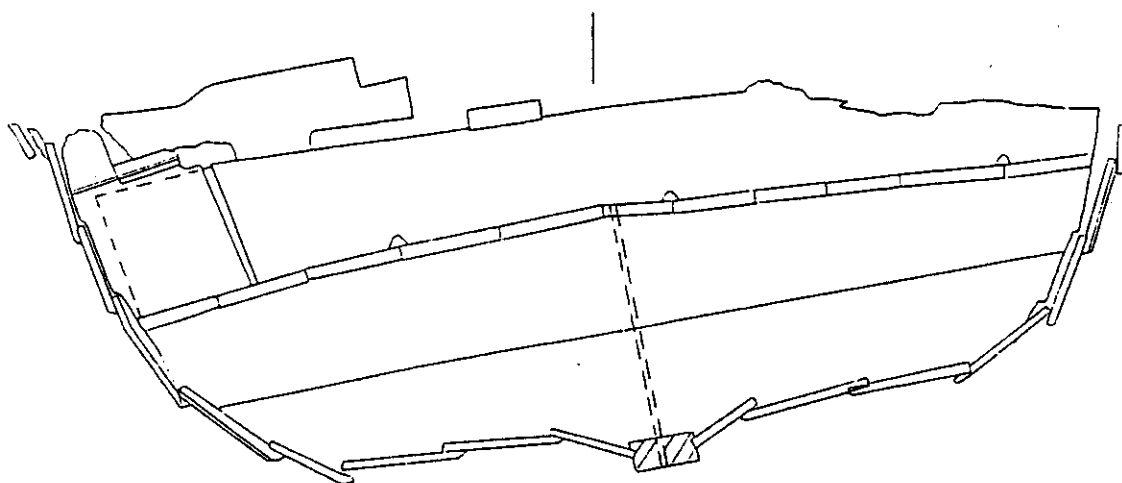
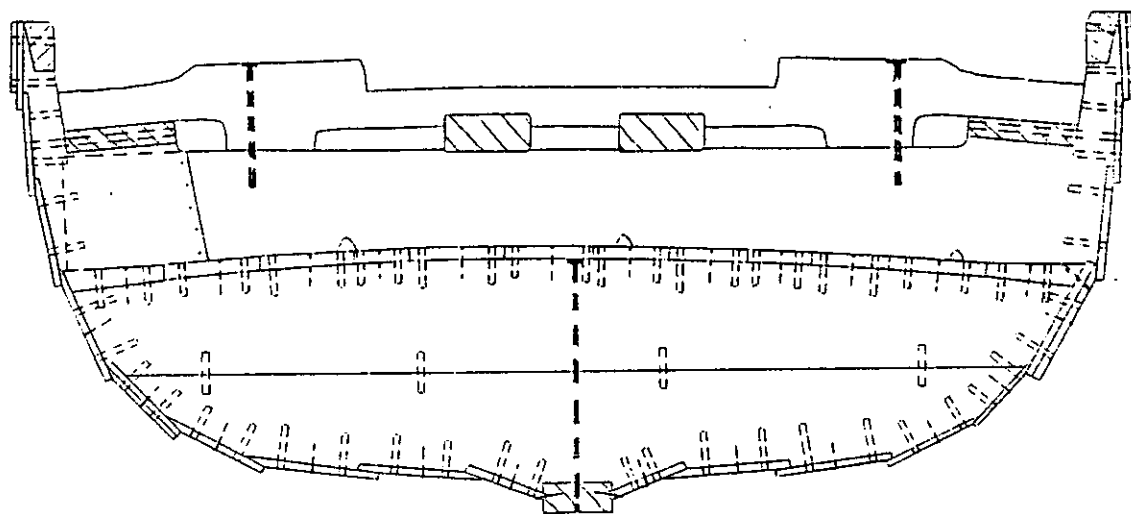
Figure 54. Section 9- a. as found, b. reconstructed.  
(Not to scale).

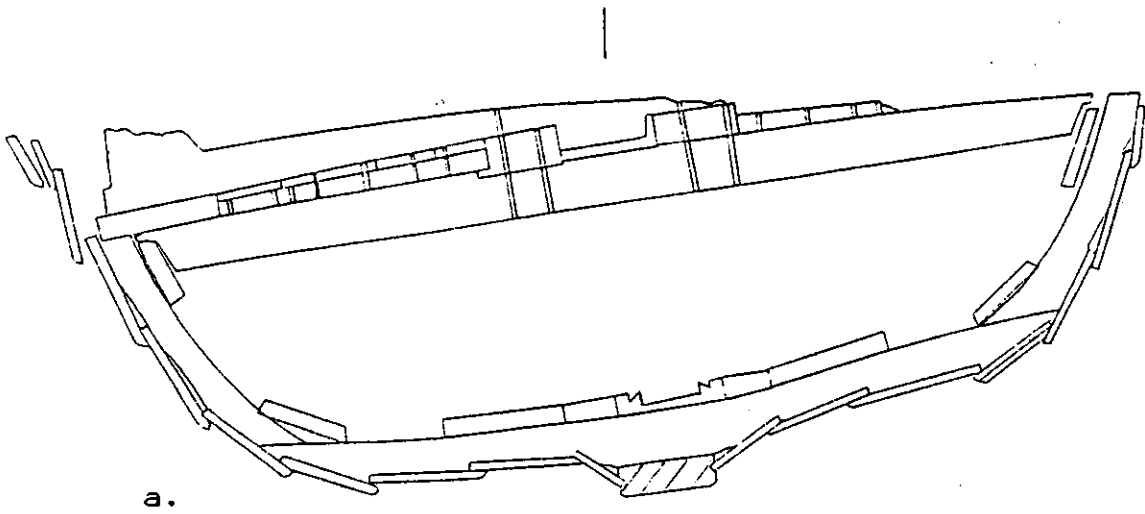
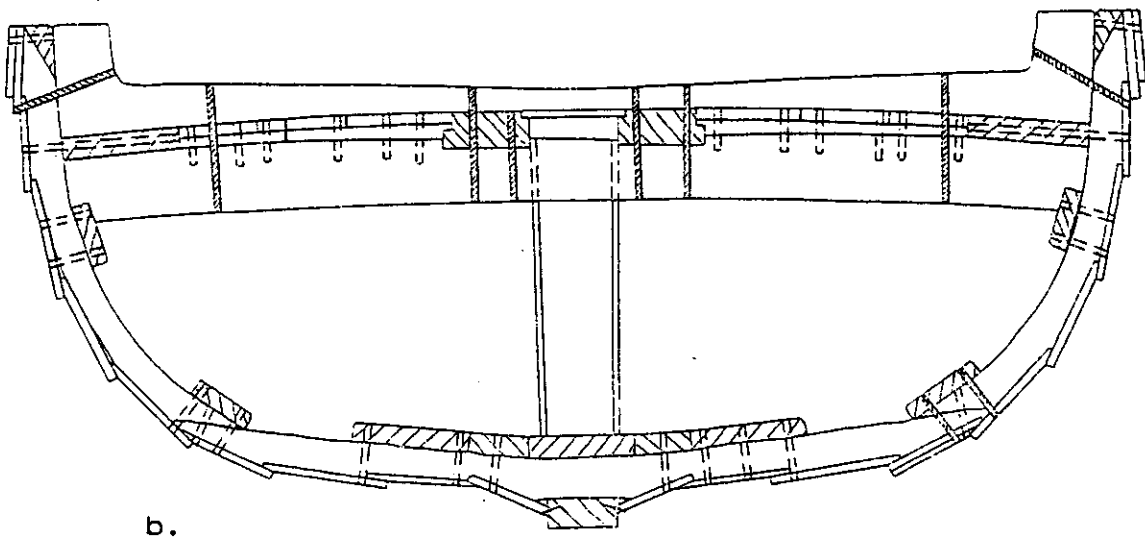
Figure 55. Section 10- a. as found, b. reconstructed.  
(Not to scale).

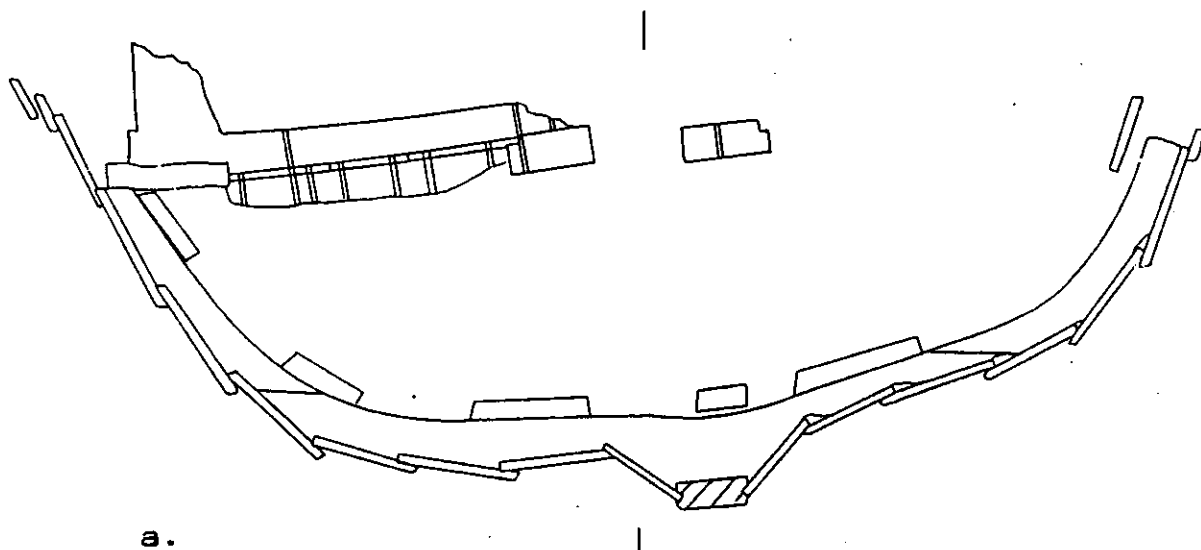
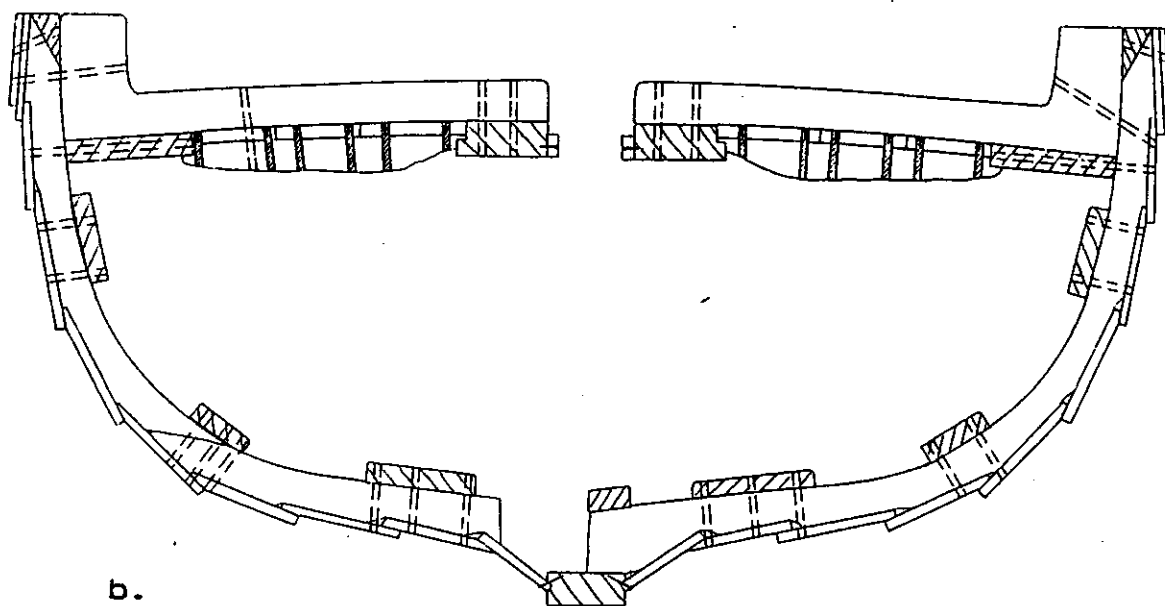
Figure 56. Section 11- a. as found, b. reconstructed.  
(Not to scale).

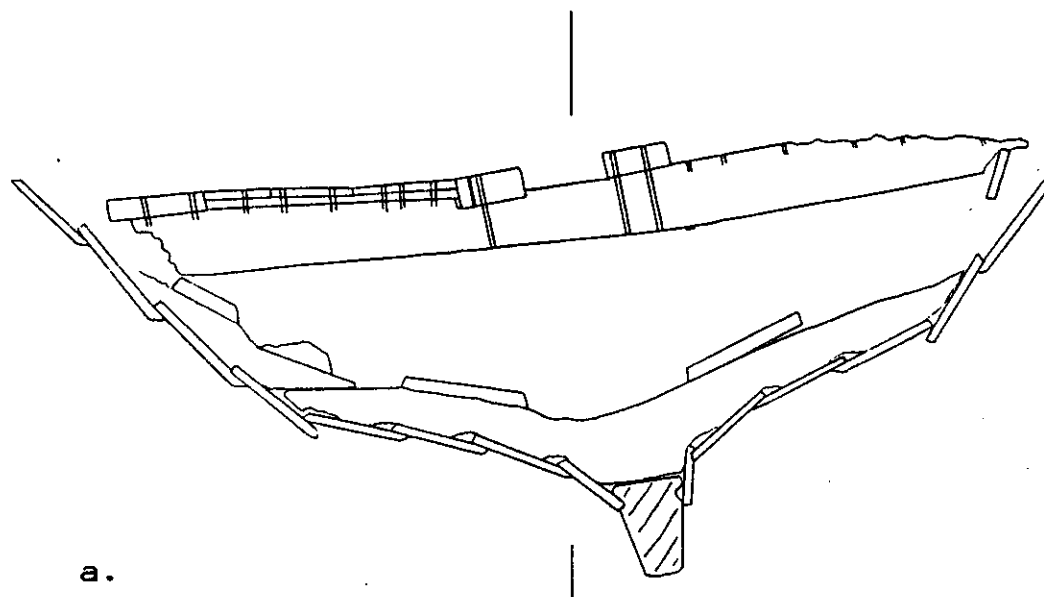
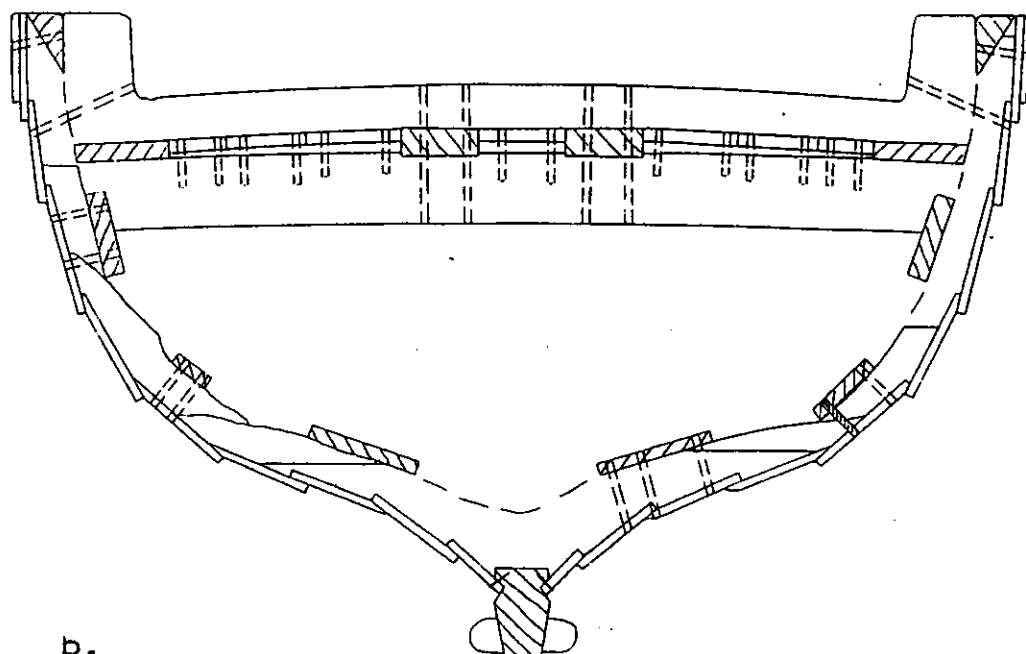
Figure 57. Section 12- a. as found, b. reconstructed.  
(Not to scale).

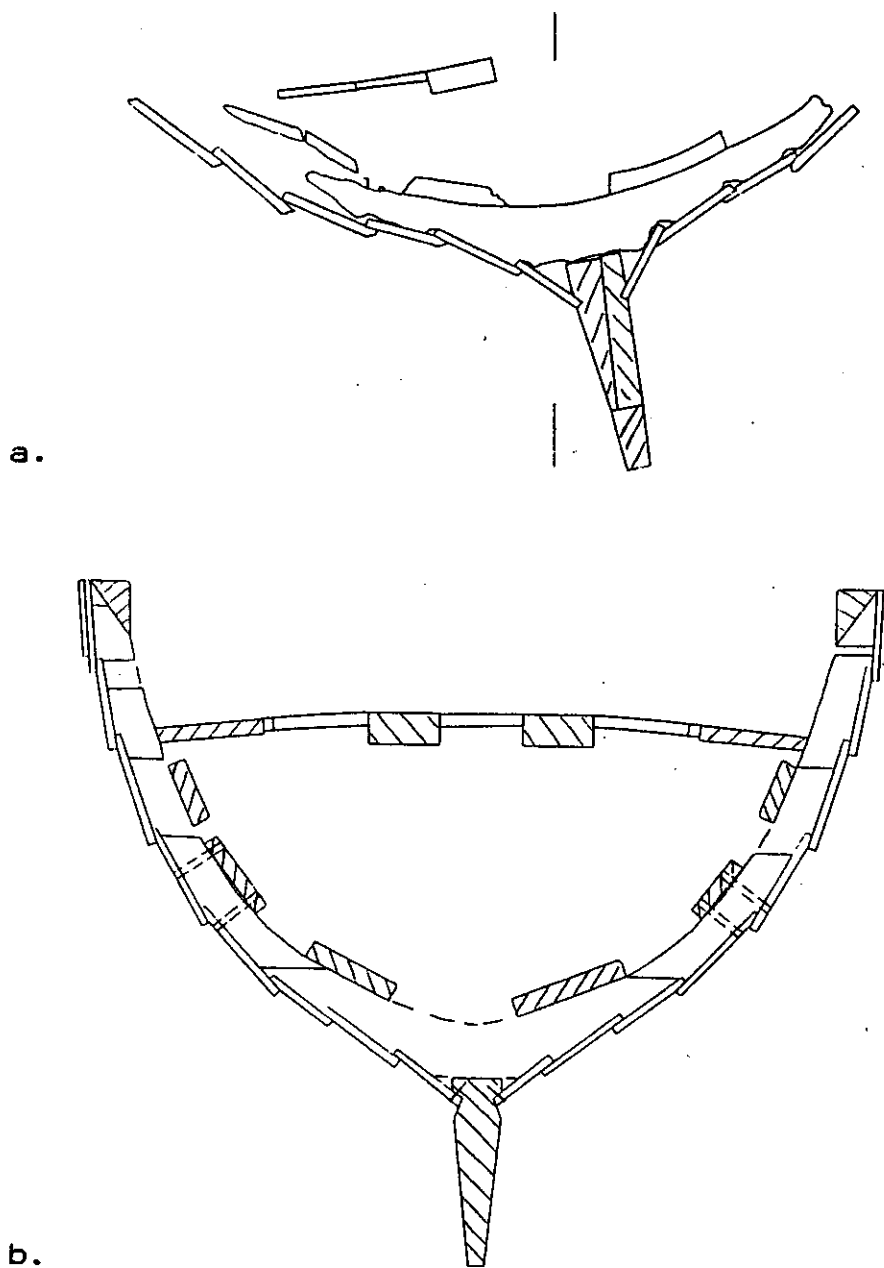
Figure 58. Section 13- a. as found, b. reconstructed.  
(Not to scale).

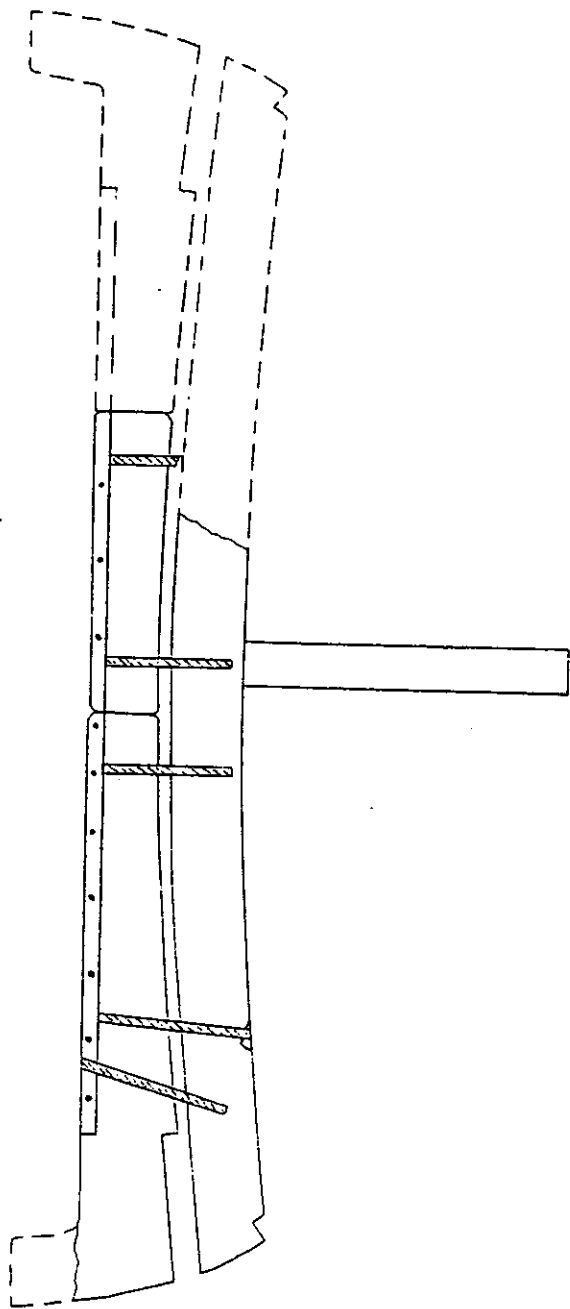
Figure 59. The forwardmost stern deck beam.  
(Not to scale).

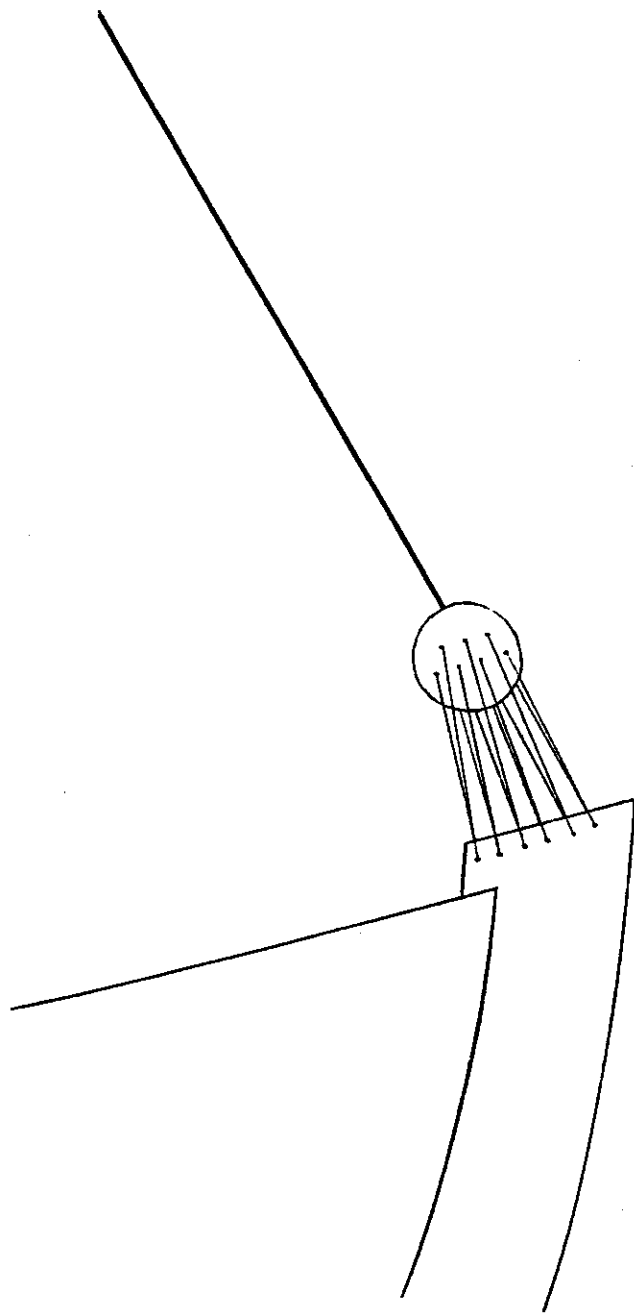
The series of five holes at the stem top were for the attachment of a forestay via a deadeye and lanyards. A similar series of holes was found on wreck W10 (Fig. 60), and the lanyards and deadeye can be seen in Fig. 60. This was a characteristic of the waterschepen called the gordijn (= curtain) (Crone, 1926: 242). As can be seen in Figs 45, 62 and 63, a foresail was attached to the forestay.

Figure 60. The stem top of W10 (not to scale; after Reinders, 1987: app. 1).

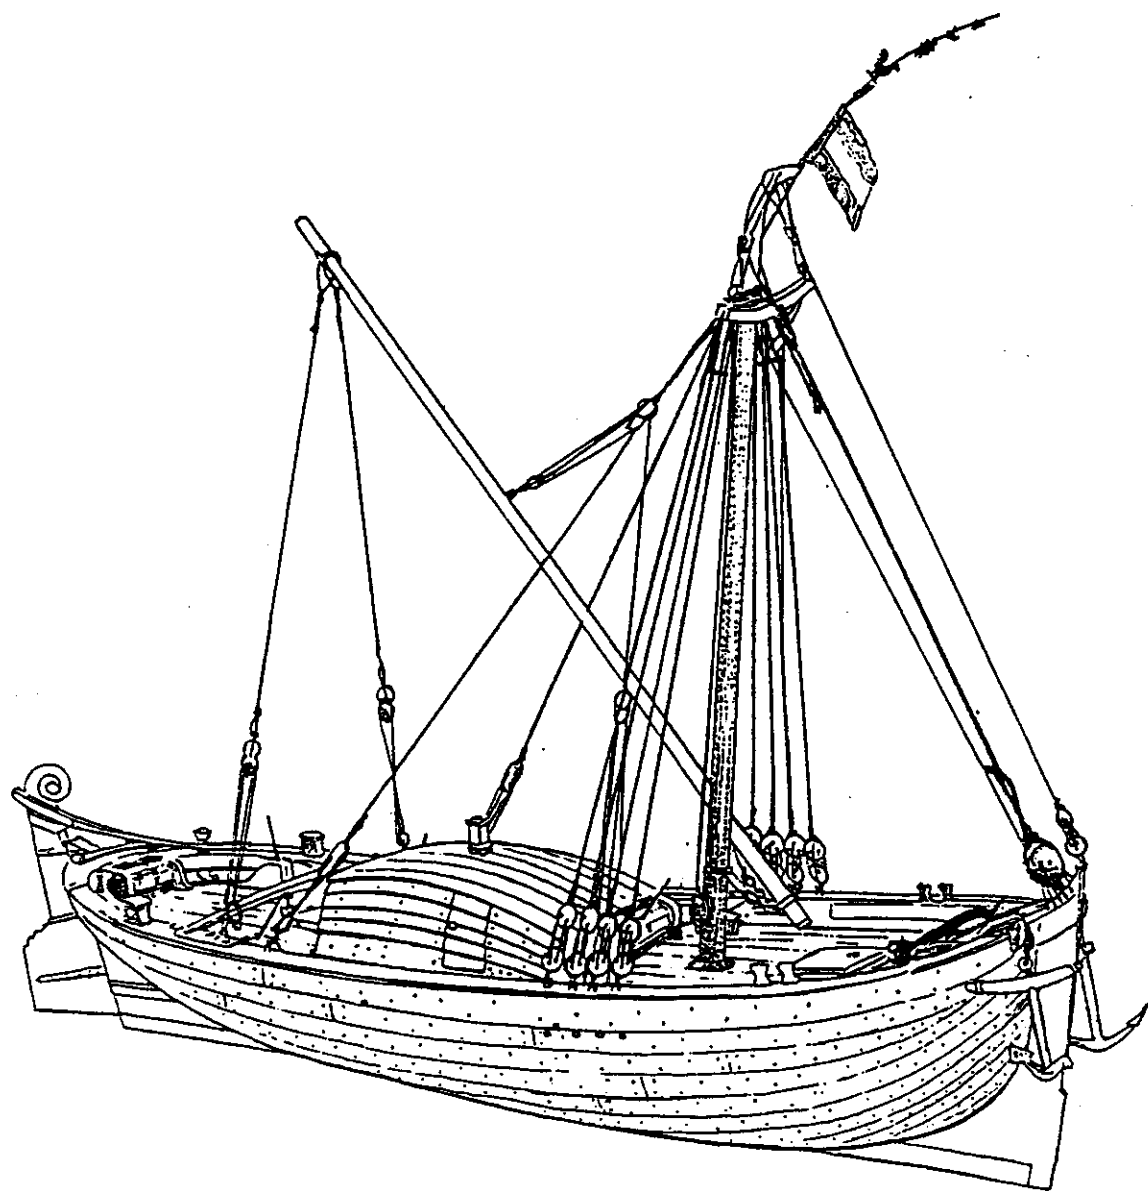
Figure 61. A drawing of a late waterschip (from Petrejus, 1971: 117).

helmsman. Fig. 62 portrays a backstay fastened to the sheer on the aft starboard quarter, while Fig. 61 shows the backstays connected to the sheer by lanyards. It is likely that NZ421 had a similar arrangement.

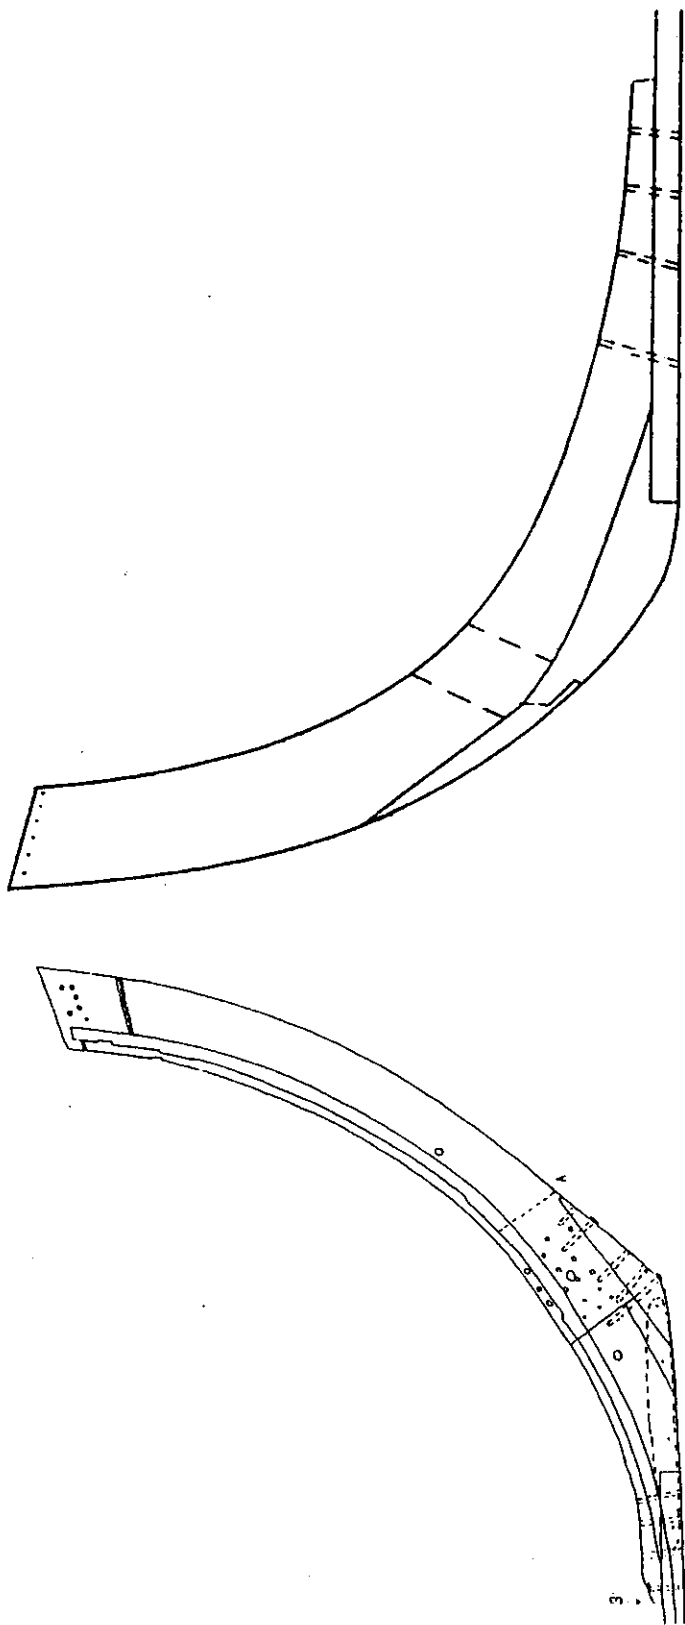
NZ421's stem is similar to that of waterschip W10 in shape and in the number of components (Fig. 64), although due to NZ421's smaller size, its stem is smaller. However, the stem of W10 has a more sophisticated construction and larger relative dimensions, that is, the molded dimensions of W10's stem are greater in proportion to its height. Both of these aspects give W10's stem the appearance of greater strength. The change in the proportional size may be attributable to the switch to the carvel technique, since W10's hull would not be as strong as the clinker-built NZ421. This might make a more massive stem necessary in order to strengthen the bow. Also, the differences in stem construction may be due to the dissimilar building techniques. The stronger hull of the clinker-built vessel would make possible the less sophisticated stem construction. If the construction of W10's stem is indeed stronger, it may be a feature developed to compensate for the reduced strength of its hull. It is possible, however, the

Figure 64. A comparison of the stems of NZ421 and W10 (scale= 1:50; W10 after Reinders, 1986b: app. 10).

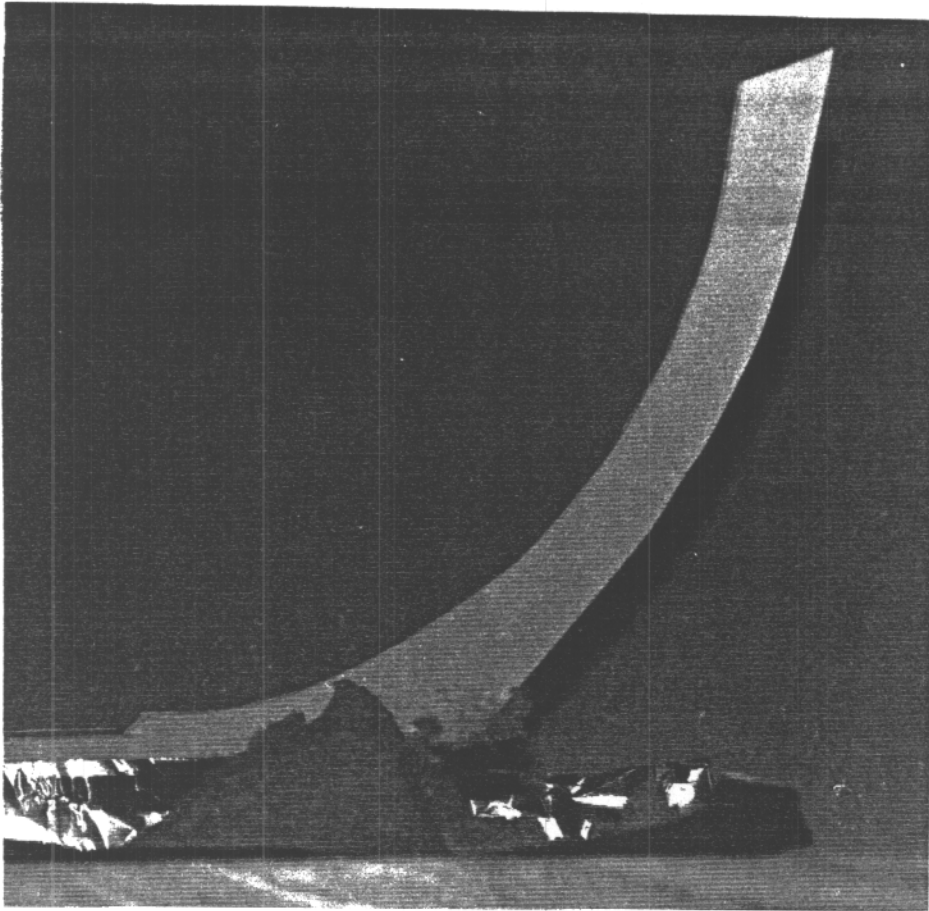
The experiment was in two parts. The first part involved pushing the model into the bank without the timbers in question attached. The second part involved the same procedure but with the timbers fastened to the model. Fig. 65 shows the result without the timbers. As can be seen, the stem cut deeply into the bank, although due to the angles of the stem face and the bank, it was lifted upward slightly. Fig. 66 shows the result with

Figure 65. Beaching the stem without the runners.

Another function of these timbers was demonstrated in the experiment. As can be seen in Fig. 65, the stem penetrated deeply enough to bring the "mud" into contact with the area of the garboard's hood ends. On the actual vessel, such repeated contact would cause undue wear on this important area, ultimately causing the failure of the hood ends and the loss of the vessel. As seen in Figs 66 and 67, the runners not only raised the vessel high enough to prevent contact with the garboards, but also laterally deflected the "mud" away from the hull.

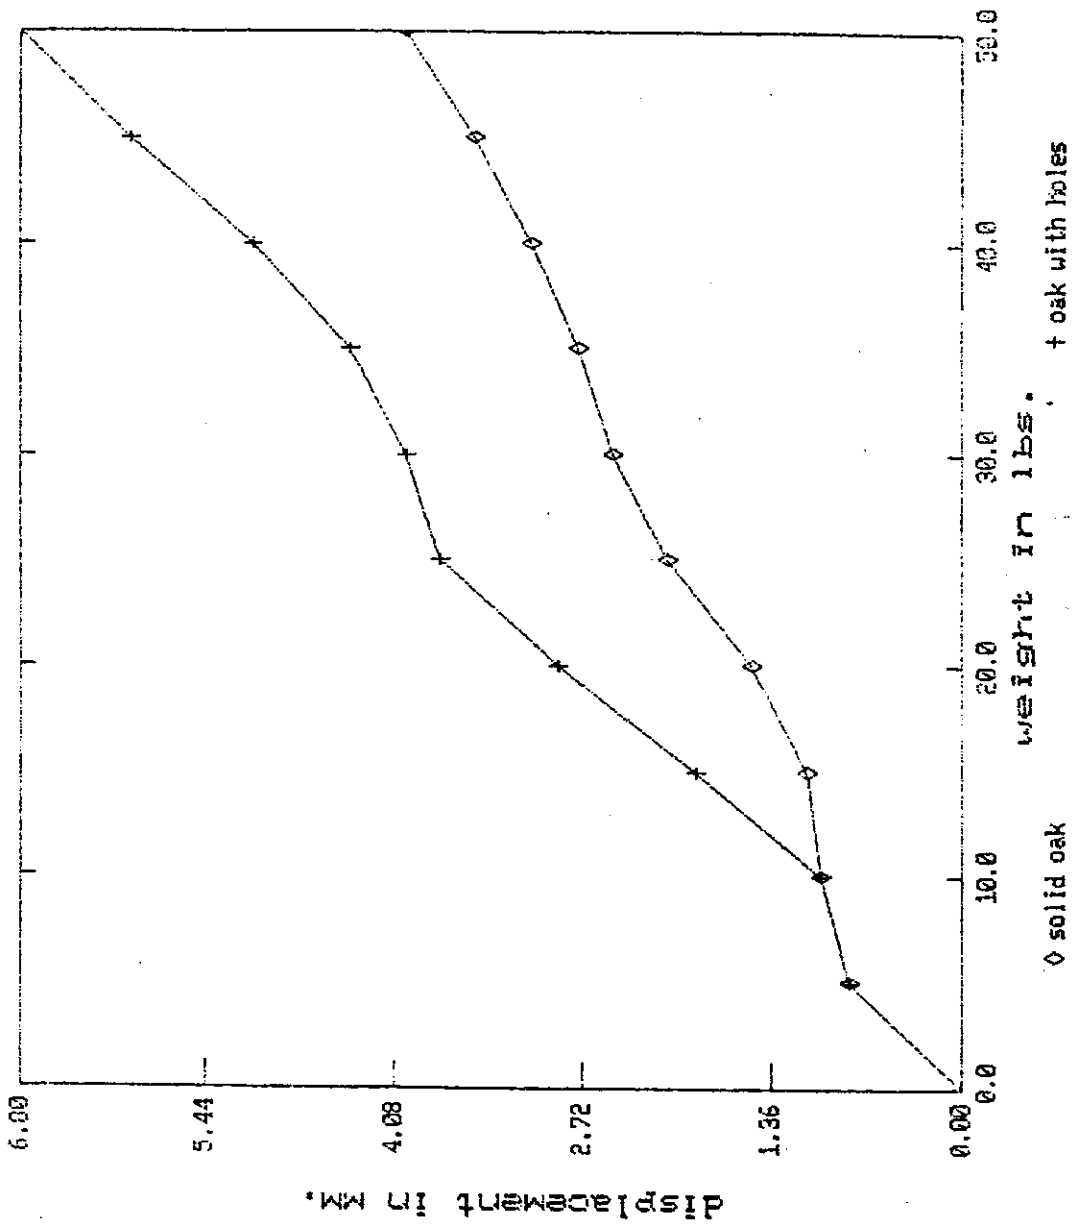
Each plank was set in an arrangement in which weight was applied to its center beginning with five pounds (2.27 kg.). This was subsequently increased in five pound increments to a total of fifty pounds (22.7 kg.). The deflection, or bending, of each plank at each increment was recorded and plotted in a graph (Fig. 70).

Figure 70. The graph comparing the deflection of the model planks plotted by weight vs. amount of deflection.

As expected, the pierced plank bent further under the weight, which was 58.8% greater at the fifty pound mark. This means that the pierced plank was 58.8% weaker than the intact plank when under 50 lbs. of direct pressure.

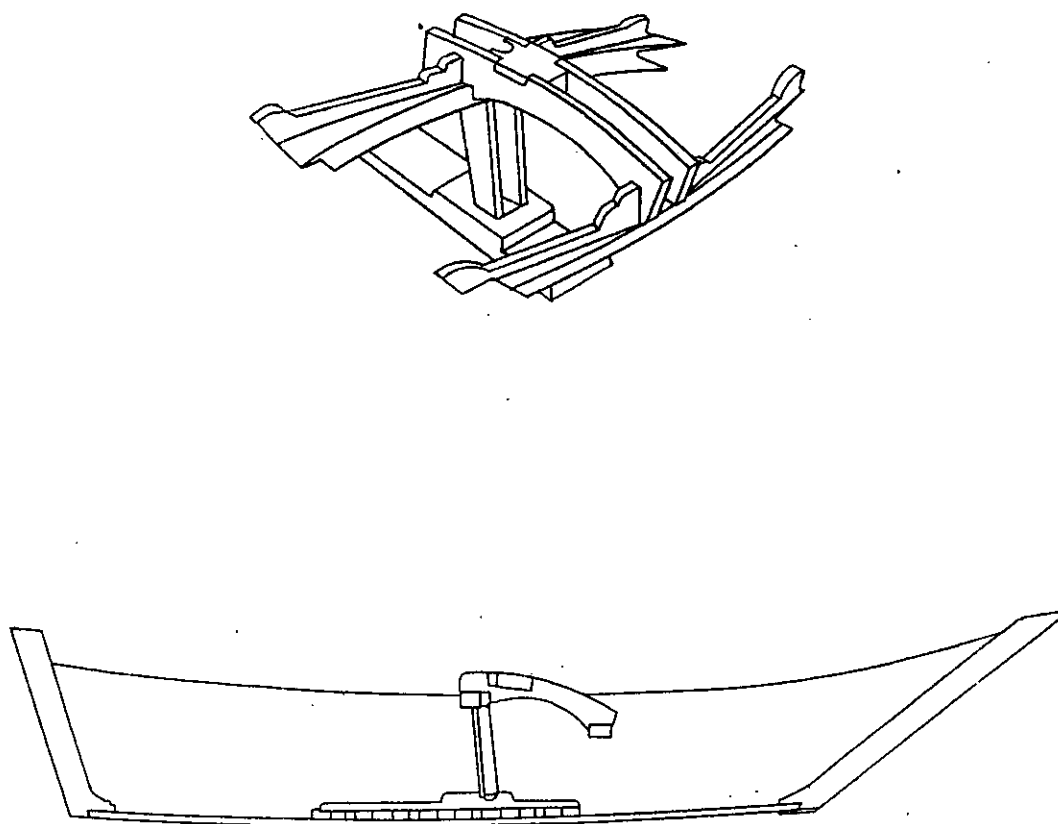
find is Kalmar I, which had timbers comparable to NZ42i's kingplanks together with supporting thwarts after the mast (Akerlund, 1951: pls. 7b, 7c). Another parallel is the Ilmenau Ever, a model from 1710, which has a mast support structure with greater similarities to NZ42i. The model (Fig. 71) is of a type first found in literary sources in 1300 (Salemke, 1971: 7) and thus has a history equally long as the waterschip (see below). On this open, flat-bottomed vessel with clinker-built sides, the mast is supported on its after side by a thwart and laterally by two timbers running fore and aft. Forward of the mast, in the top faces of these two timbers, is a rabbet into which fits a mast partner. The mast partner may be similar to the missing one on NZ42i, although it is not known if this item on NZ42i was one piece with the hatch, pump included (see p. 144).

The Ilmenau Ever also has vertical timbers running from the longitudinal timbers to the mast step, with an additional third vertical timber after the mast. The timbers forming this "sheath" or "chute" are fastened at both ends, thereby securing the upper structure to the step (Salemke, 1971: 12). This is in contrast to NZ42i, where the timbers were removable and were apparently used to wedge the mast in the socket and between the kingplanks.

Figure 71. The Ilmenau Ever (after Salemke, 1971: 10, 12).

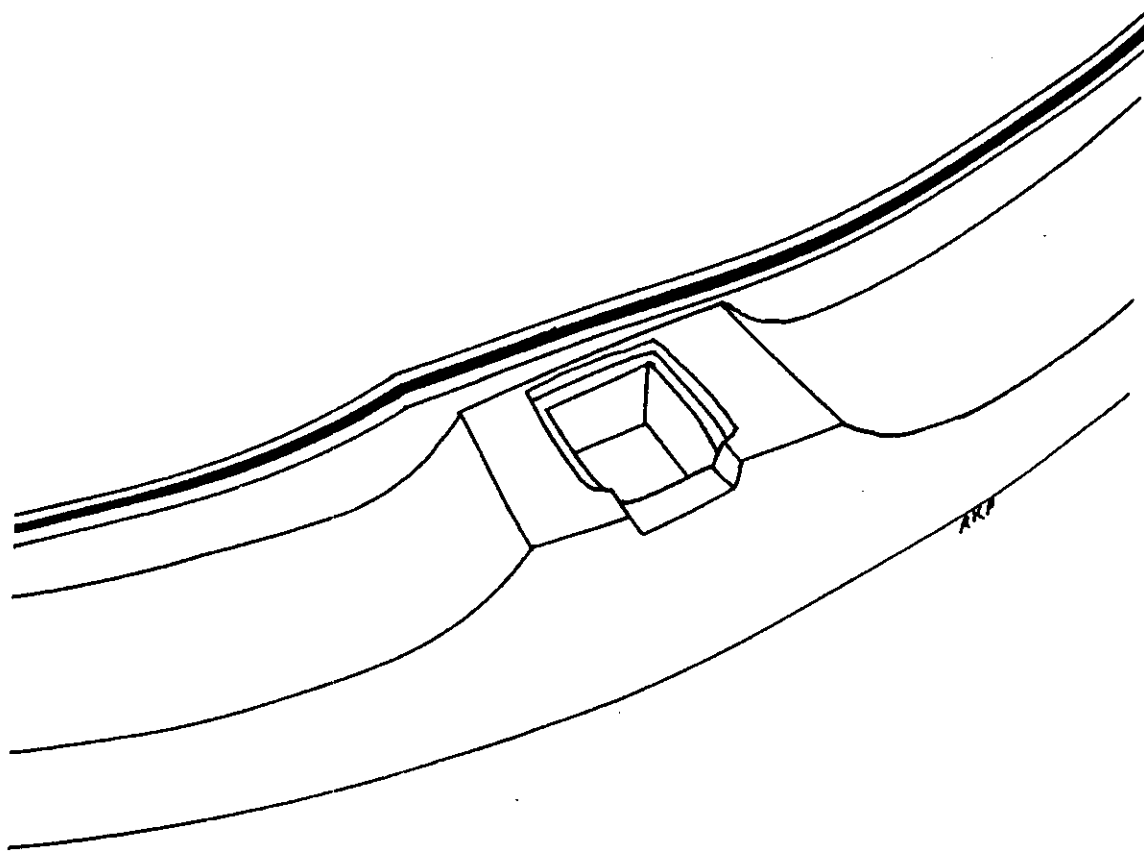
Figure 72. The mast socket of the Kollerup cog (after Crumlin-Pedersen, 1979: fig. 2.11).

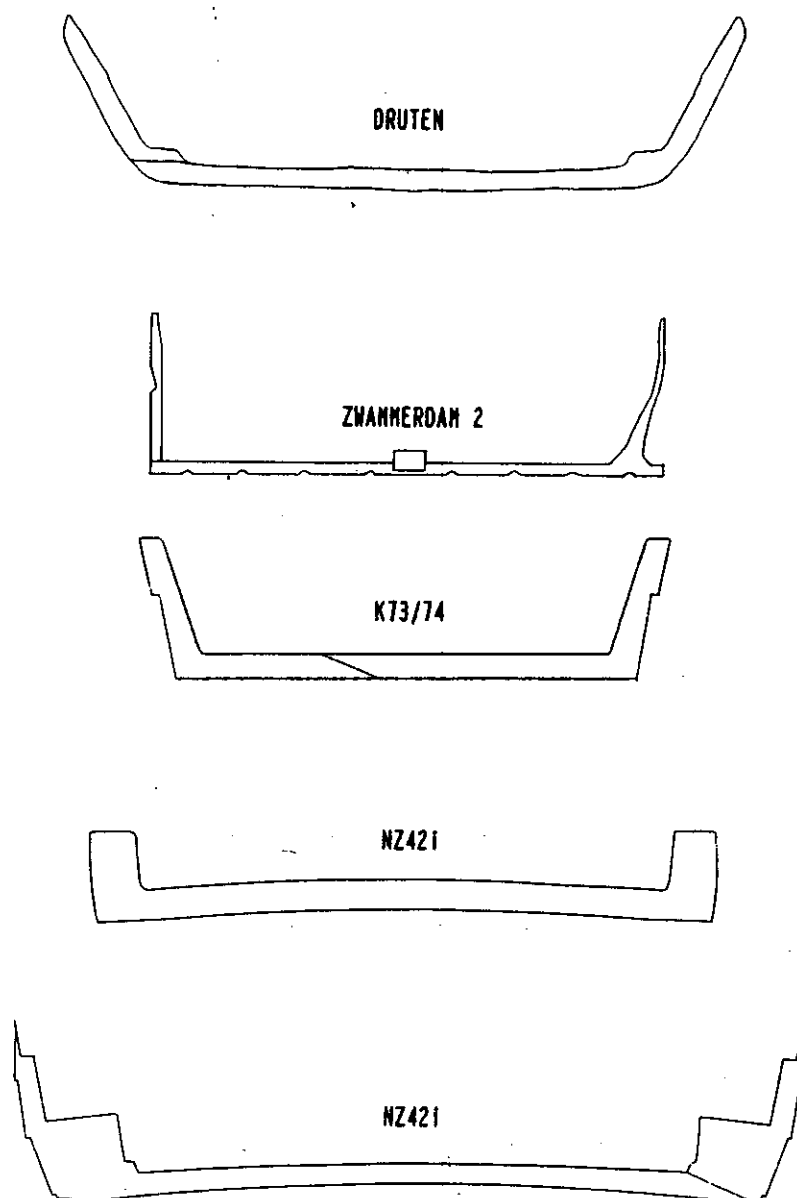
Later vessels with similar construction have been found in the polderlands. The most notable of these is K73/74 whose frames consist of two timbers scarfed near the centerline and with vertical knees on their outboard ends (Fig. 73) (Reinders, 1986: 21).

Figure 73. Frames of the Druten barge, Zwammerdam 2 and K73/74 compared to riders of NZ421 (after Lehmann, 1978: fig. 6; de Weerd, 1978: fig. 19 and Reinders, 1986a: app. 6).

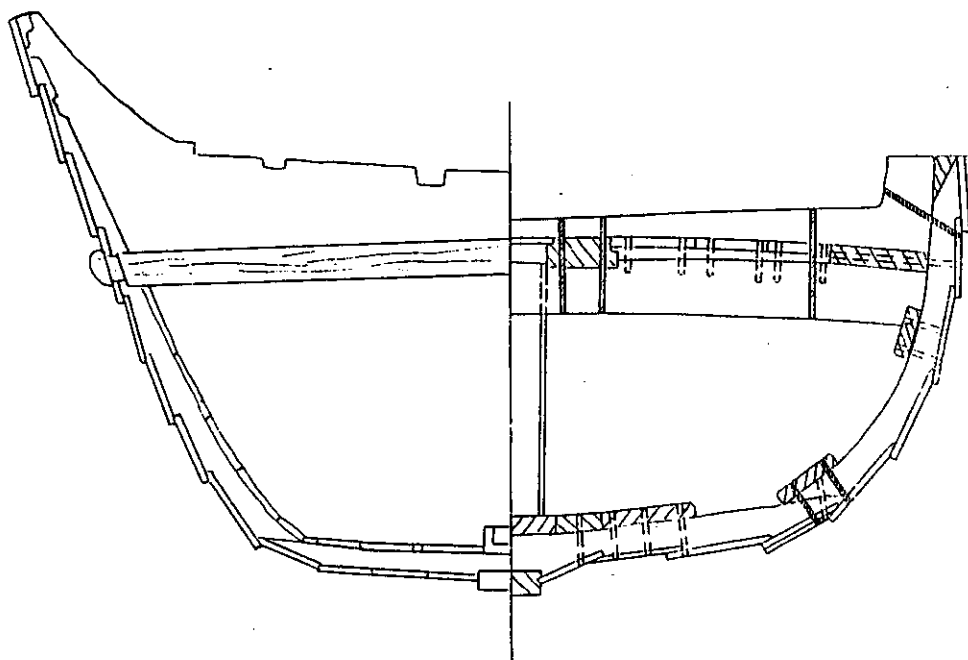
While shape and construction of the vessels are different, a comparison between sections of NZ42i and the Bremen Cog (Fig. 74) demonstrates that the bulkheads above the beams on the cog section not only have a similar function to the rider beams of the waterschip but also that the bulkheads exhibit the stylized shape of a timber with a vertical knee on each end.

Figure 74. Comparison of a section of NZ421 and a section of the Bremen cog (cog section after Steusloff, 1983: 201).

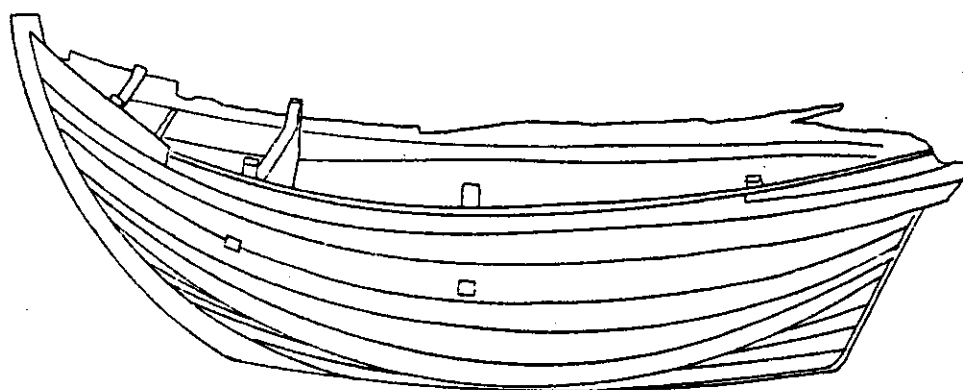
However, there is one medieval artifact that is reminiscent of the waterschip. This is the Ebersdorf ship model (Fig. 76). This model, although claimed to be a cog (Steusloff, 1983: 189), shares only a few characteristics with cogs, such as the through beam/bulkhead combination. Unlike cogs, the model is clinker-built throughout, has a convex stem and a straight post, has no hooks at the keel ends and contains no inner posts. Other features of the model include

Figure 76. The Ebersdorf model (after Steusloff, 1983: 191).

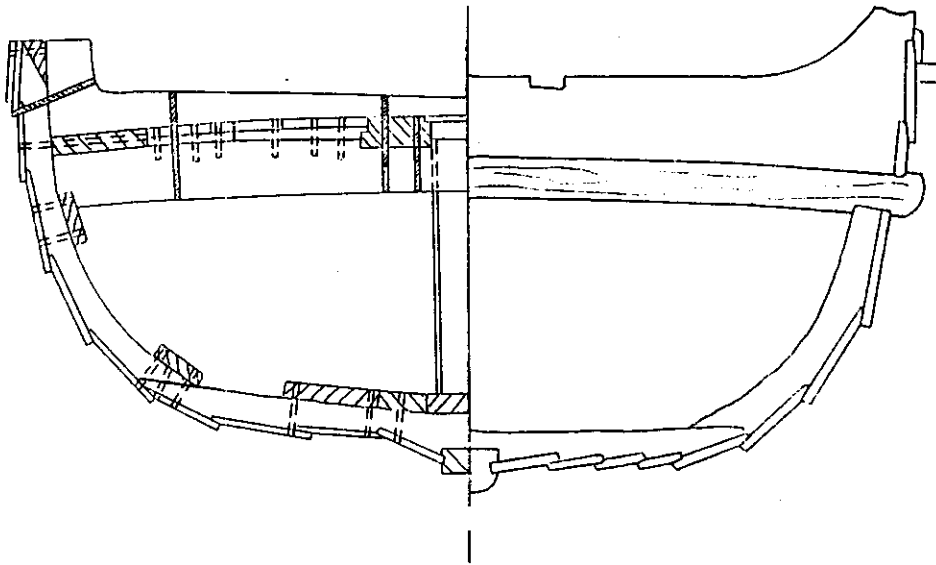
A comparison between sections of the Ebersdorf model and NZ42i illustrates their similarities (Fig. 77). Without the through beam and the keel, the Ebersdorf section is similar to the waterschip section. They both are clinker-built throughout, have futtocks placed on top of floor timbers and have timbers placed above the beams extending to the sheer. The model's profile is also similar to that of NZ42i (Fig. 76). While it lacks the waterschip's low stern, the model's stern is lower than its bow, and the shape of its forward section, as well as its pronounced sheer, resemble NZ42i. These similarities demonstrate an affinity between the two vessels, and it can be asserted that the waterschip is a variation of the type represented by the model.

Figure 77. Comparison between a section of NZ42i and a section of the Ebersdorf model (Ebersdorf section after Steusloff, 1983: 201).
