**THE WATER STREET SHIP:  
PRELIMINARY ANALYSIS OF AN EIGHTEENTH-CENTURY  
MERCHANT SHIP'S BOW**

**A Thesis**

Near the middle of the eighteenth century, a worn, 100-foot-long merchant ship was installed for pier cribbing off Manhattan Island's East River shore, in New York City. In 1982, the substantially intact ship was uncovered by archaeologists conducting a building site survey at 175 Water Street. The excavators removed approximately the first 8 feet of the vessel's bow and its associated structure, the knee of the head.

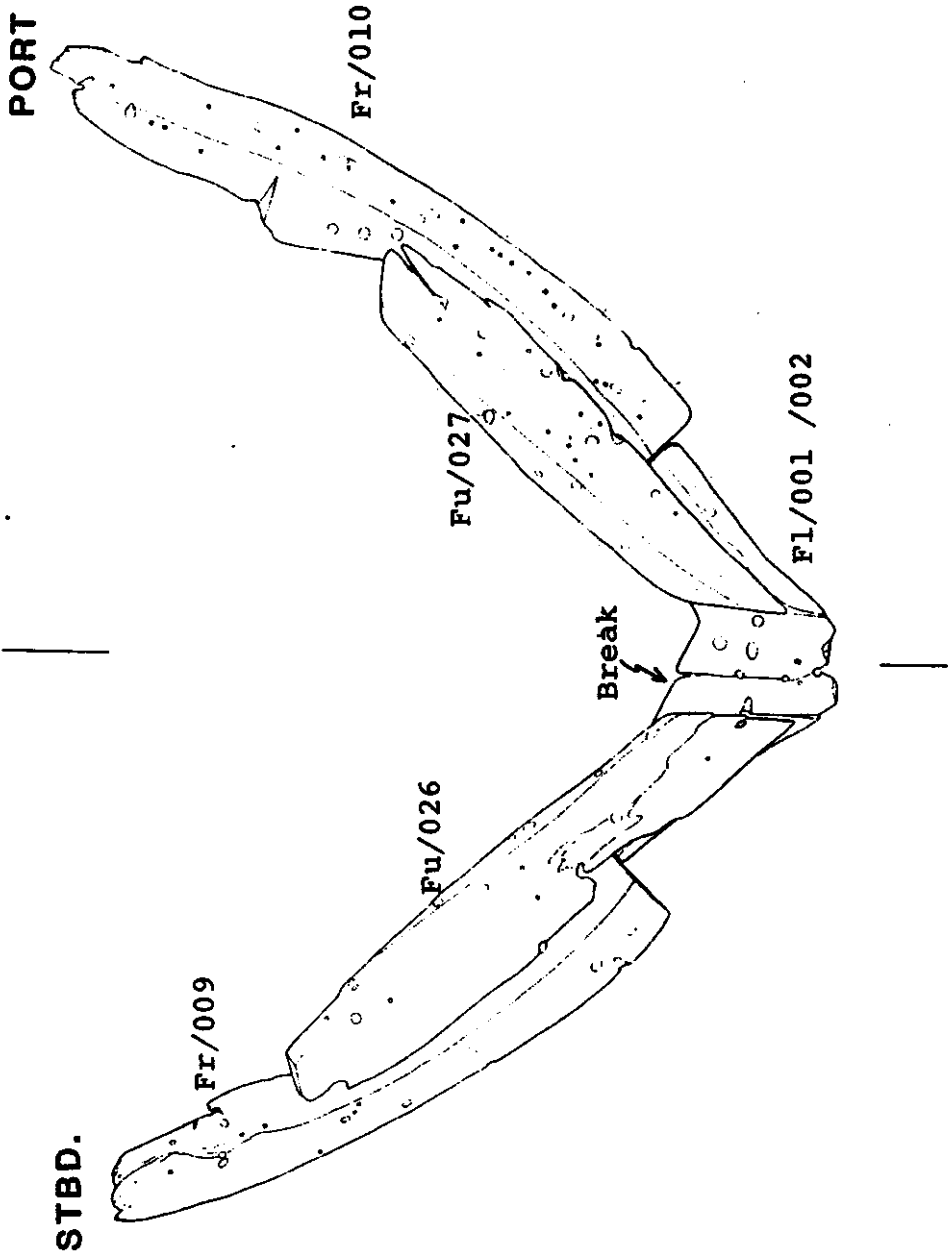
Ill. 3. Water Street ship. The first frame, forward view. (Drawing author)

The forwardmost three frames and the port futtocks of the fourth frame were salvaged and documented in the laboratory (ills. 3, 4, 5, 6, and ill. p. 47).

Each frame is composed of a floor timber and six curving futtocks arranged to form a nearly solid double row of timbers, with the sharply-angled floor timber located on the after side of the frame.

The frames of the Water Street ship are solidly built from a double row of timbers overlapped and fastened fore-and-aft (ills. 3-6, pp. 12-15, and ill. 17). The space between the frames is less than half the frame's room; in other words, much less than the sided dimension of the floors or futtocks. The fastenings of the frame components must therefore be more than twice as long as the space between the frames, requiring the ship's frames either to have been assembled prior to installation or constructed sequentially from the master couple to the ends of the vessel.

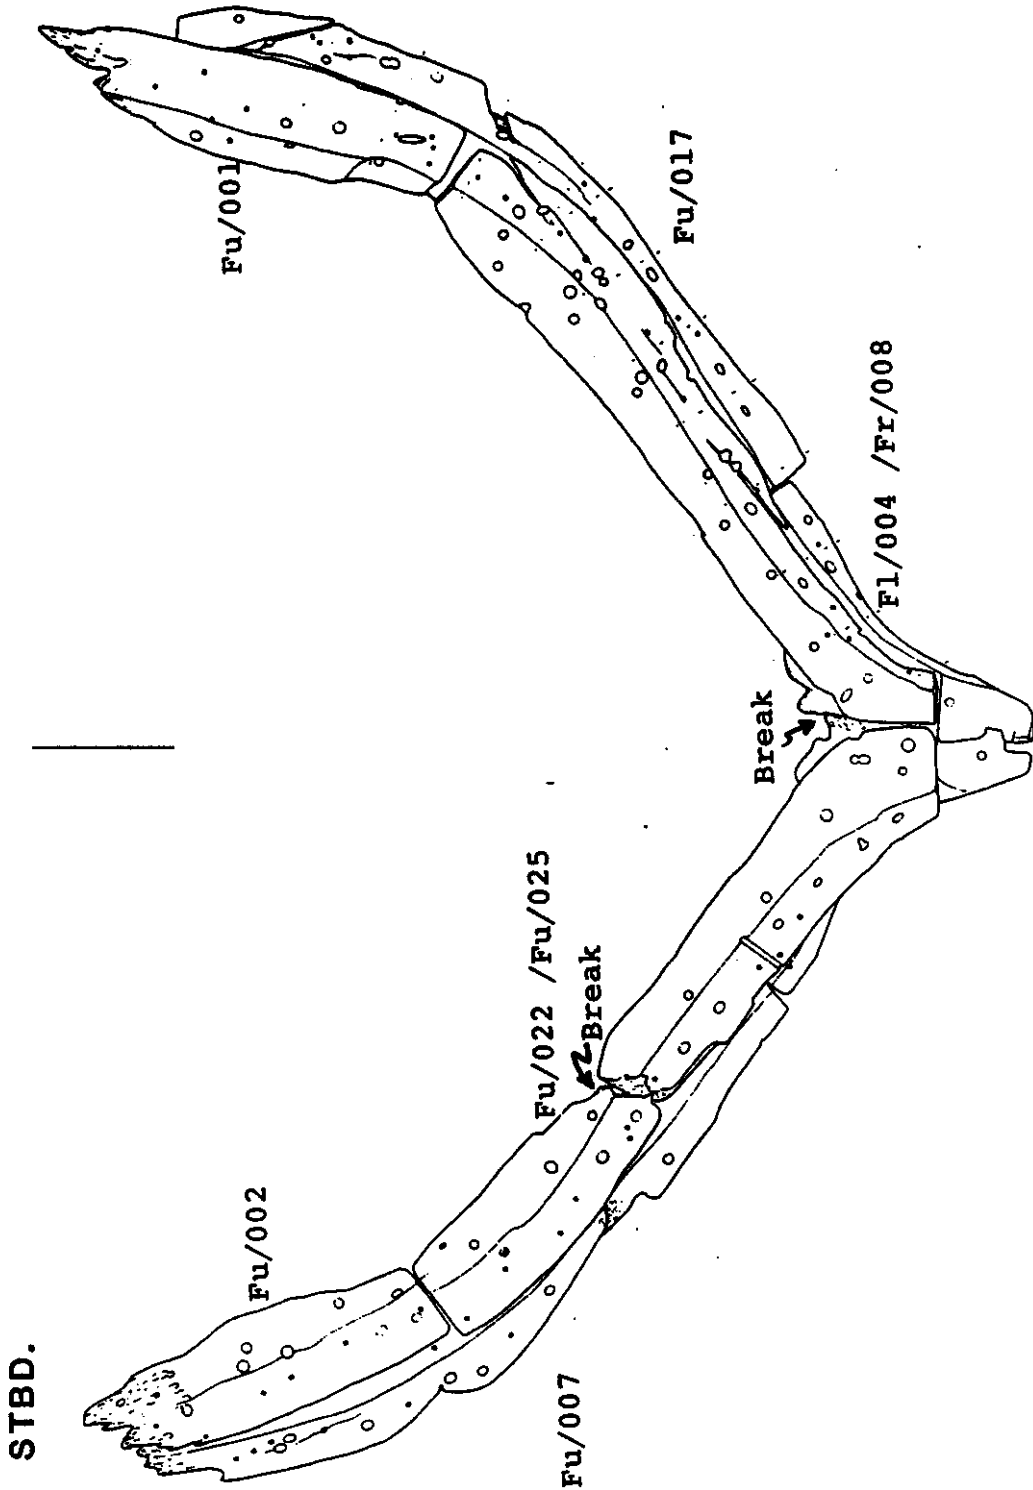
ILL. 4. Water Street ship. The second frame, forward view. (Drawing author)

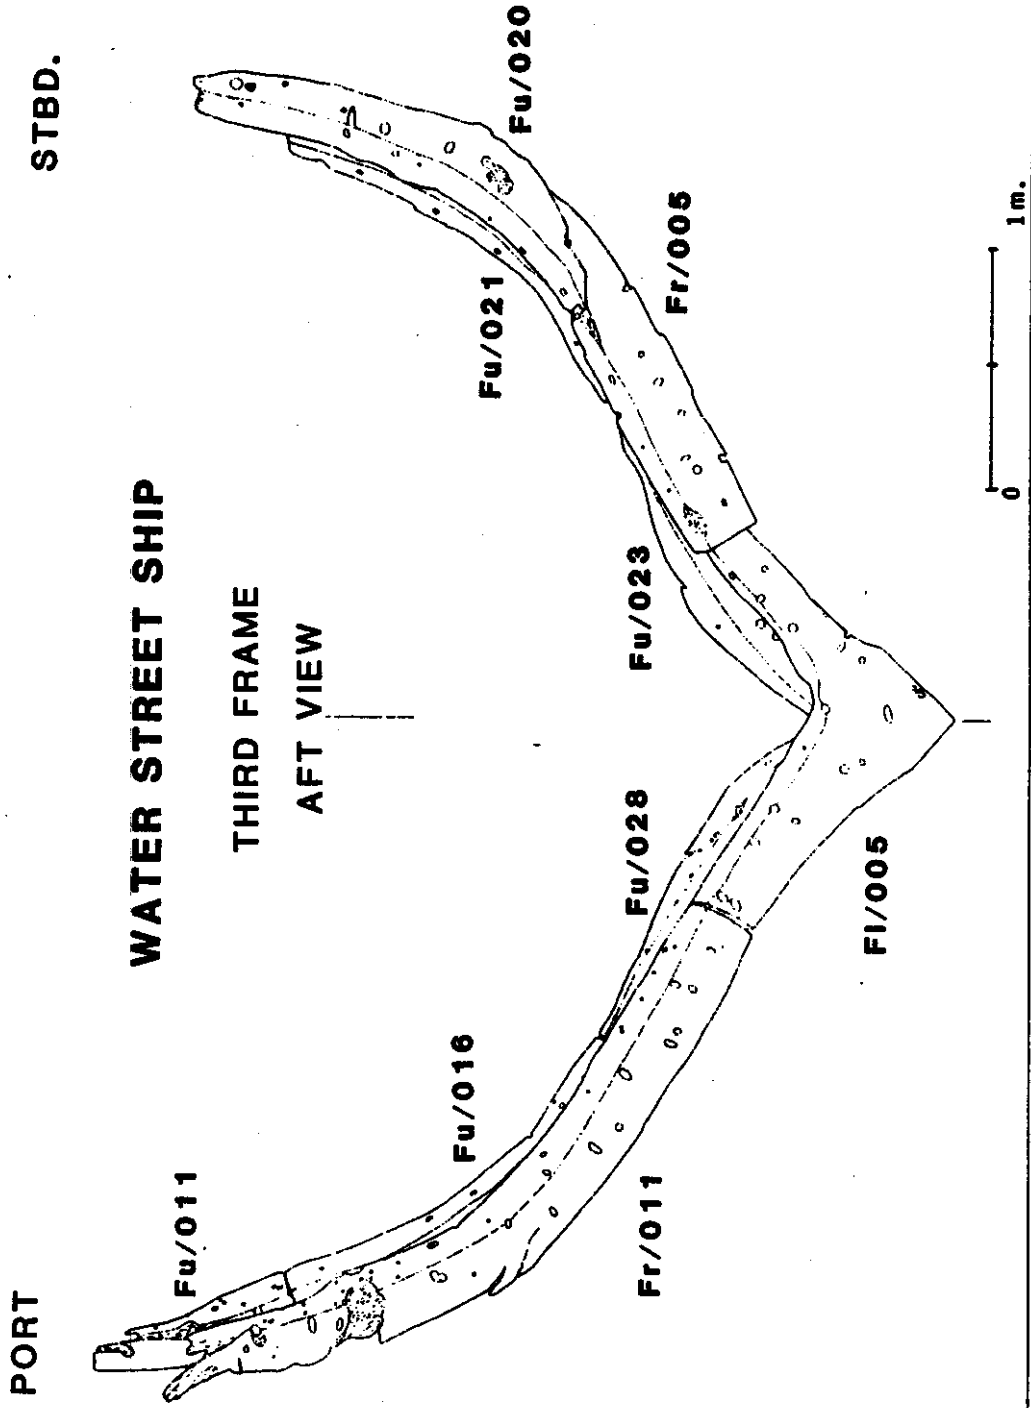
Ill. 5. Water Street ship. The third frame, forward view. (Drawing author)

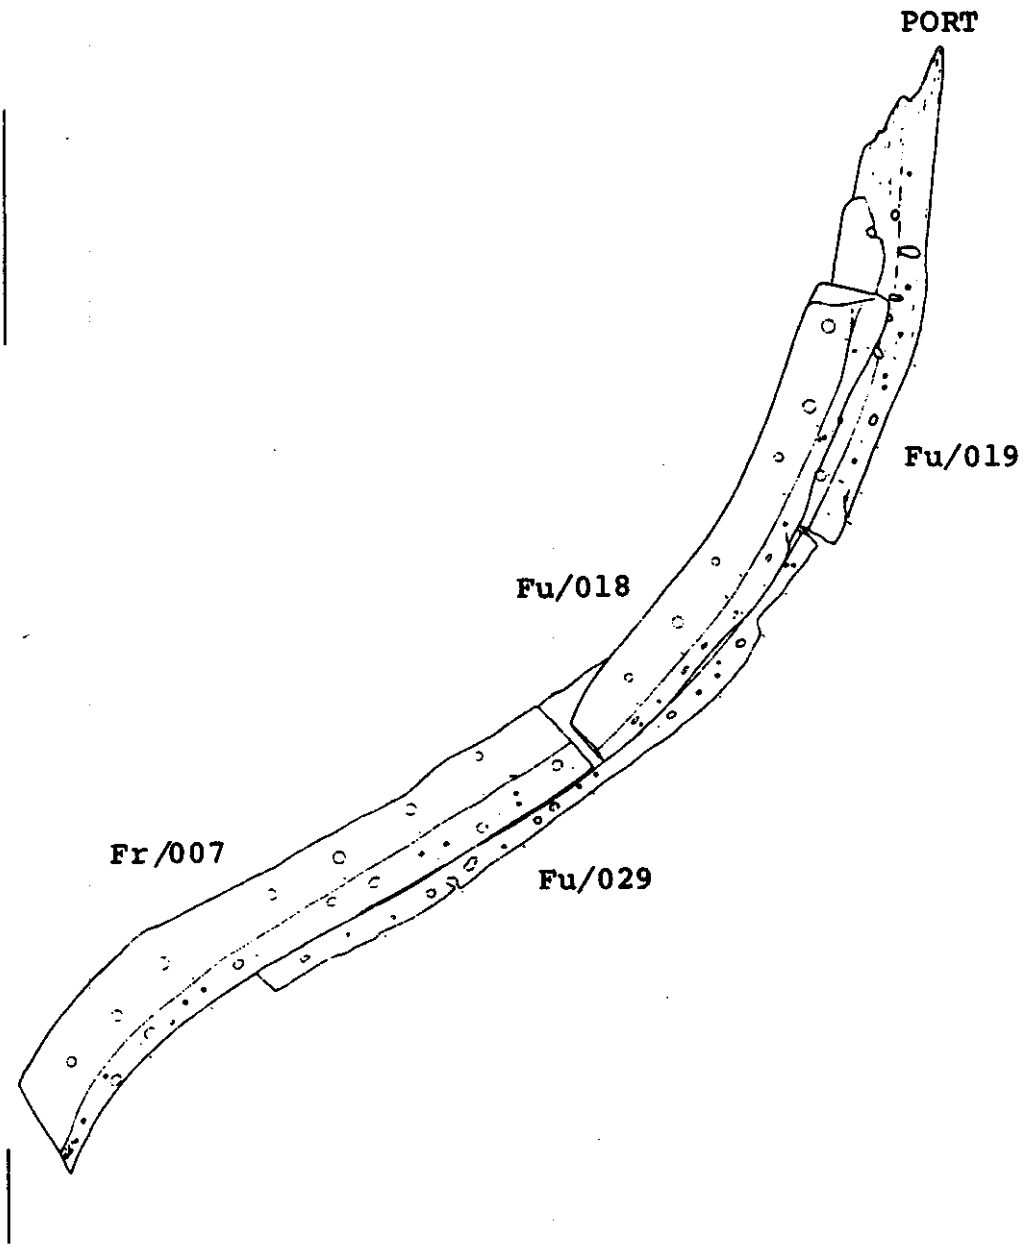
Ill. 6. Water Street ship. The fourth frame, forward view, port futtocks only. (Drawing author)

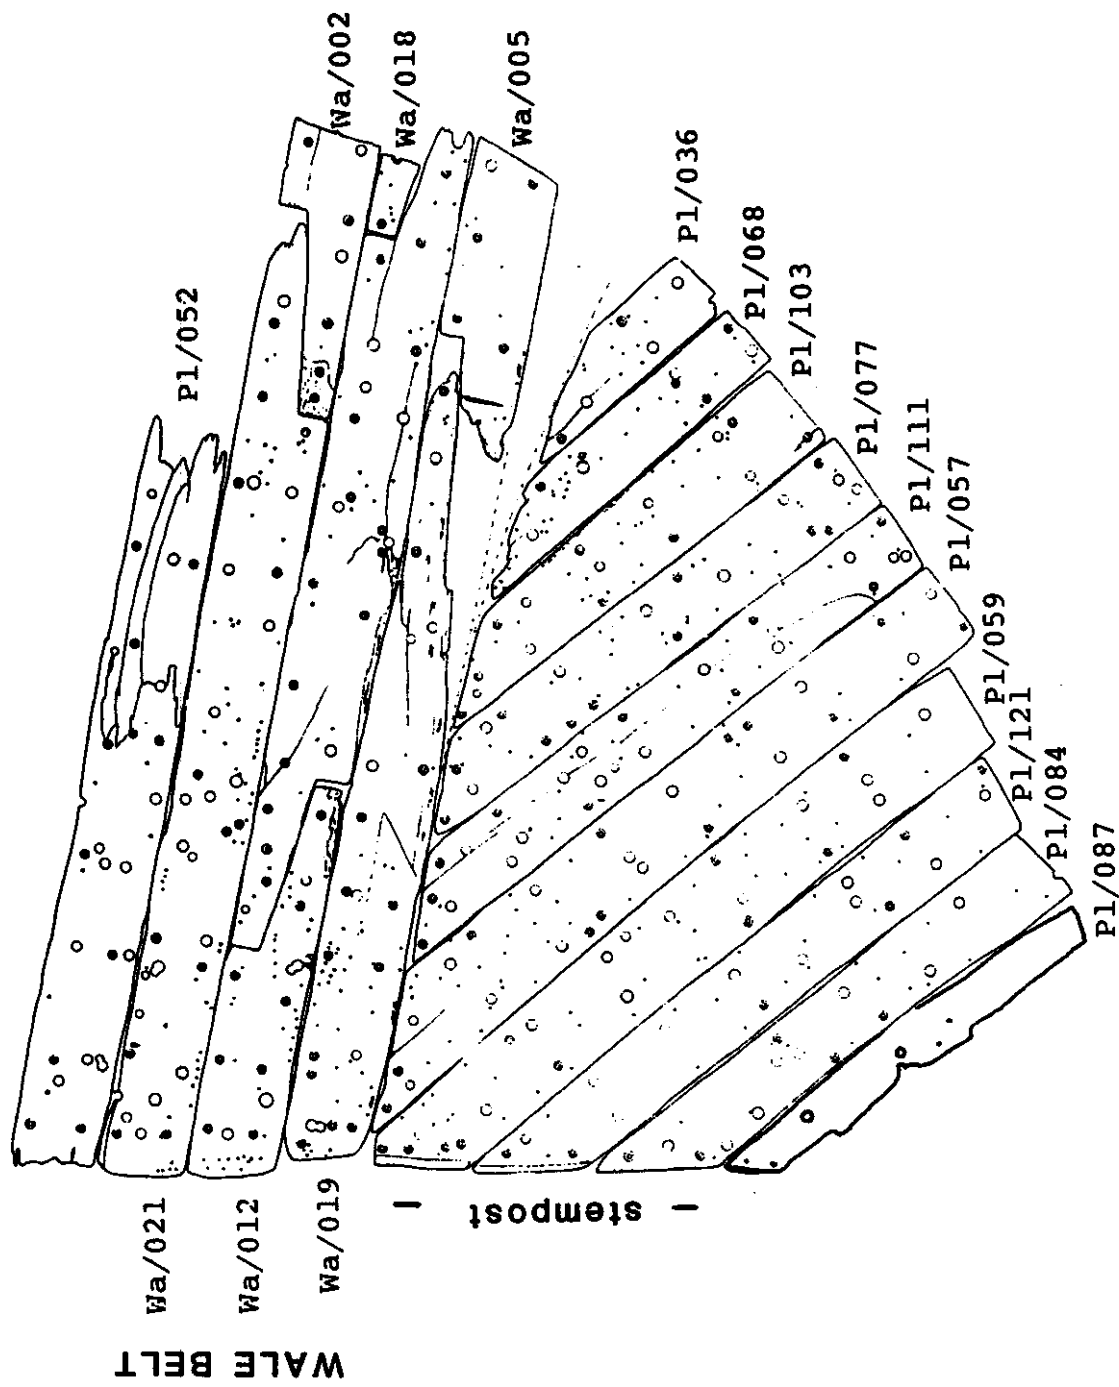
The bow of the Water Street ship includes the lower, or main, wale belt (ills. 7, 8). The 78 cm.-wide belt is comprised of three parallel, contiguous strakes of planking, each is approximately 26 cm. broad and 10.9 cm. thick. The wales spring from the stempost at only a slight angle aft and downward. They were not directly attached to the stempost, but were fastened to the hawse pieces and frames of the vessel with treenails 2.9 to 3.6 cm. in diameter, and iron nails 1.8- to 2.7 cm.-square which had heads 2.5 to 4.2 cm. in diameter. The individual segments used to make up each strake are hewn from curved timbers, their arcs more acute than the natural curve of the grain. The segments of each strake are not fastened to one another, but linked indirectly with long flat-scarphs spanning two or more frames.

Ill. 7. Water Street ship. Port side wales and hull planking. (Drawing author)

On the forward portions of the wales are holes, 2.3 cm. in diameter, which held bolts attaching the cheek pieces to the ship. Similar iron fastenings linked the wales to the deck clamp and lodging knees found within the vessel. The outer surface of the wales are riddled with small, square holes left by disintegrated iron nails.

Erosion and loss of wood due largely to marine borer damage are found throughout the wale belt. The damage increases in severity towards the lower margin, especially along the edges of the wale segments. The after ends of the wale belts were sawn through during the ship's excavation.

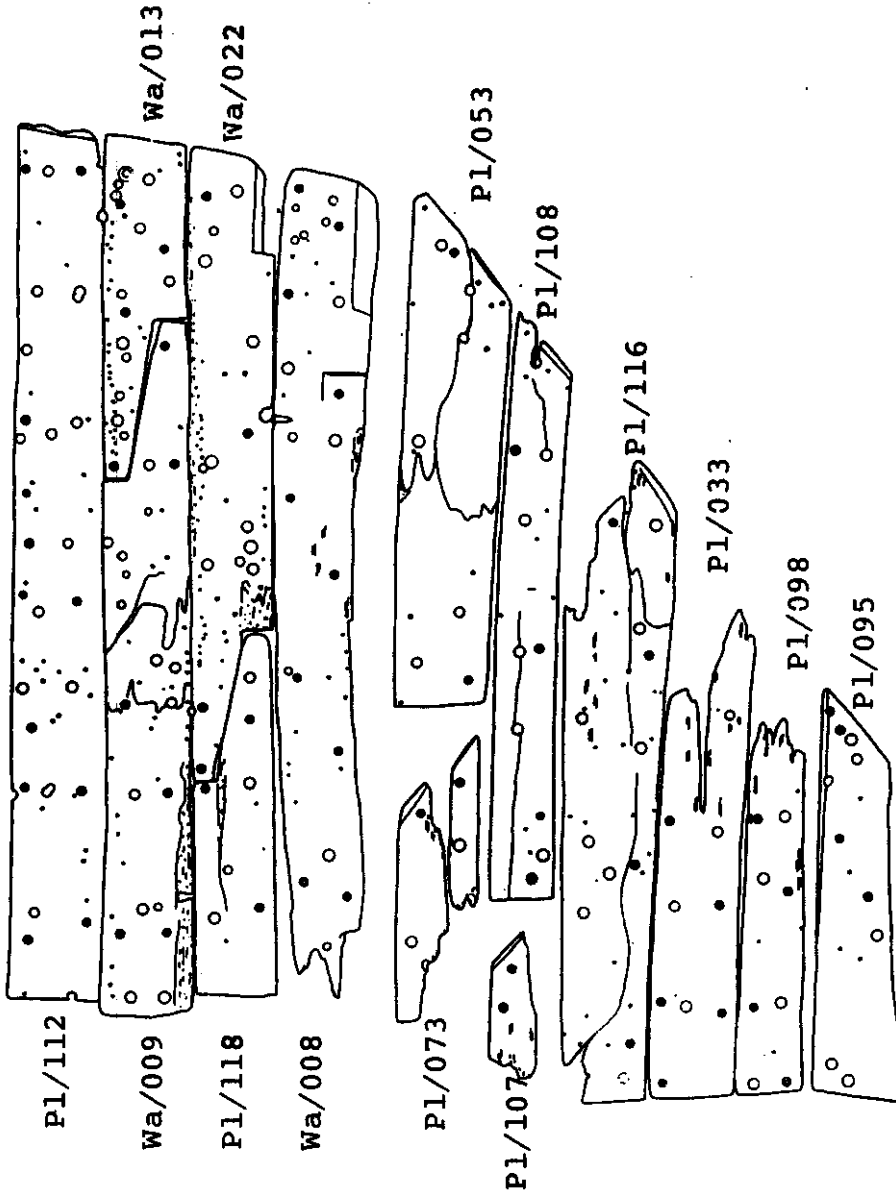
Ill. 8. Water Street ship. Starboard wales and hull planking. (Drawing author)

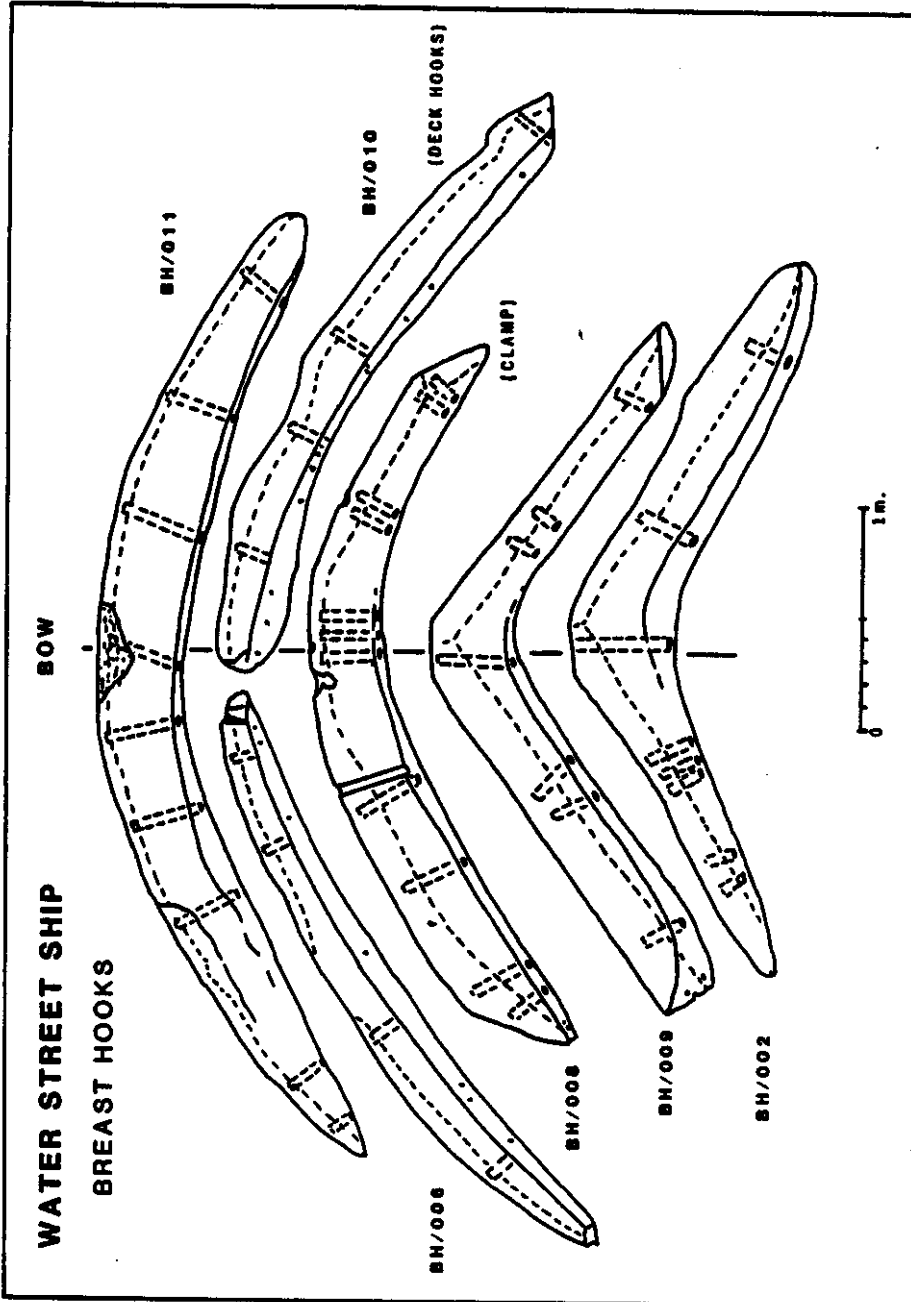
Five large breast hooks were preserved in the ship (ill. 9). The uppermost hook (EK/001, not shown) corresponded with the approximate upper margin of the preserved portion of the vessel and exhibits heavy deterioration and loss of wood. The second hook (BH/010) is a gently curving timber 4.27 m. long. Below that, another curved breast hook (BH/008) bridged the gap between, and secured the ends of, the port and starboard lower deck clamps. The lowest two hooks (BH/002, BH/009) are angular,

Ill. 9. Water Street ship. The breast and deck hooks. The uppermost hook (Ek/001) is not shown. (Drawing author)

exhibit a reverse curve where they fit into the hollows of the lower bow.

With the possible exception of the eroded and fragmentary EK/001, each hook was attached to the stem with a single iron fastener, 2.5 to 3.7 cm. in diameter, and to the sides of the vessel with two additional iron bolts and a pair of treenails in each arm. Additionally, a few square iron nail shaft holes are found in the feathered tips of the hooks' arms. Treenails fastening the hull planks penetrated the outboard faces of the three upper hooks.

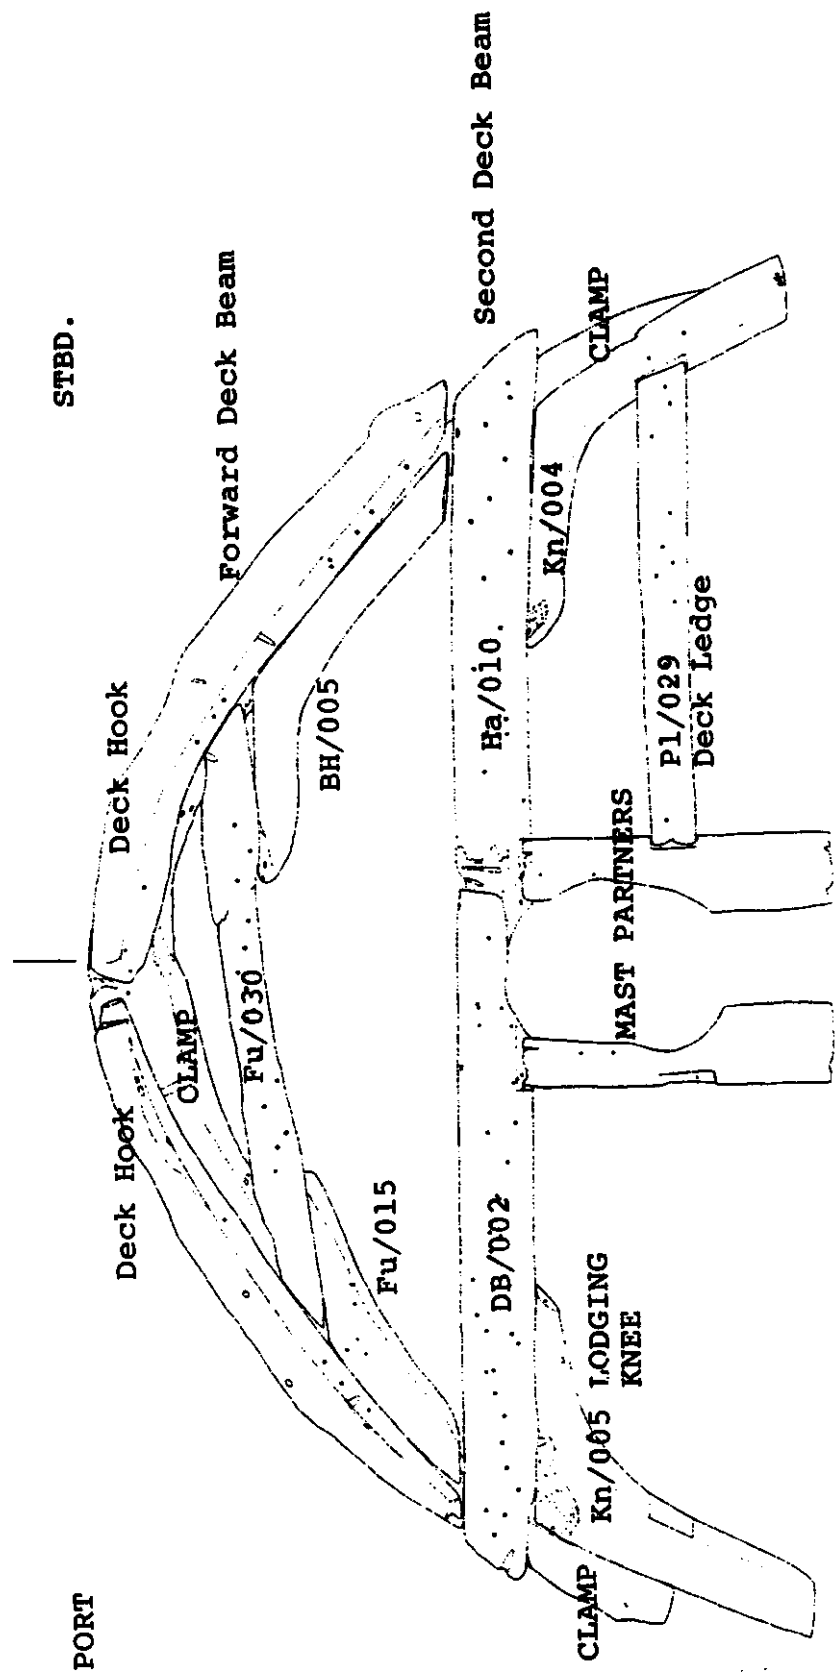
Broad, thick timbers which both supported the deck beams and acted as internal wales were laid up aft to fore throughout the length of the vessel (ill. 10). Their forward ends were overlapped by, and secured to, a breast hook (BH/008). The clamps (port: WW/001; stbd.: BH/007) are sided at 37 cm., and their moulded dimensions average 20 to 22 cm. They were secured by means of iron bolts, 2.5 cm. in diameter, which passed through the frames and corresponding wales on the outside of the ship. Each clamp is notched 8-15 cm. deep along its upper margin to receive the

Ill. 10. Water Street ship. Deck supports. (Drawing author)

dove-tailed ends of the major deck beams. Additional iron-stained holes are found where the deck beam lodging knees were attached to the vessel with long bolts.

Horizontal knees are found aft of either end of the deck beams (ill. 10, p. 28). In all cases the baulk arm of each knee was fastened to the side of the vessel with iron bolts while the lighter branch arm was fastened to its deck beam with similar bolts.

Two planks (port: DB/001; stbd.: PL/038), each 1.3 m. long, 55 cm. wide, and 5.5 to 7.0 cm. thick were nailed into sloping notches cut into the aftermost portion of the top margin of the main deck beam (ill. 10, p. 28). The last 5 cm. of the undersides of their ends are beveled. The partners are separated from one another by a gap that had become enlarged and rounded due to damage incurred prior to their excavation. The deck ledges (see: Deck Ledges, below) sat in sloping notches cut near the center of the partners' outer margins.

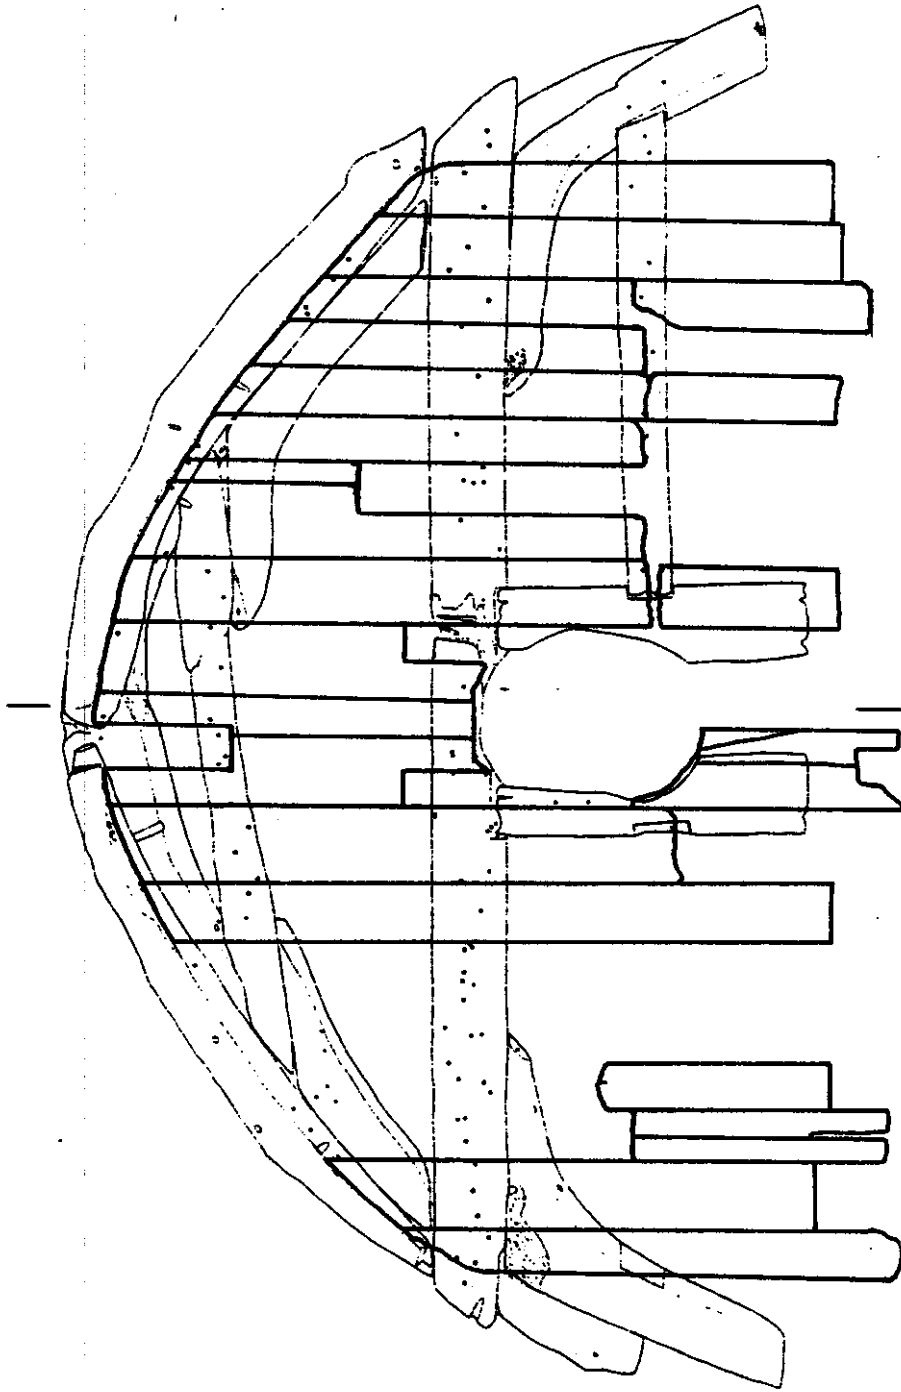
The majority of the deck planking is of fir or similar softwood (ill. 11). The planks average 25 to 30 cm. broad and 4.5 to 7 cm. thick. Most of the long planks were sawn free of the ship during excavation. In general, the planks ran parallel to the keel, their forward lengths "nibbed" where the vessel narrowed towards the fore. A single

Ill. 11. Water Street ship. Deck planking. (Drawing author)

caulking bevel is located along the upper one-third to one-half of each plank's outboard edge, and traces of yellowish mastic material were found in and around many of the seams. Two, or occasionally three, square iron nails affixed each plank to each support it crossed. The nails' heads were recessed below the surface of the planks in square mortises cut 1 cm. deep and about 2.5 to 3.0 cm. across.

Because the decking was crushed against the inside of the vessel's hull by tons of filling material, the planks are curved and cracked where they bent over the supporting structures. The planks' upper surfaces are smoothed, but their lower surfaces still show irregular marks of large, hand-powered saws. The edges of the planks also show sawing marks except where the above-mentioned caulking bevel has been cut.

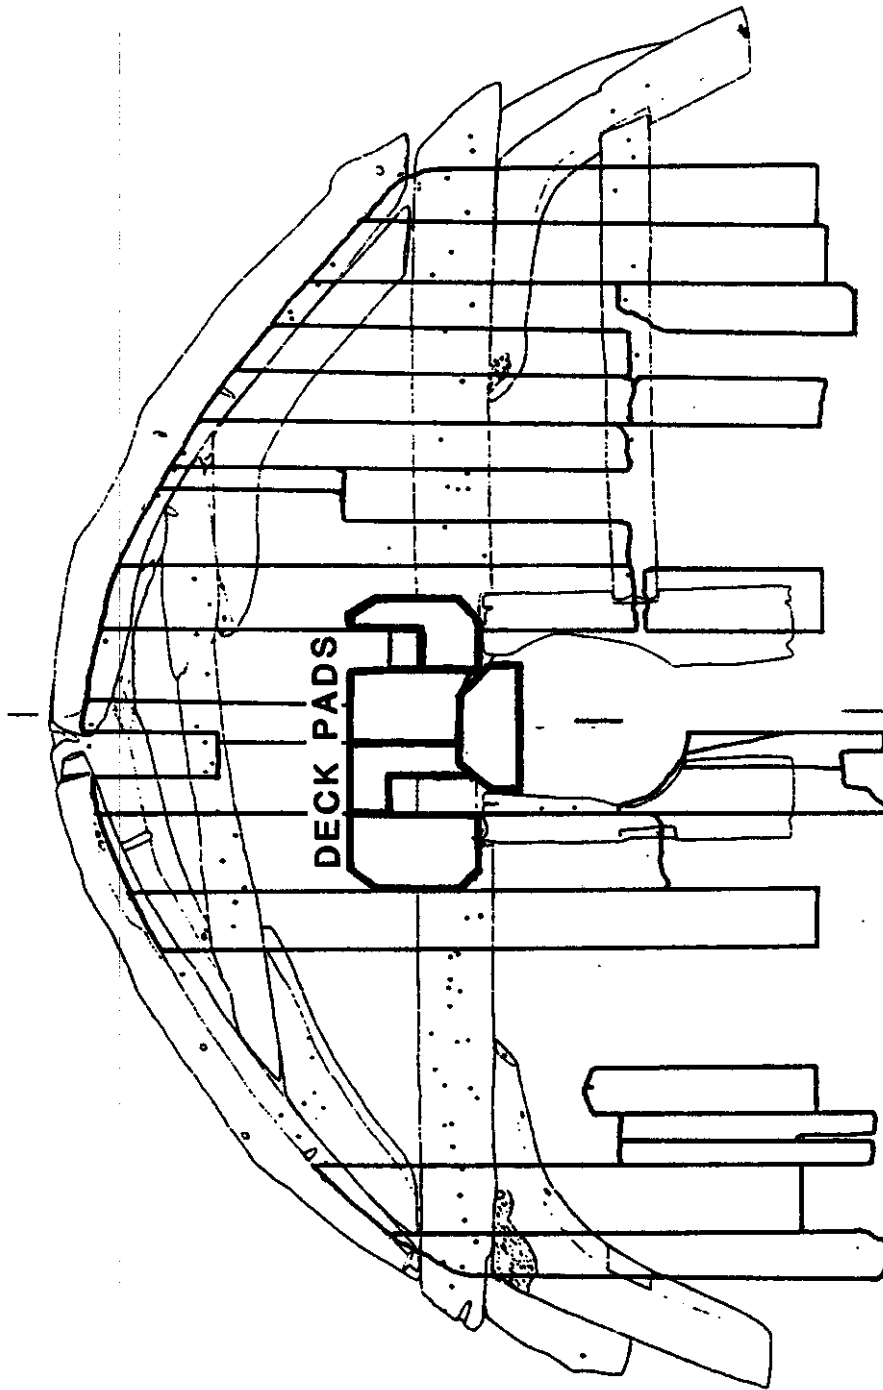
Where the deck was pierced by mast, bits, or other structures, the decking within a distance of 15 to 20 cm. of the members was covered with a second layer of planking of equal thickness (ill. 12). The edges and corners of the doubling planks are rounded. This second layer was fastened with iron nails in a manner identical to that of the deck.

Ill. 12. Water Street ship. Deck pads around bitts and mast. (Drawing author)

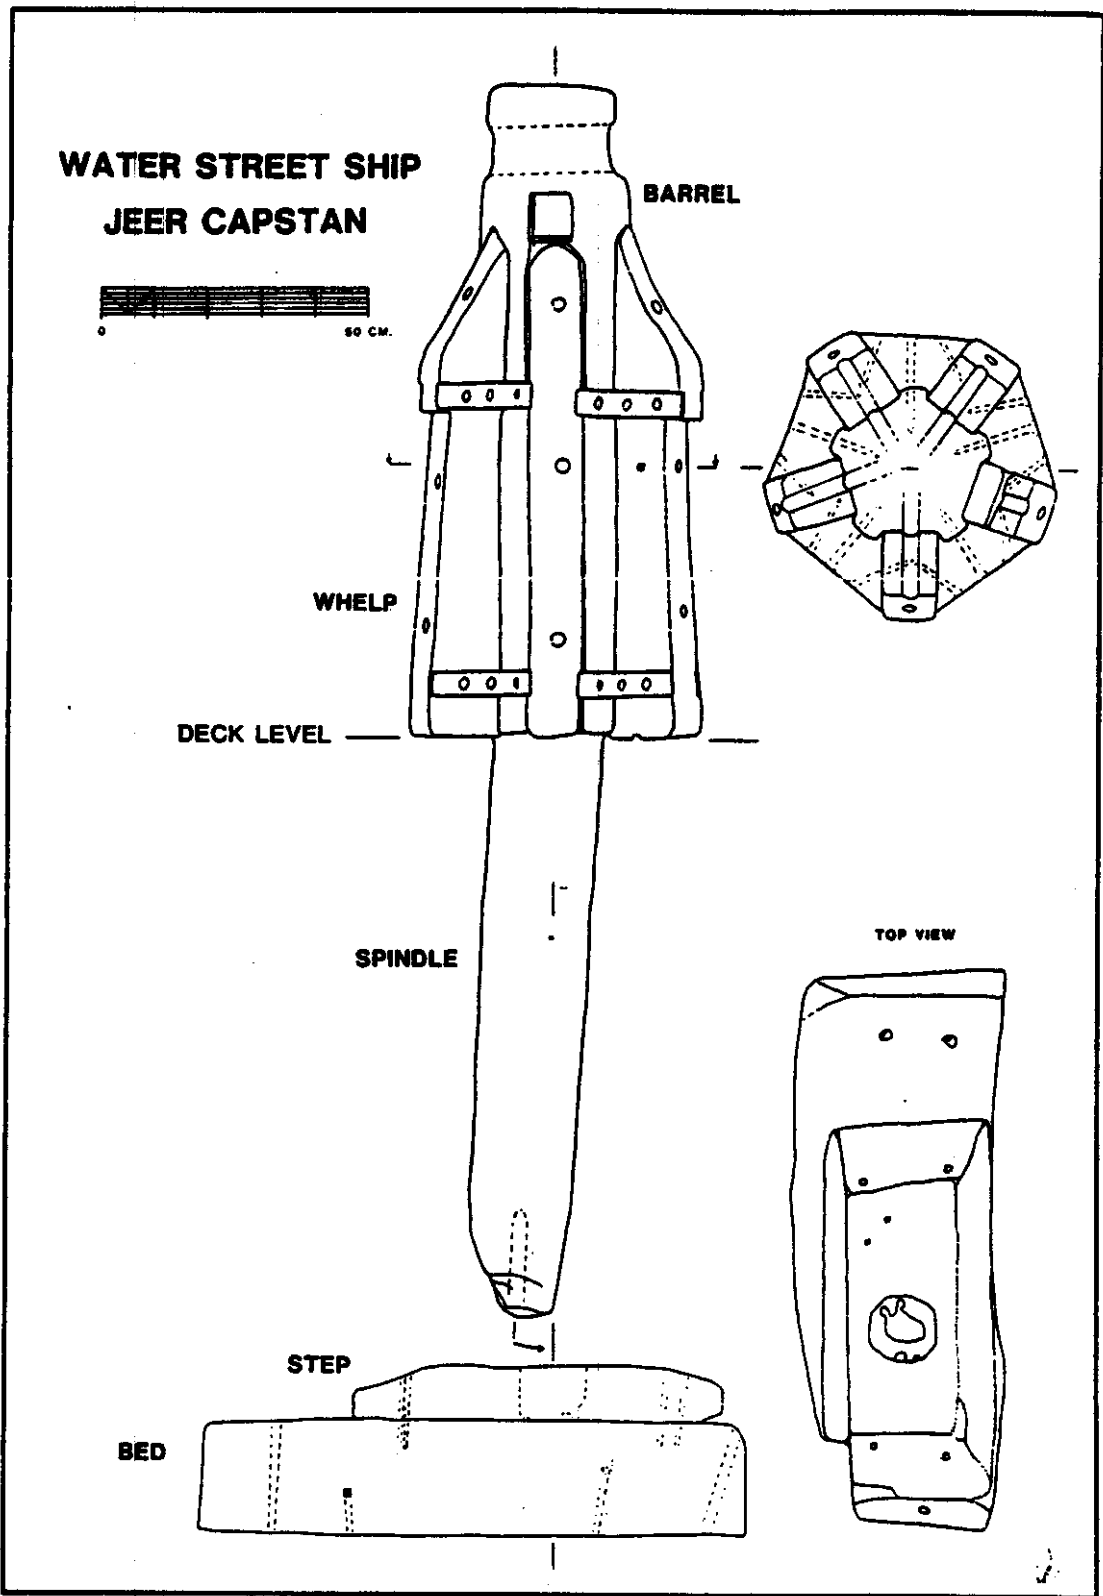
A capstan was found collapsed in the forward area of the vessel (ill. 15). Although, like the pump and mast fragments described below, it lies outside the strict confines of this thesis, its rarity makes it significant and worthy of examination.

The capstan's overall length is 2.31 m. divided approximately in half between the barrel and the spindle, all of which is cut from a single length of fir or other softwood. Radiating from the barrel are five vertical whelps, braced by two rows of chocks. The capstan is relatively intact, with the exceptions that the barrel and

Ill. 15. Water Street ship. Jeer capstan. (Drawing author)

spindle are bent about  $5^{\circ}$  out of line, seven of the chocks are missing, and the lower end of the spindle is eroded.

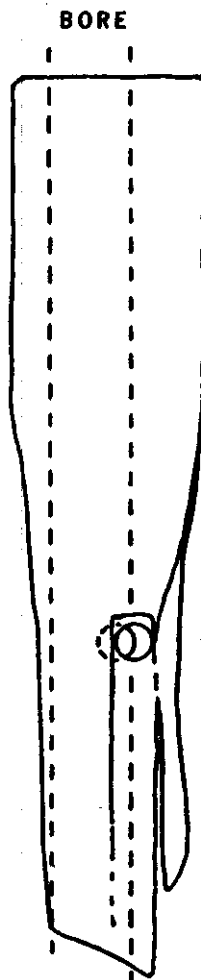
Fig. 1

The head of a ship's pump was recovered from the hold of the vessel (ill. 16, fig. 1). It is not certain if the fragment belongs to this vessel or if it is contemporaneous trash dumped from near-by shipyards.

The fragment is 1.52 m. long, broken and chopped at its lower end. Octagonal in section, but slightly flattened, it

has a maximum width of 37.5 cm. with a bore hole 12.5 to 13 cm. in diameter. An outflow hole, 5.8 cm. in diameter, is located at the bottom of a mortice 7.5 cm.-square, which is in turn centered 97.5 cm. from the top of the pump fragment. The pump stock was cut from fir or some other fine-grained softwood and is still bouyant.

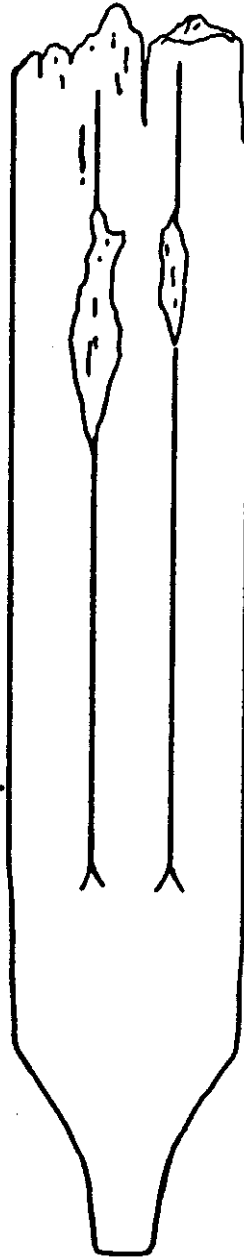
Fig. 2

Ill. 16. Water Street ship. Pump and mast fragments.  
(Drawing author)

A 2.26 meter-long fragment comprising the lower end of a mast was recovered from the rubble filling the vessel near the hold's after end (ill. 16, fig. 2, p. 47).

The octagonally-sectioned stub was chopped and broken short at its upper end, but is otherwise well preserved. The stub's maximum diameter is approximately 40 cm., but it is only 36 cm. across the flats.

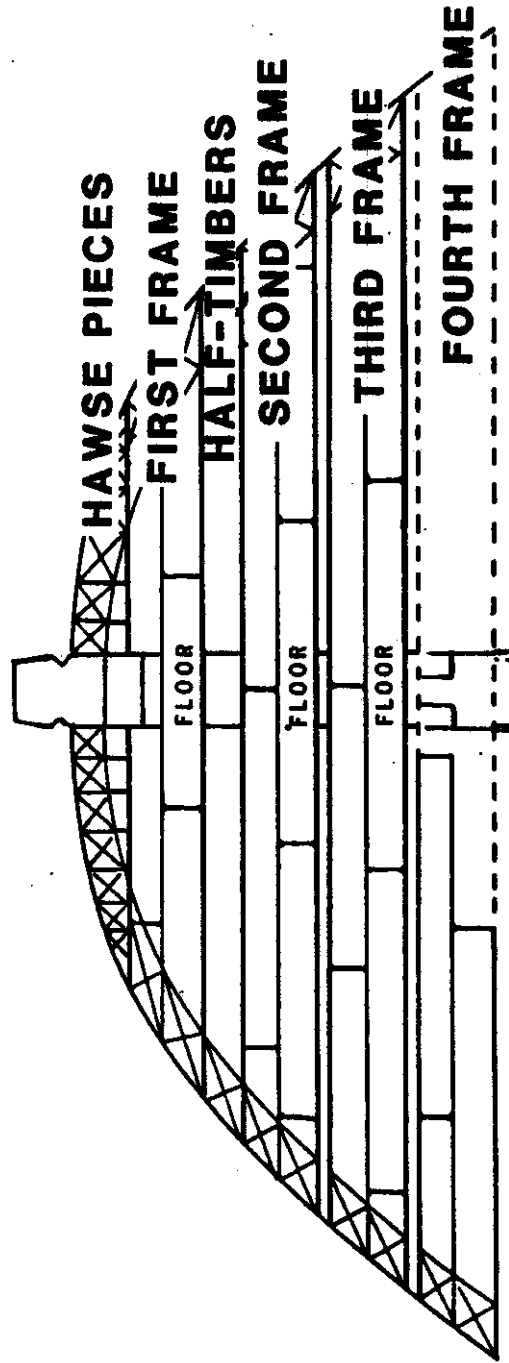
Ill. 17. Water Street ship. Overhead schematic of frames. (Drawing author)

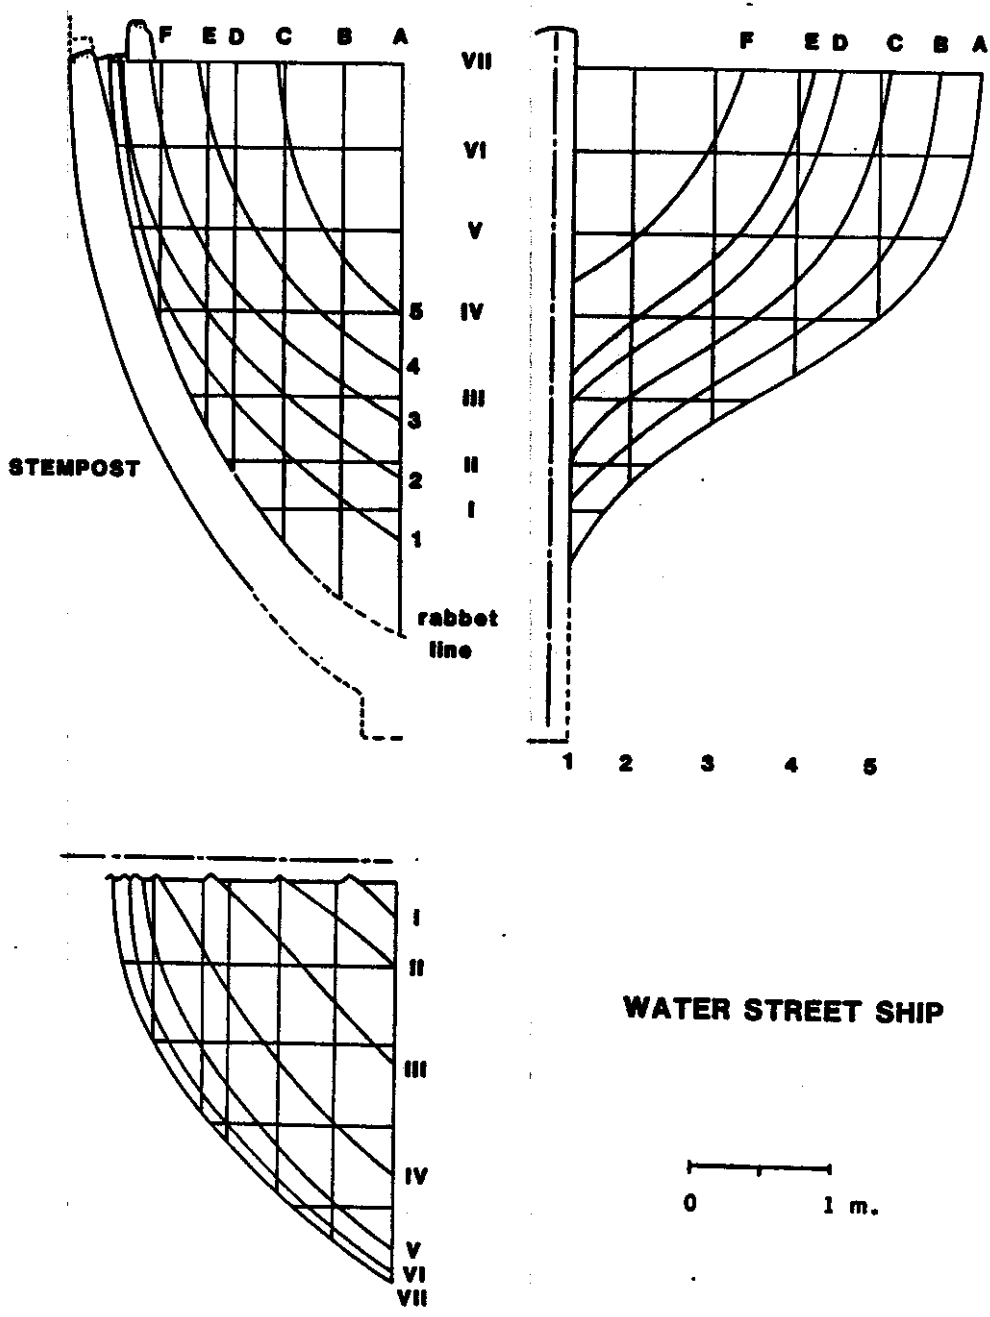
An examination of the Water Street ship's lower waterlines (ill. 19) shows that portion of the vessel's

Ill. 19. Water Street ship. Lines drawings, port side. (Drawing author)

bows to be hollowed.<sup>31</sup> The difficulty in bending planks to match these complex curves was somewhat mitigated by running the sweep of the planking as a series of parallel diagonals. The planks originating at the stempost continue aft and underneath the turn of the bilge while the higher strakes, the ones which terminate in the wale belt, sweep aft to cover the sides of the hull.

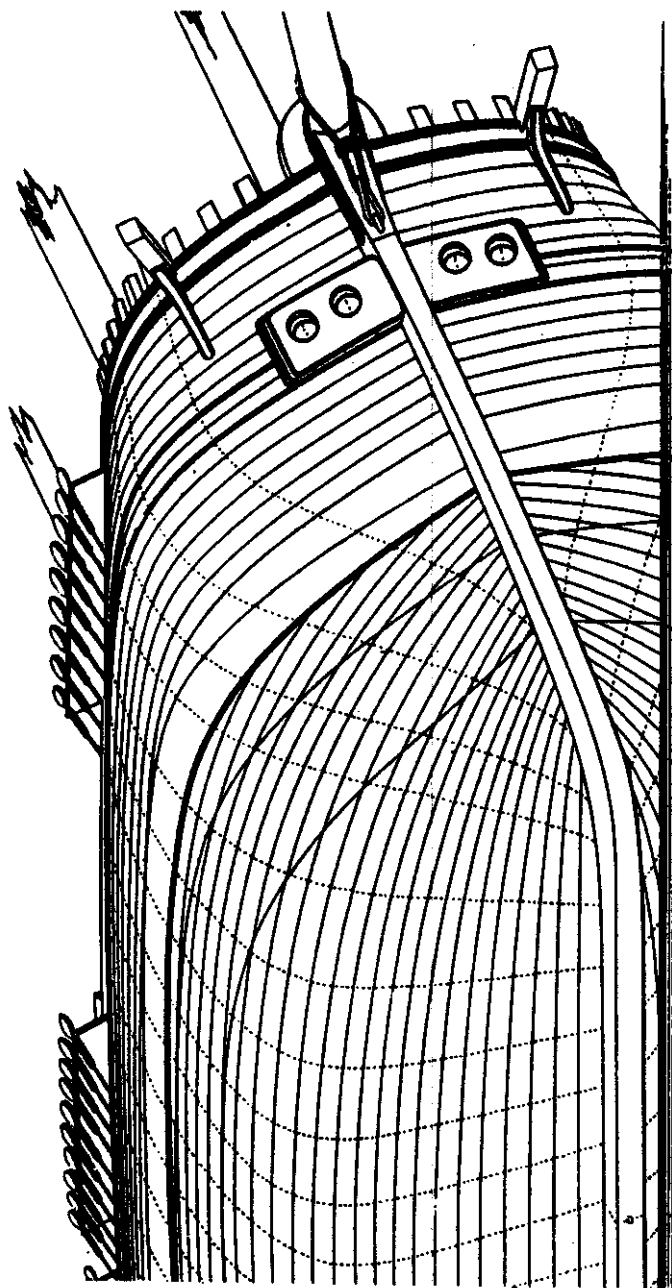
Ill. 20. Lower hull planking as drawn by Chapman (1768).

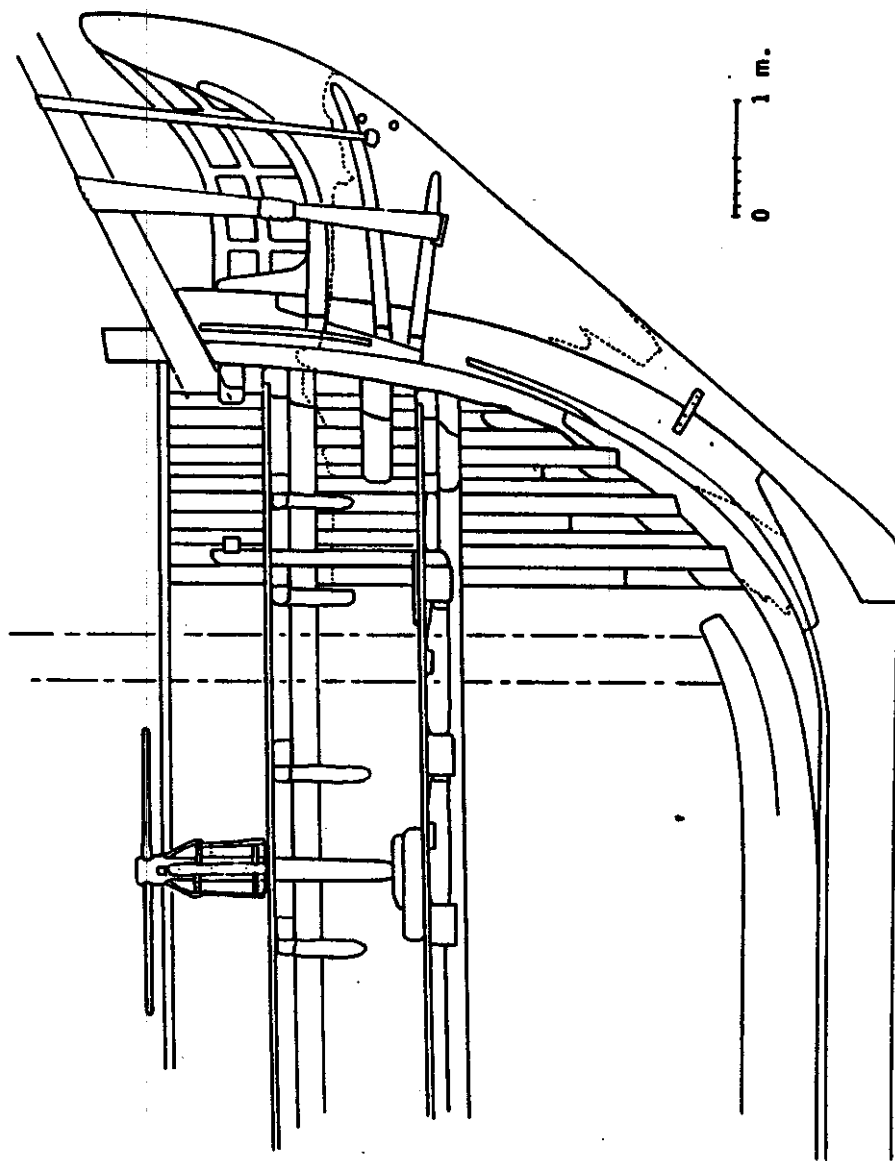
Ill. 21. Water Street ship. Reconstruction of the bow, interior view of port side.  
(Drawing author)

It should be noted that my chosen orientation requires a nearly vertical stempost above the main wales. Contemporary stemposts for a ship of similar size range between 18 and 22 feet (5.5 and 6.7 m.) in length.<sup>86</sup>
