**THE WATER STREET SHIP:  
PRELIMINARY ANALYSIS OF AN EIGHTEENTH-CENTURY  
MERCHANT SHIP'S BOW**

**A Thesis**

Near the middle of the eighteenth century, a worn, 100-foot-long merchant ship was installed for pier cribbing off Manhattan Island's East River shore, in New York City. In 1982, the substantially intact ship was uncovered by archaeologists conducting a building site survey at 175 Water Street. The excavators removed approximately the first 8 feet of the vessel's bow and its associated structure, the knee of the head.

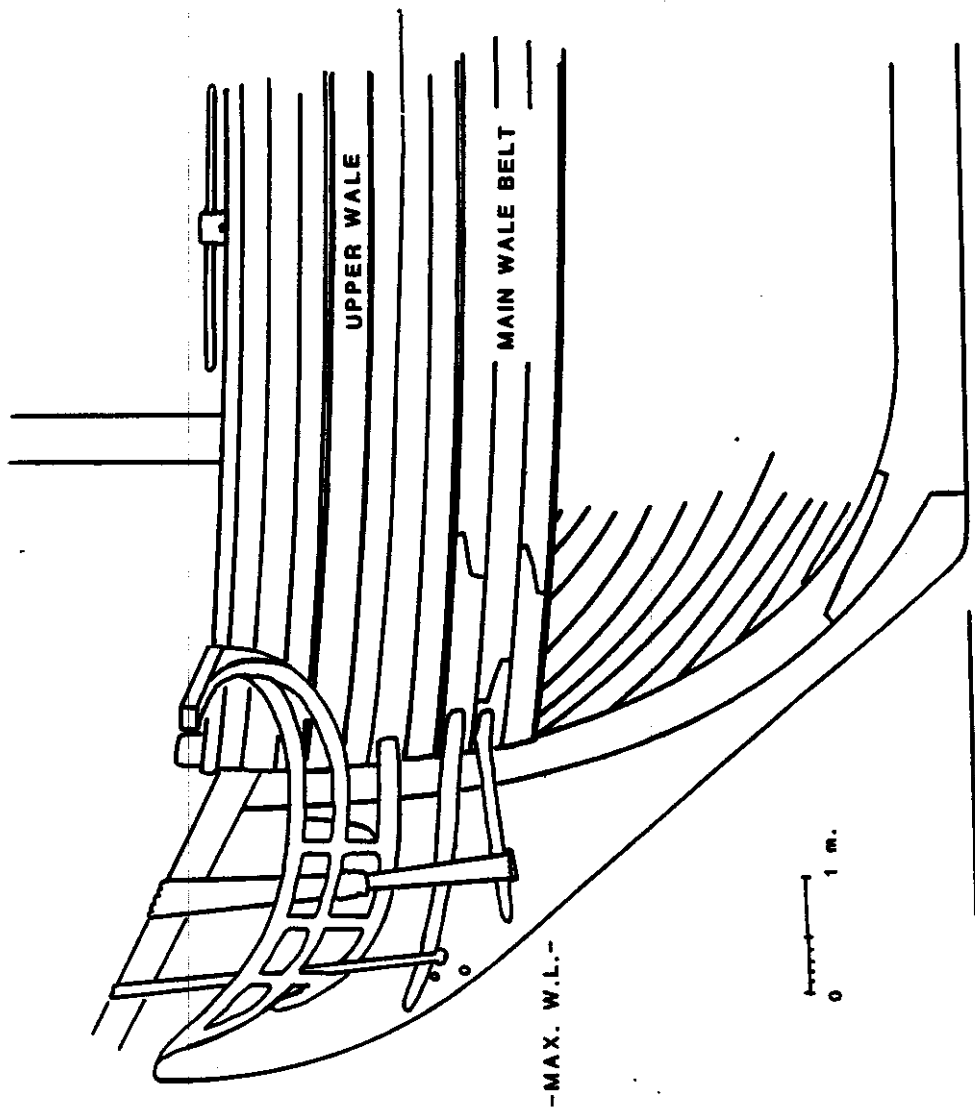
Ill. 22. Water Street ship. Reconstruction of the bow, exterior view of port side.  
(Drawing author)

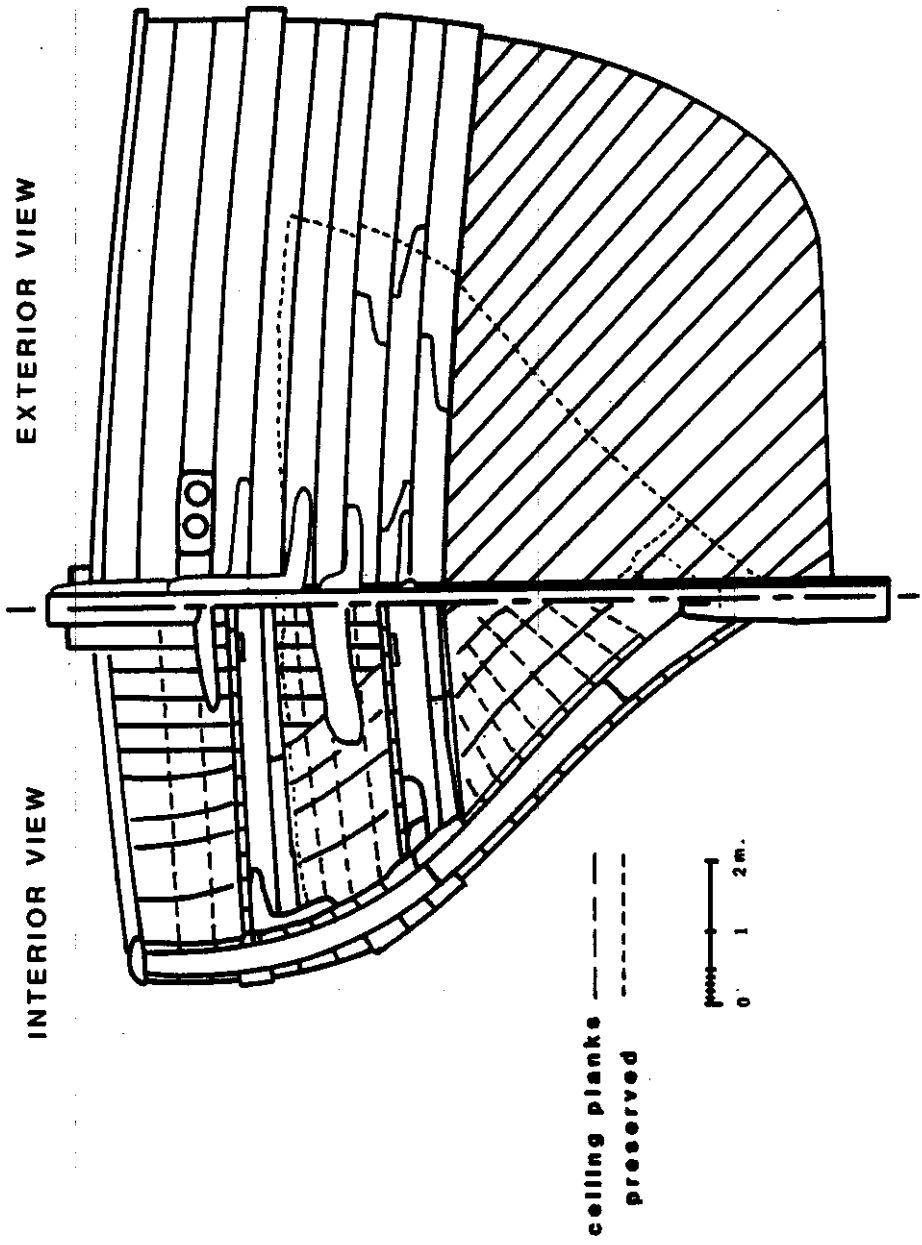
Ill. 23. Water Street ship. Reconstruction of the bow, end view. (Drawing author)

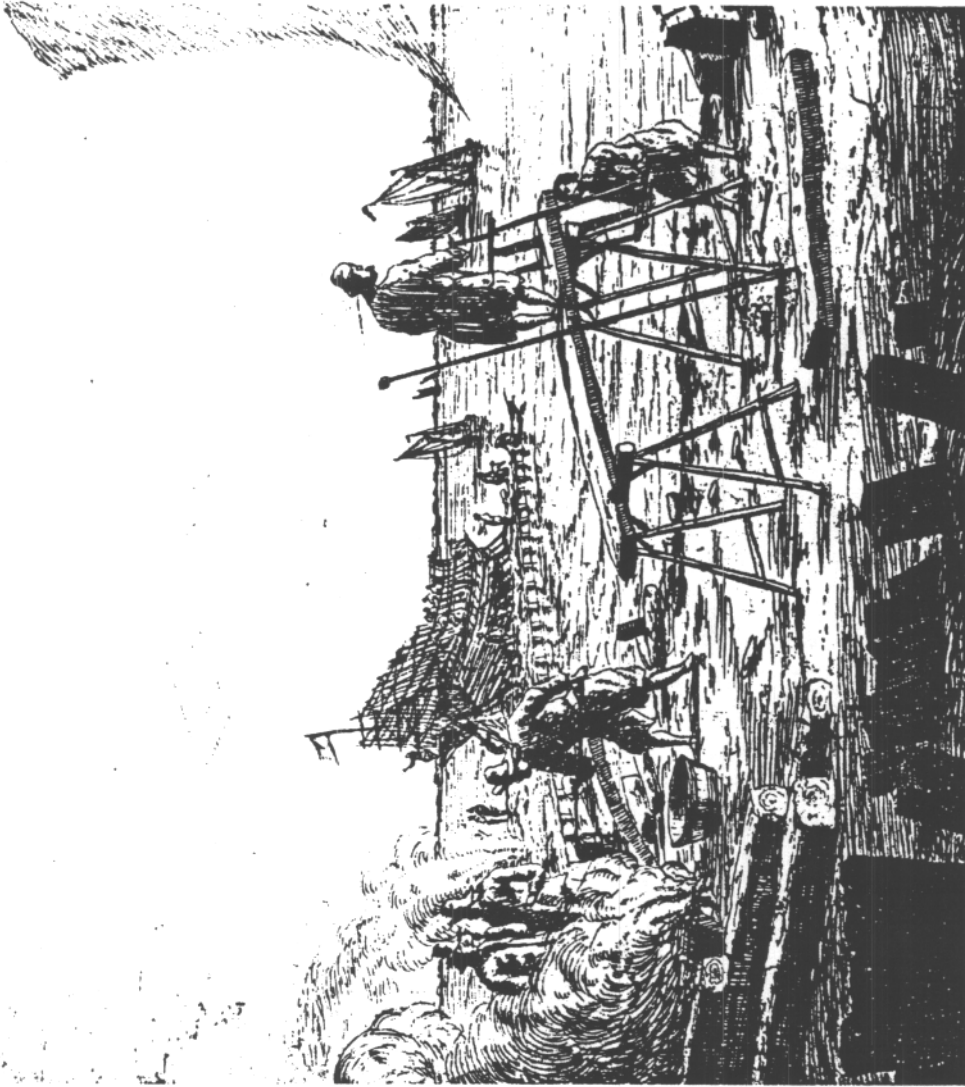
Pl. 1. "Charring" planks in order to bend them (left) and two men sawing planks (right).  
Etching from drawing by Reinier Nooms (d. 1664).

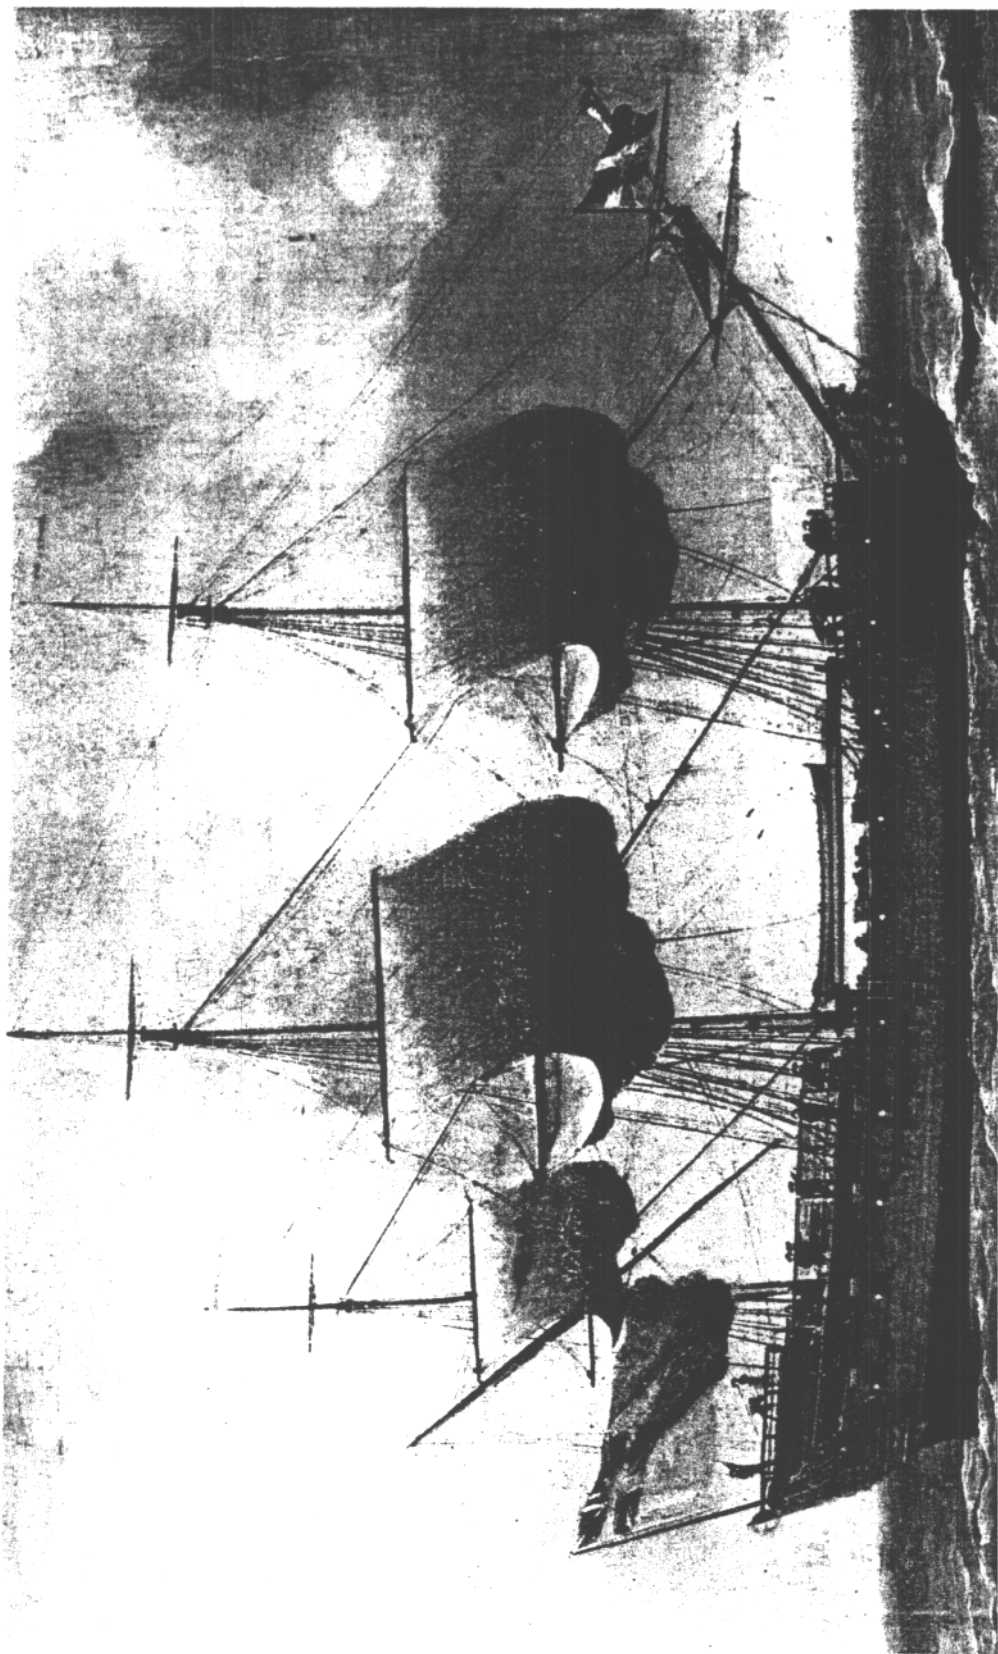
Pl. 2. The Bethel, an American merchant vessel similar to the Water Street ship.  
(Unsigned oil, dated 1749, courtesy Peabody Museum)

In general form and construction, the bow of the Water Street ship conforms to a pattern common among eighteenth-century merchant ships; that is, a bluff-bowed vessel, hollowed slightly below the wales, whose forward frames were installed vertically. It was built largely of oak, possessed two decks, and was equipped with a head. A similar vessel of the period is presented in plate 2.
