**THE MEPKIN ABBEY SHIPWRECK:  
DIVING INTO MEPKIN PLANTATION'S PAST**

A Thesis

Major Subject: Anthropology

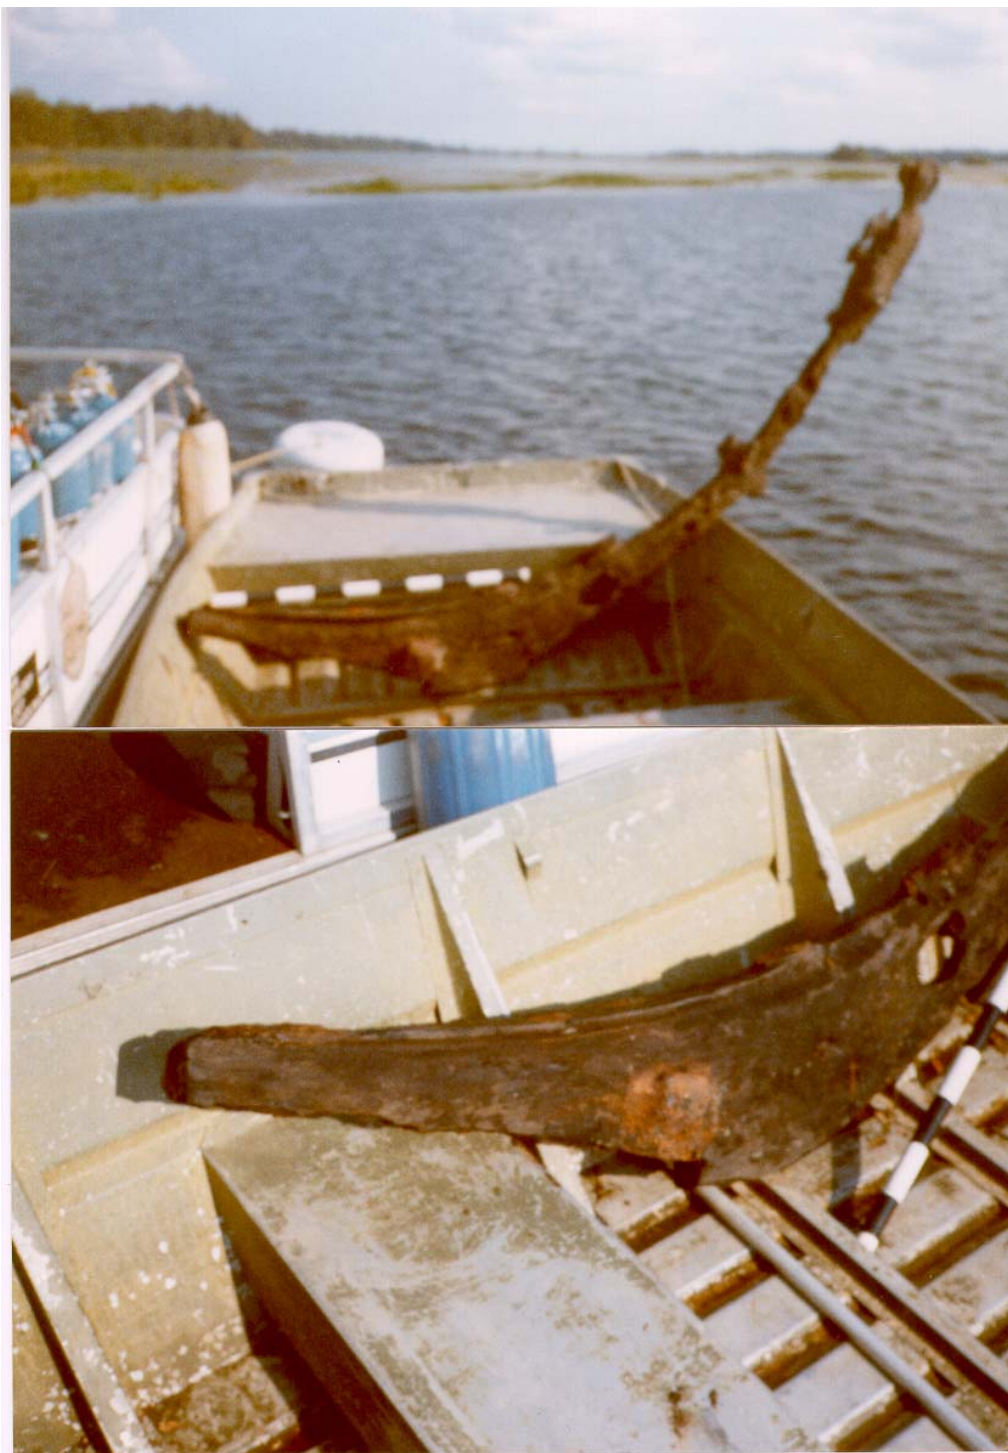
Figure 9. Two Views of the Stem (photographs taken October 2000 by Sue Vezeau). The complete stem is shown at top and a detail of the base and the keel scarf is shown in the lower photo.

We elected to bring up the stem (Figure 9) and the mast step (Figure 10) to photograph and record on board our dive boat then return them to their original locations. The stern assembly, in storage at a nearby plantation, was also re-recorded and photographed (Figure 11). I made copies of all field notes and upon my return to Texas A&M University, began an analysis and interpretation of the hull. This included preparation of ship's lines based on the wreck plan (Figure 12), frame curvatures, historical data, development of a scantling list in both imperial and metric measurements (Appendices A and B), and the creation of construction drawings (Figure 13) that included an interior profile, a deck plan, and a section drawing specifically chosen to highlight the saddle mast step. The reconstruction of the ship was based not only on the wreck plan, frame sections, and related research conducted in 2000, but also on the preliminary report written in 1981 from the 1980 field work.

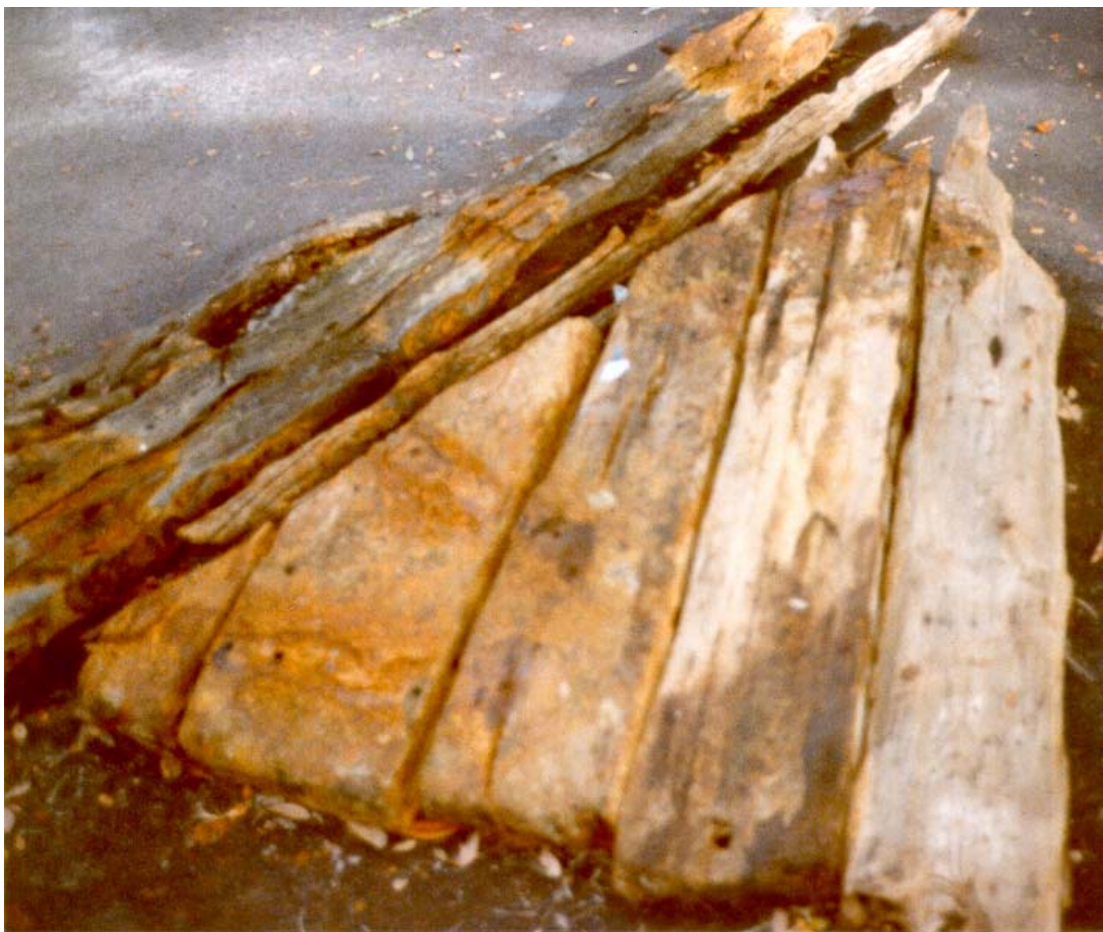
Figure 11. The Rudder Assembly (photograph taken October 2000 by Sue Vezeau).

The rudder stock was constructed from two pieces of wood. These timbers are highly eroded but were connected with .4 inch (1.02 cm) square-headed iron bolts or spikes, and treenails. Iron-stained notches show where the two iron straps were used to hold the rudder blade and stock together. There are also iron stains remaining from the pintle straps. The rudder, rudder stock, stern knee, and stern post were all recovered in 1980 and conserved by the SCIAA team. Another piece, also labeled as rudder stock, was recovered as well but was not with the rest of the assemblage in 2000. It could possibly have fit between the two remaining pieces of stock, together making up the rudder post and securing the blade to the stern post. The resulting post would probably have been 8 feet, 3 inches (2.52 m) in height, 1 inch (2.54 cm) thick, and 6 inches (15.24 cm) wide. The 1980 report also mentions a small piece of wood concreted to the rudder that could have been a rudder stop, but it no longer exists; a rudder stop is used to keep the rudder from floating out of the gudgeons.

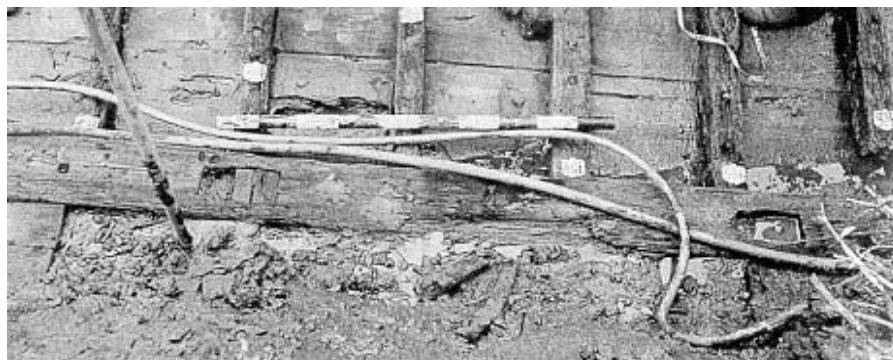
Figure 36. Malcolm Boat's Mast Steps (photo courtesy of SCIAA).

Two rectangular mast steps were carved into the keelson: one located above the midship frame (approximately one third of the vessel's length abaft the stem) and the other step, which was partially plugged, was set further aft, yet still in the forward half of the ship (Figure 36). Amer and Hocker describe the boat as being 'designed for strength and with the ability to carry heavy loads' (1995: 300). They also felt that 'the transom stern would have enhanced the vessel's cargo-carrying capacity and seaworthiness for offshore voyages' (Figure 37). The Malcolm boat would have been suited to both offshore and riverine usage, and the reconstruction drawings by William Judd show a fine craft that was well made, functional, and aesthetically pleasing (Figure 38).

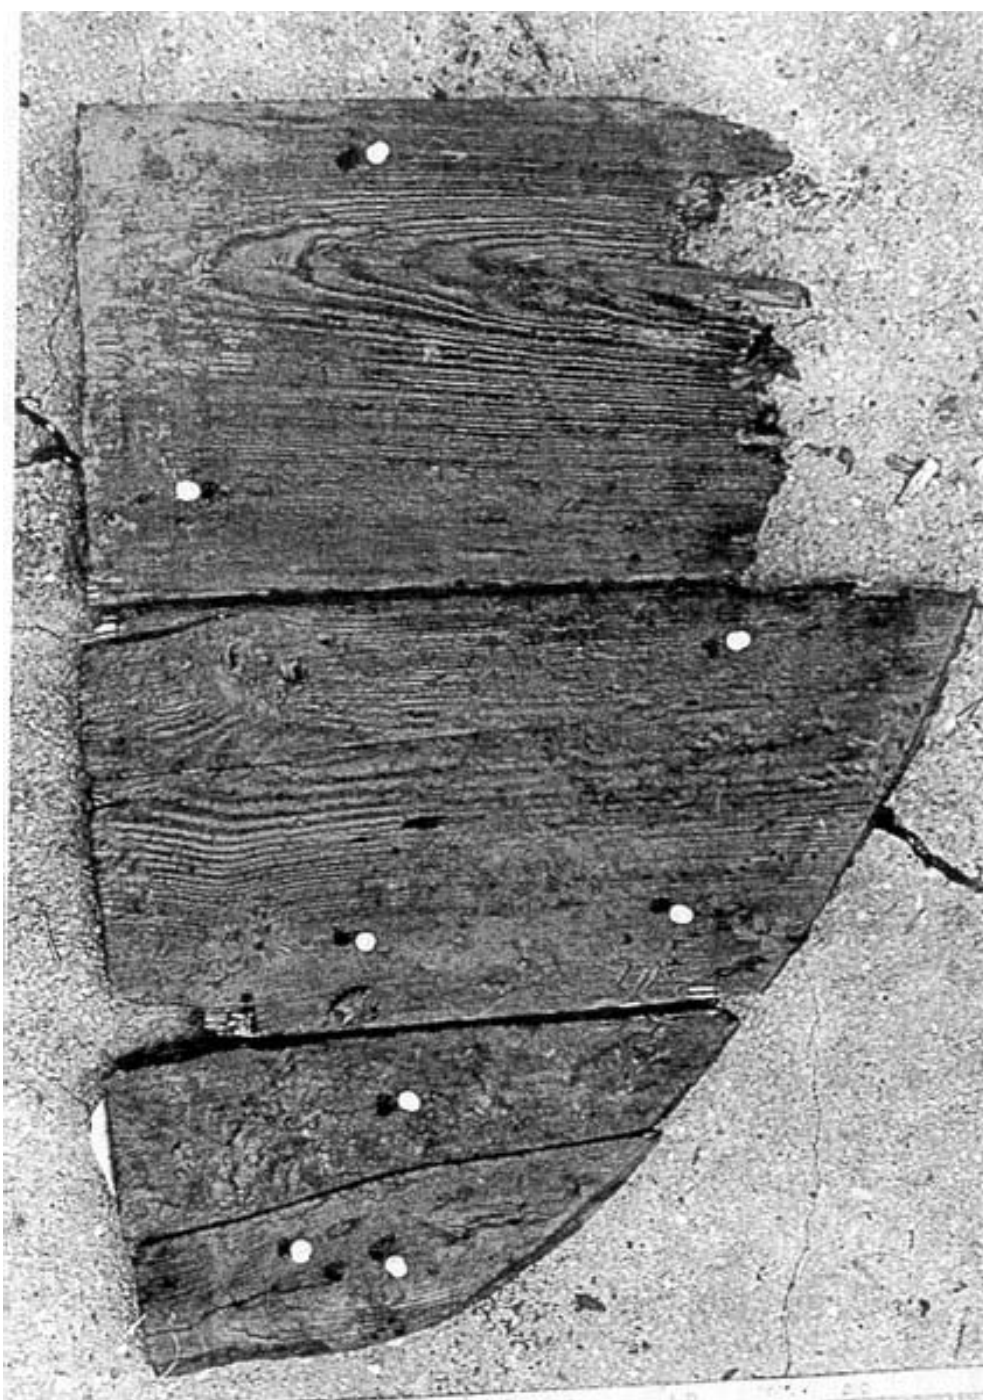
Figure 37. Malcolm Boat's Surviving Transom Planking (nail holes are highlighted by white pins but the scale shown at the bottom of the photo is unreadable in the originally published photograph). One of the three planks was located wedged tightly against the stern post, the other two planks were excavated aft of the stern (Amer and Hocker 1995: 48) (photo courtesy of SCIAA).

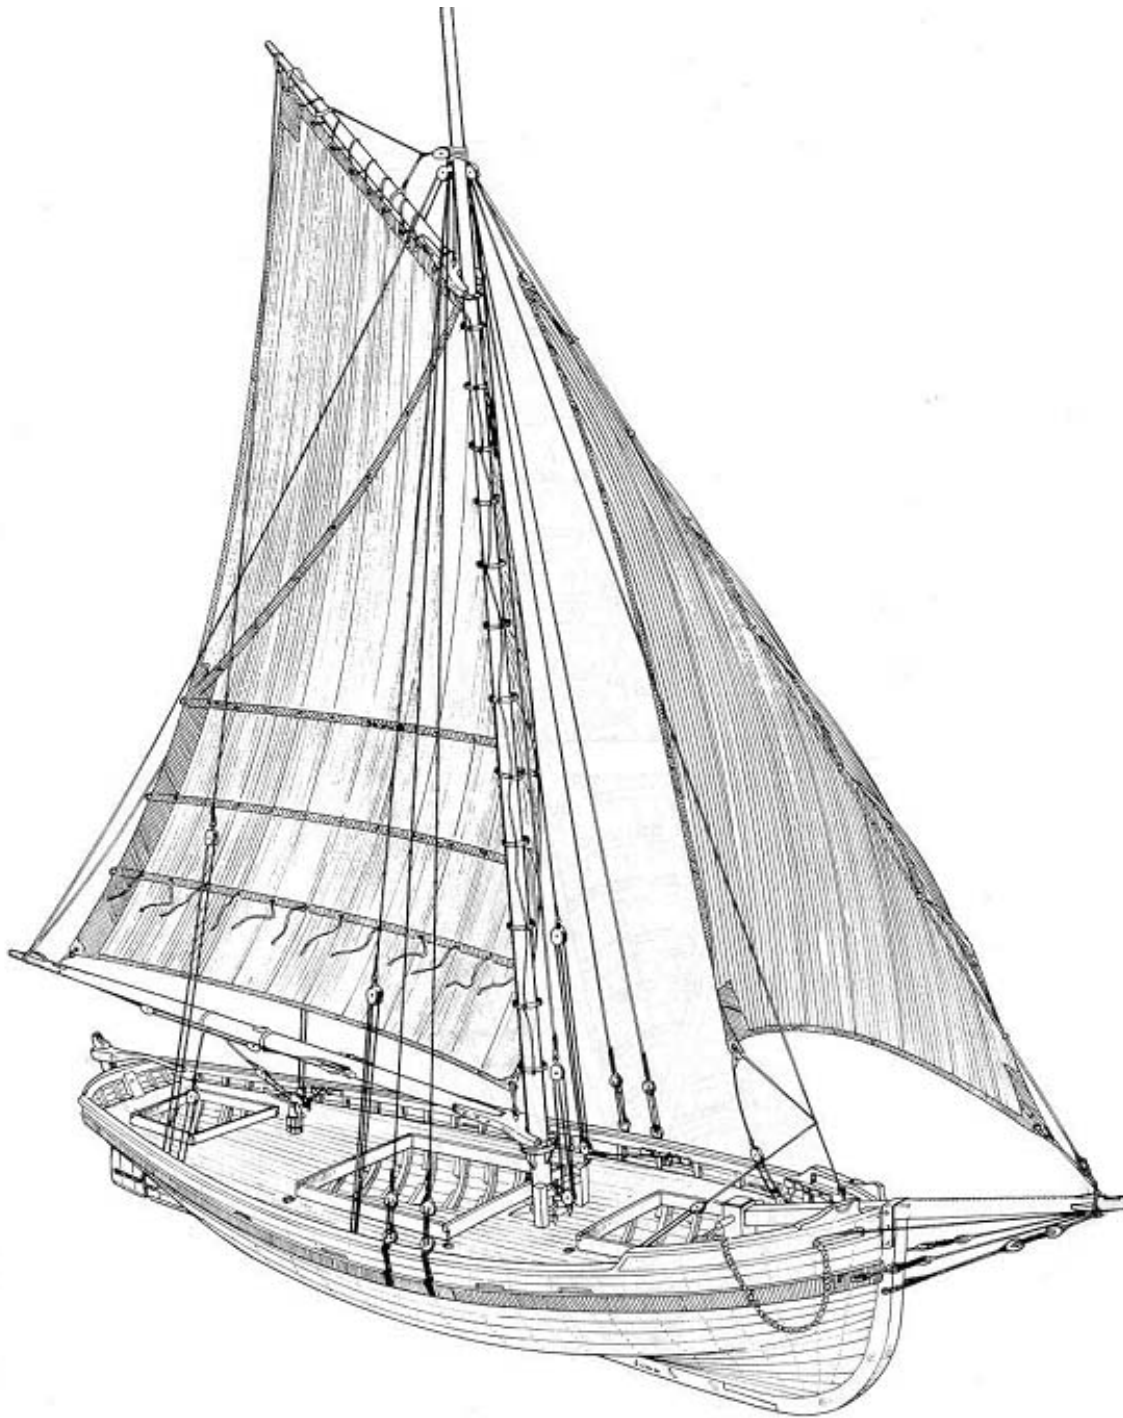
Figure 38. Reconstruction of the Malcolm Boat with a Gaff Rig (drawing by William R. Judd, courtesy of SCIAA).
